Appendix B:

Geotechnical and Structural Analyses

APPENDIX B GEOTECHNICAL AND STRUCTURAL

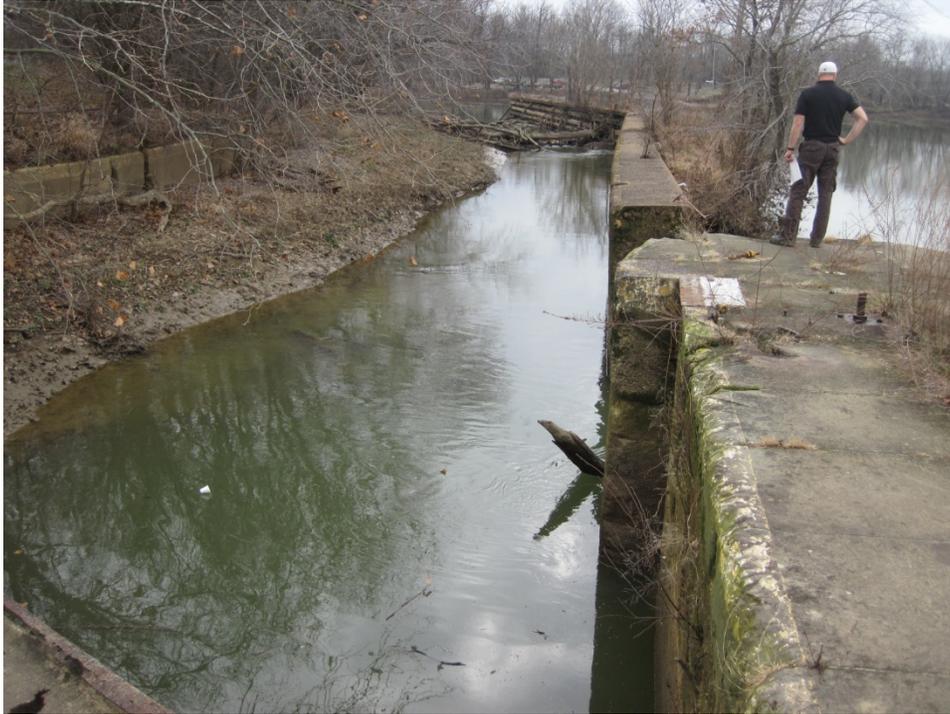
Since routine maintenance was no longer performed on the project, significant siltation has continued to occur around the miter gates and in the lock approaches. Considerable debris had accumulated in the area downstream of the lower miter gates, and the upstream approach has heavy siltation (Figure GR3-5).

Figure GR3-5: Upstream approach channel from river wall at Green River Lock and Dam #3 (Dec. 2013)

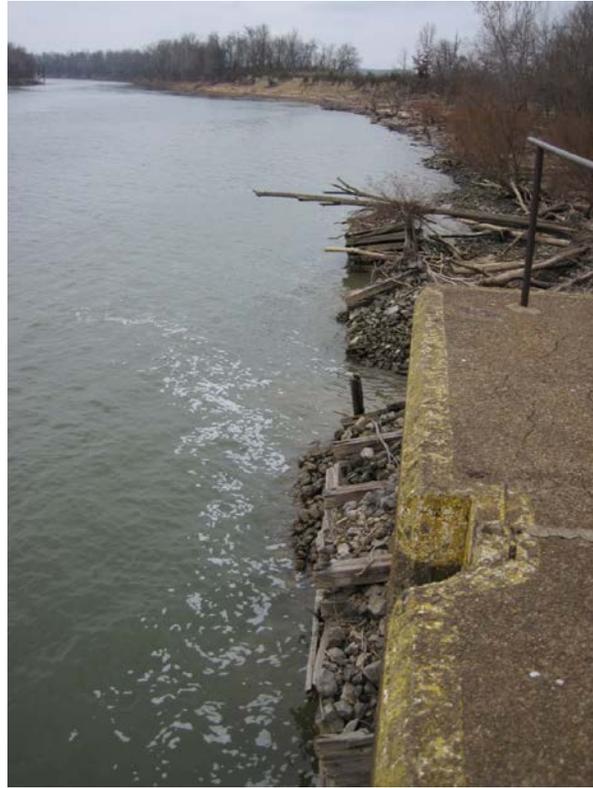
From a stability standpoint, the majority of the project appeared to be in satisfactory condition. The exception to this observation is the rock filled timber cribbing portion of the downstream guide wall, which is in a condition of failure (Figure GR3-6). This wall appears to have deteriorated more since the last inspection in 1998. It has continued to settle and rotate riverward significantly, and it appears a portion of the wall has fallen down or been eroded away completely.

Figure GR3-6: Downstream land side approach wall failure at Green River Lock and Dam #3 (Dec. 2013)

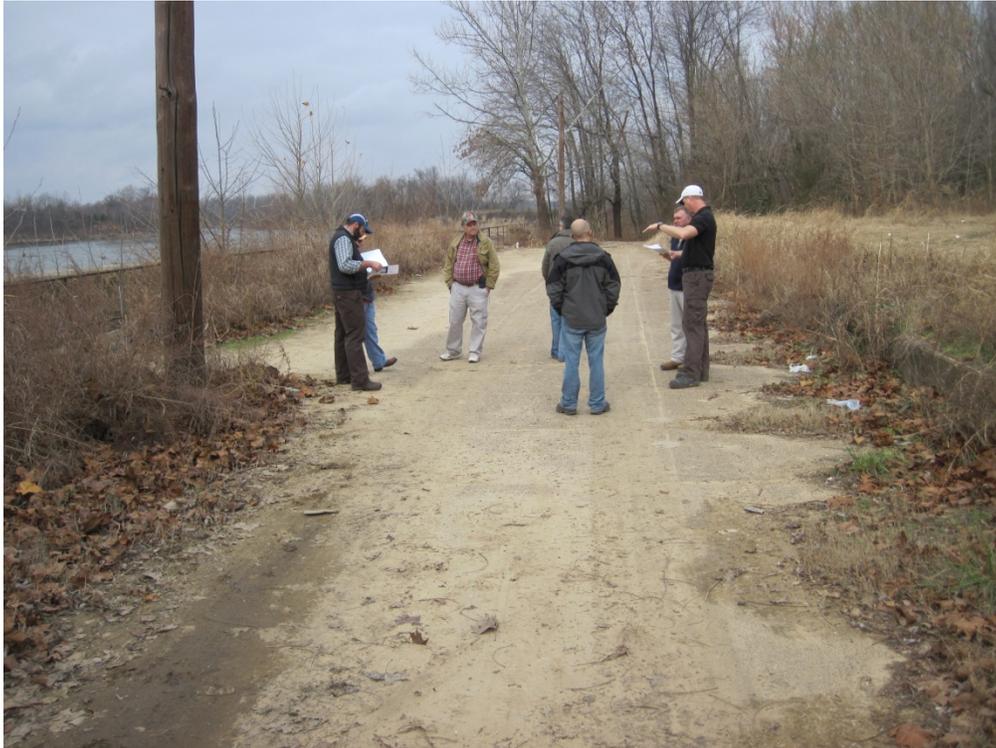
The lockmaster's house and one maintenance shed are still in existence. The primary maintenance/office building has burned down since the previous inspection in 1998. The house roof is in poor condition and is in a state of failure. The brick walls are still intact and are not in any danger of imminent collapse (Figure GR3-7). The esplanade, although cracked, can still adequately support vehicular traffic (Figure GR3-8).

Figure GR3-8: Esplanade at Green River Lock and Dam #3 (Dec. 2013)

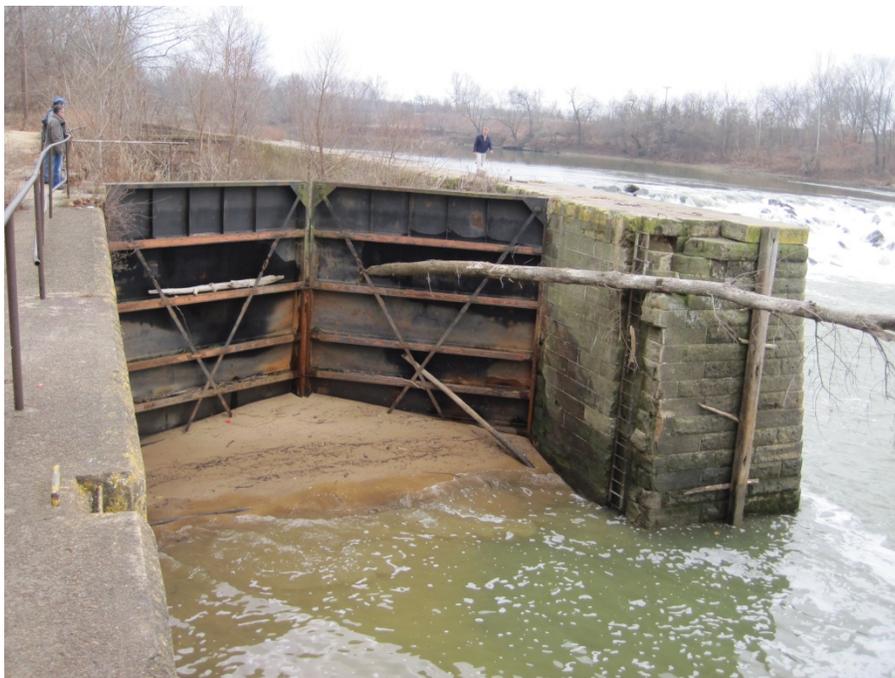
The lock walls are in good condition. They are constructed of cut stone masonry. Their alignments are straight and there appears to be no signs of settlement. There are some root intrusions under the first layer of limestone blocks on the riverside (Figures GR3-3 & GR3-4). The downstream bullnose is losing some of its limestone blocks on the downstream end of the wall. This loss is far enough away from the downstream miter gates that it should not have an effect on the gate's structural integrity (Figure GR3-9).

Figure GR3-9: Downstream bullnose and miter gates at Green River Lock and Dam #3 (Dec. 2013)

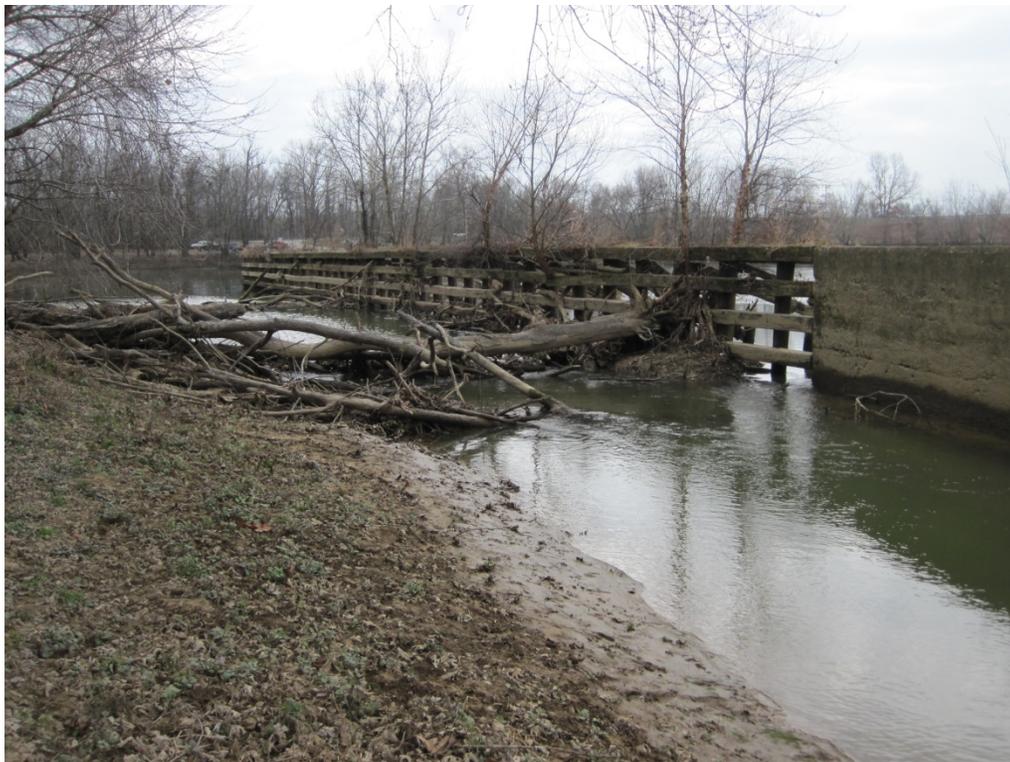
The upstream guard wall is made of timber piling and appears to be in good condition (Figure GR3-11). The downstream guide wall is made of timber cribbing and has failed. It is not impacting the rest of the project.

Figure GR3-11: Downstream miter gates at Green River Lock and Dam #3 (Dec. 2013)

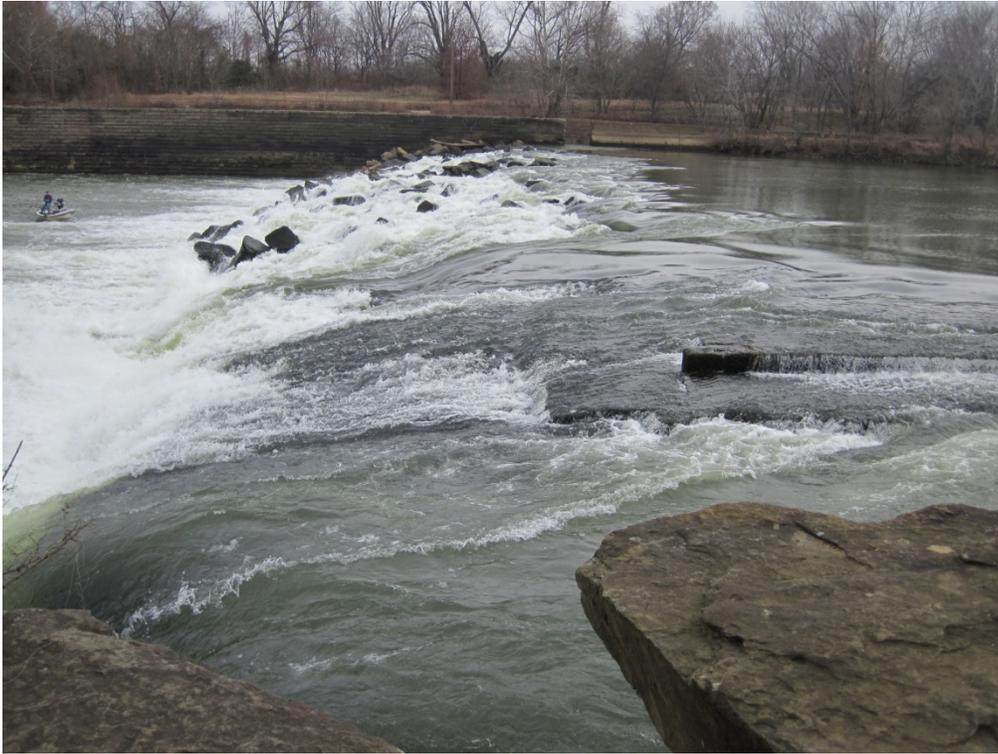
The dam consists of large derrick stones placed on timber cribbing. It appears to be stable (Figure GR3-12).

Figure GR3-12: Dam at Green River Lock and Dam #3 (Dec. 2013)

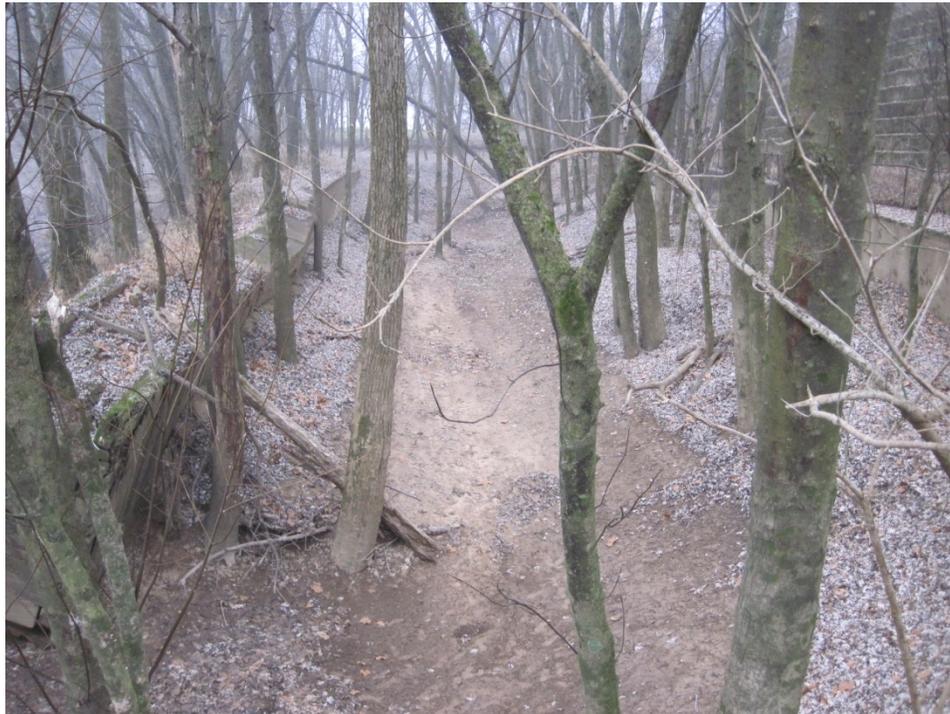
Due to the breach of the dam, there was no pool differential, and the upstream approach to the lock was completely silted in, with significant tree growth (Figure GR4-5). A major section of the dam was gone due to the breach (Figure GR4-6). Significant siltation had occurred downstream of the right bank abutment of the dam.

Figure GR4-5: Upstream approach channel from upstream miter gates at Green River Lock and Dam #4 (Dec. 2013)

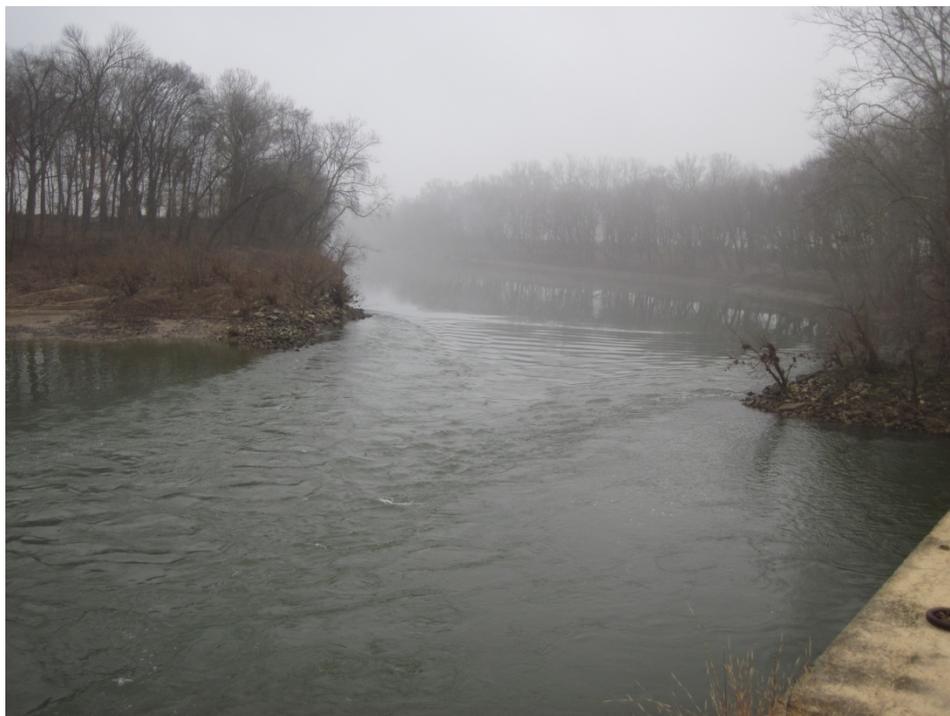
Figure GR4-6: Section of dam missing due to breach at Green River Lock and Dam #4 (Dec. 2013)

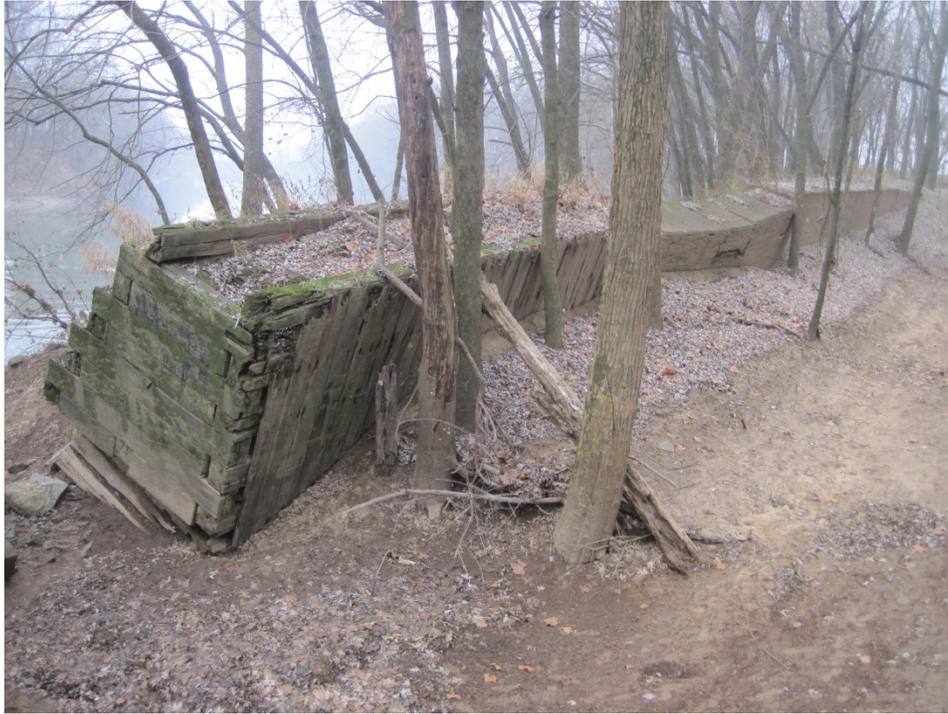
Due to the breach in the dam, the upstream approach channel is completely silted in, with significant tree growth. This tree growth has caused the upstream approach wall, which is constructed of wood cribbing, to fail by rotating landward. It appears the wall rotation has been stabilized by the tree growth and silt on either side.

Figure GR4-7: Upstream river side approach wall failure at Green River Lock and Dam #4 (Dec. 2013)

No actions are recommended for the section of the upstream guard wall which has failed. Should the wall continue to rotate, it will not cause any damage.

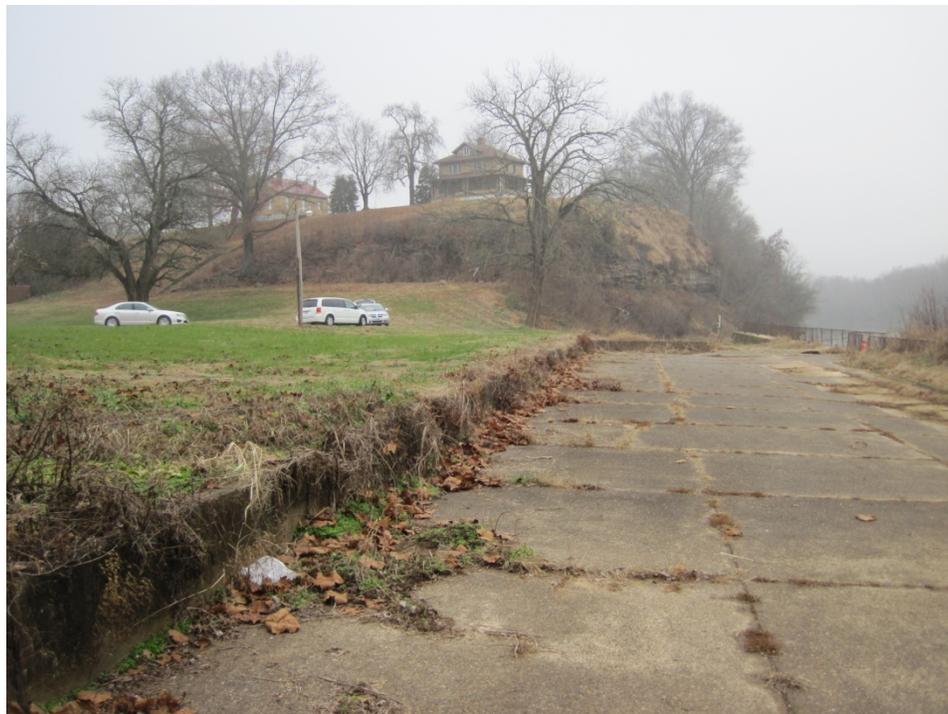
The esplanade appears to be in good condition and can still support vehicular loads (Figure GR4-8). The lock wall alignments are straight and there appears to be no settlement. There is some root intrusion in some of the limestone block joints. Also, there are some limestone block faces that have spalled off due to freeze-thawing. But overall, the lock walls are considered to be structurally sound (Figures GR4-3 & GR4-4).

Figure GR4-8: Esplanade at Green River Lock and Dam #4 (Dec. 2013)

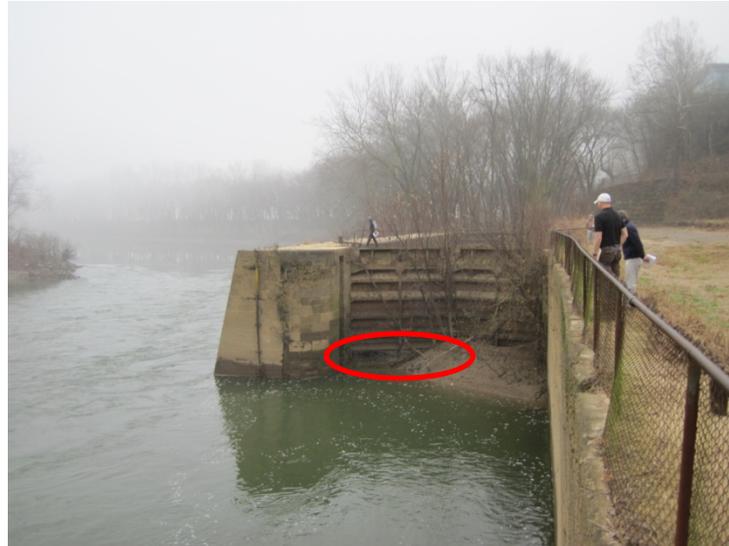
The upstream miter gates are holding back a significant amount of silt and tree growth. All visible structural member connections look sound (Figures GR4-10). The downstream miter gate is missing its members at and below the waterline, and there is some visible rusting and pitting of the rest of the gates (Figures GR4-9).

Figure GR4-9: Missing structural members at and below the water line, Green River Lock and Dam #4 (Dec. 2013)

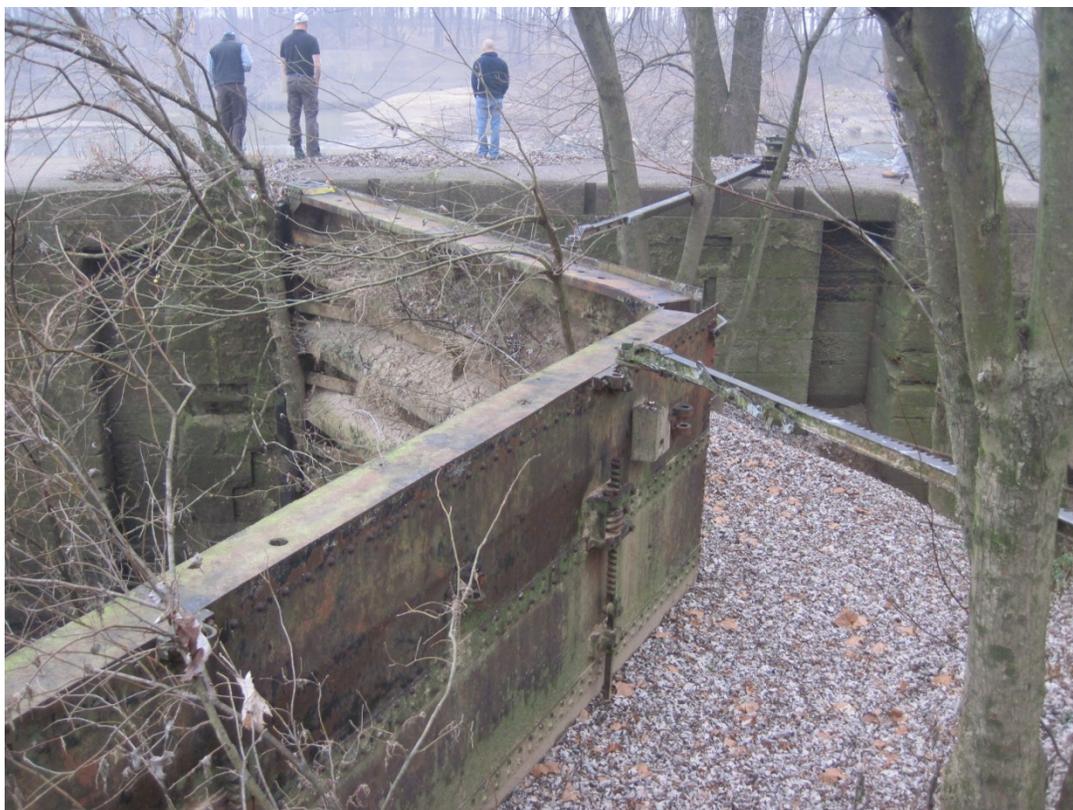
Figure GR4-10: Upstream miter gates holding back a significant amount of silt and tree growth, Green River Lock and Dam #4 (Dec. 2013)

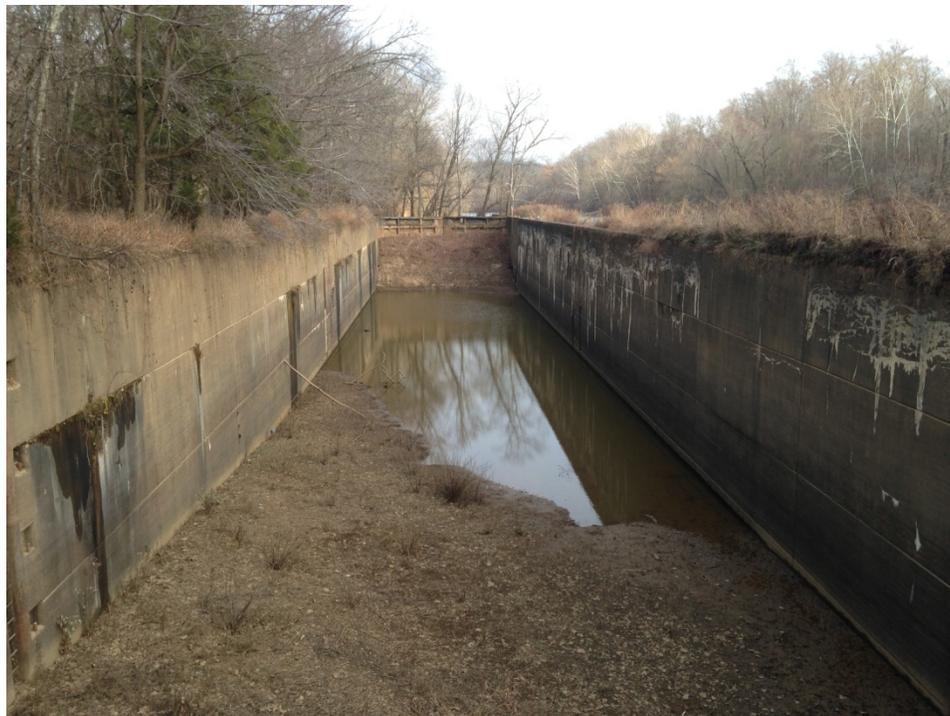
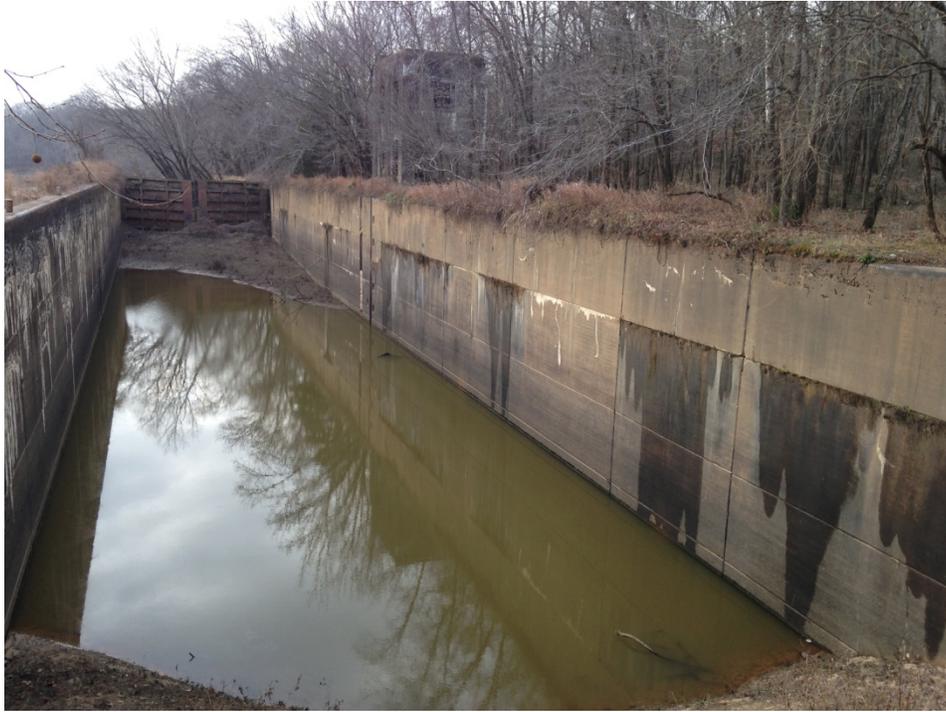
The miter gates are holding back a significant amount of silt and tree growth. At least 3/4 of the upper gate and half of the lower gates are covered by silt (Figures GR5-2 & GR5-3). The structural member connections that are visible look sound. There is some visible rusting and pitting of the steel. The concrete dam, though underwater at the time of the visit, appears to be in good condition. Since the dam is underwater, any potential undermining, underseepage, or other structural deterioration is unknown (Figure GR 5-6). The only way to fully assess the condition of the dam would be when the flow was sufficiently low that water was not passing over the dam. This flow condition is very rare.

Figure GR5-2: Siltation of lock chamber and vegetation at Green River Lock and Dam #5 looking upstream from downstream miter gates (Dec. 2013)

Figure GR5-3: Siltation of lock chamber and vegetation at Green River Lock and Dam #5 looking downstream from upstream miter gates (Dec. 2013)

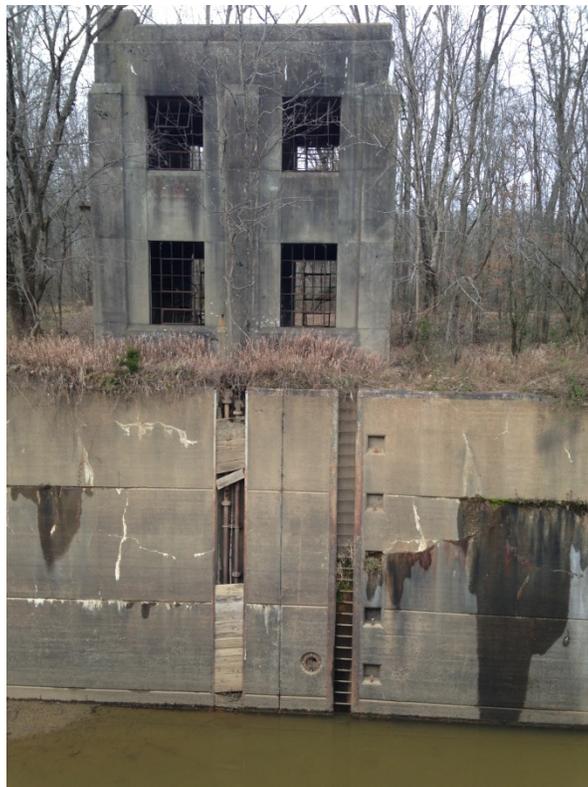
The two story control tower is missing window panes but otherwise appears in good condition (Figure GR5-4). There is no exposed reinforcing and the condition of the concrete is good. The spiral stairs are still intact that provides access to the second level. The balcony at the second level is still structurally sound and is in good condition. Additionally, a lifting beam was observed on site that could be salvaged.

Figure GR5-4: Power House located on the land side wall at Green River Lock and Dam #5 (Dec. 2013)

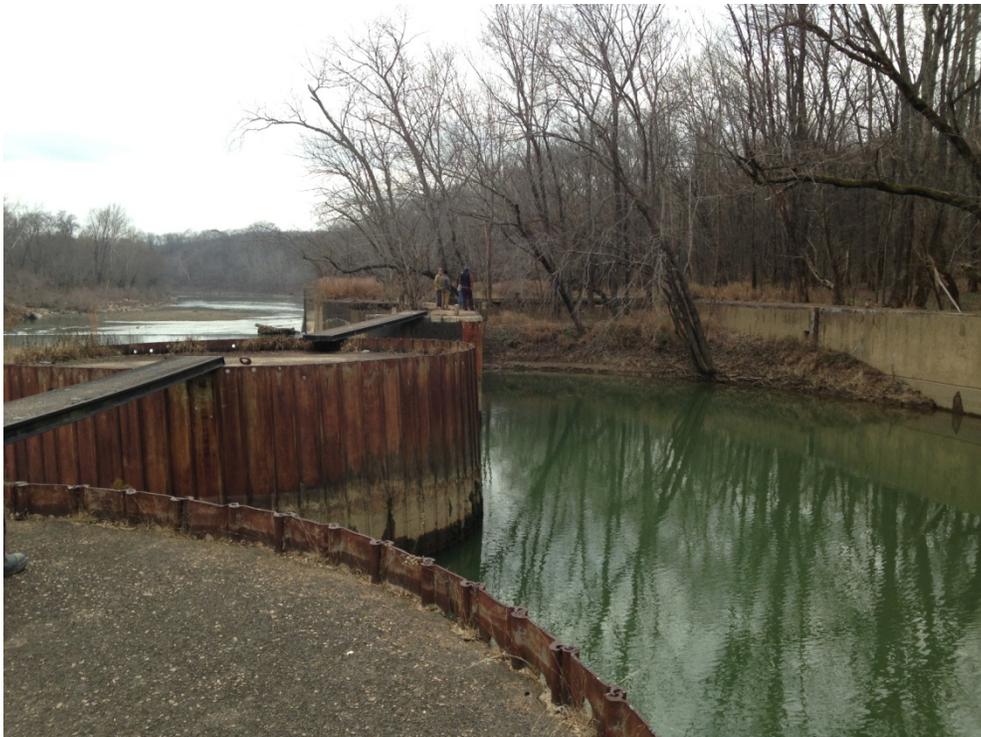
The concrete lock walls have good alignment and show no signs of settlement. There are some visible cracks, but the overall conditions of the lock walls are good. The upper and lower guide walls have excellent alignment, show no signs of settlement, and look in very good condition (Figures GR5-2 through GR5-4). This lock system also used two sheet pile cells as part of the river side upstream guard walls. These cells, which are linked together by walkway planks, appear to be in good condition (Figure GR5-8).

Figure GR5-8: Upstream guard cells with walkway planks looking downstream (Dec. 2013)

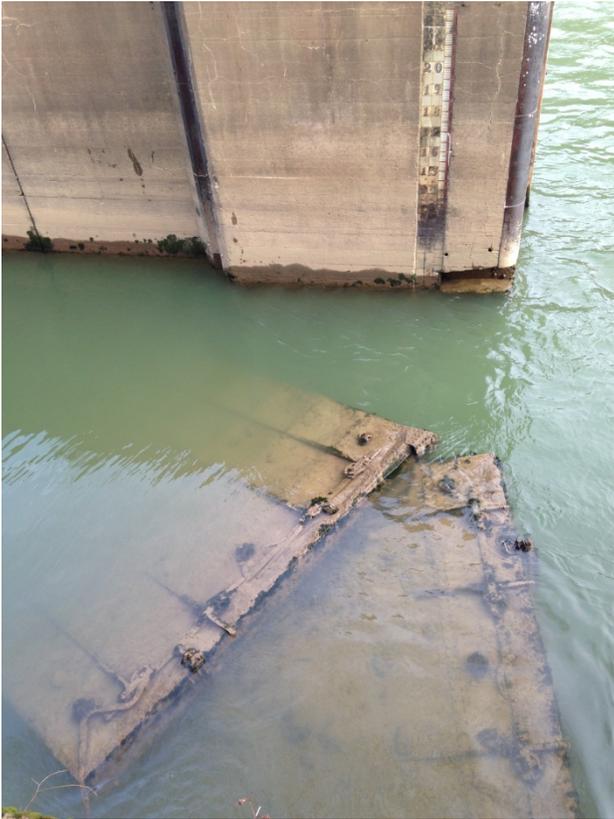
The downstream miter gates have been cut off and are lying in the chamber. The upper gates were encased in concrete to a height equal to that of the dam.

Figure GR6-2: Downstream miter gates have fallen into lock chamber at Green River Lock and Dam #6 (Dec. 2013)

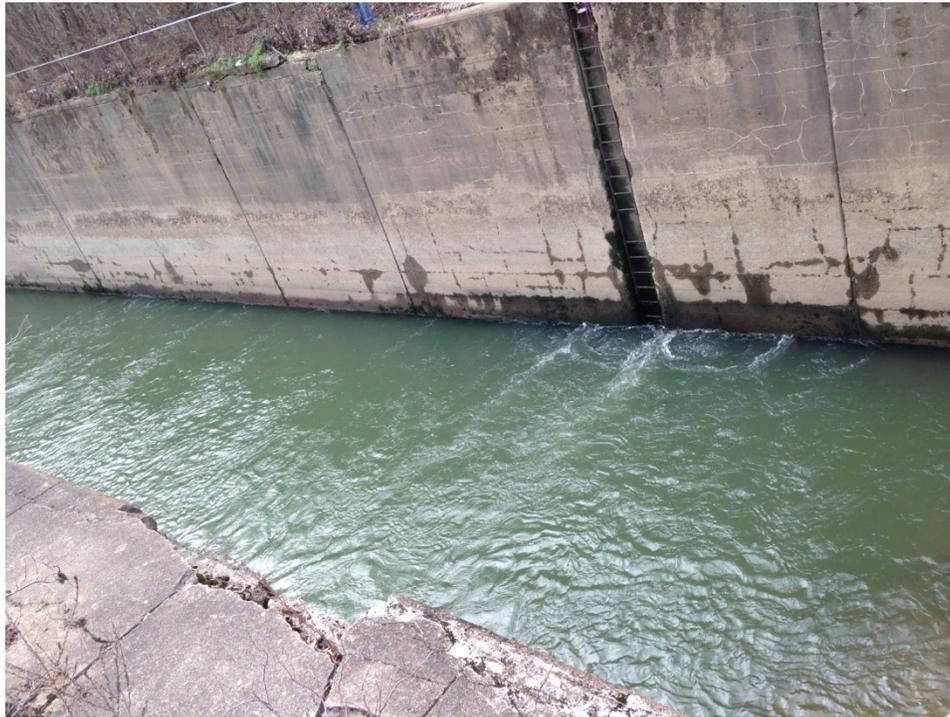
Since the downstream gates have been removed siltation has not occurred around the upstream and downstream gates, inside and outside of the lock chamber. However, debris has accumulated in the upper approach area, and between the sheet pile cutoff and the upper gates (Figure GR6-7). Some spalling was evident on the lock walls (Figure GR6-3).

Figure GR6-3: Lock chamber looking downstream from river wall at Green River Lock and Dam #6 – note seepage under lock wall at ladder (Dec. 2013)

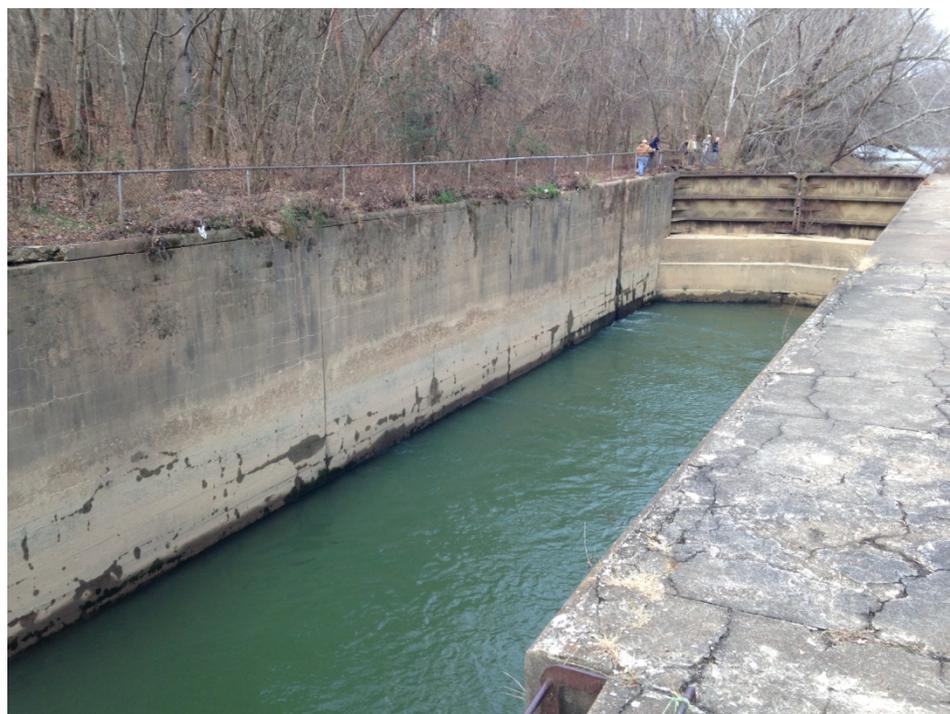
The concrete in the lock walls appear to be undergoing some deterioration but are in satisfactory condition overall. The alignment still appears to be good with no visible signs of settlement (Figure GR6-4).

Figure GR6-4: Lock chamber looking upstream from river wall at Green River Lock and Dam #6 (Dec. 2013)

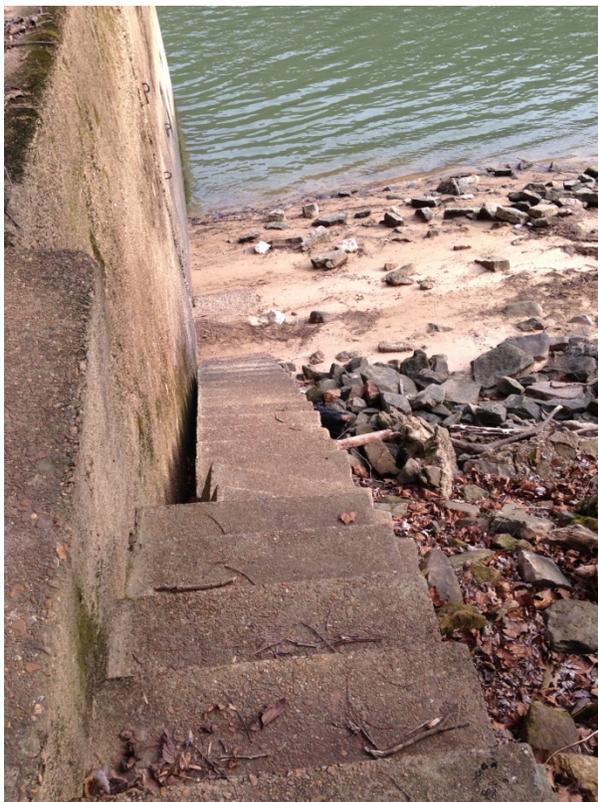
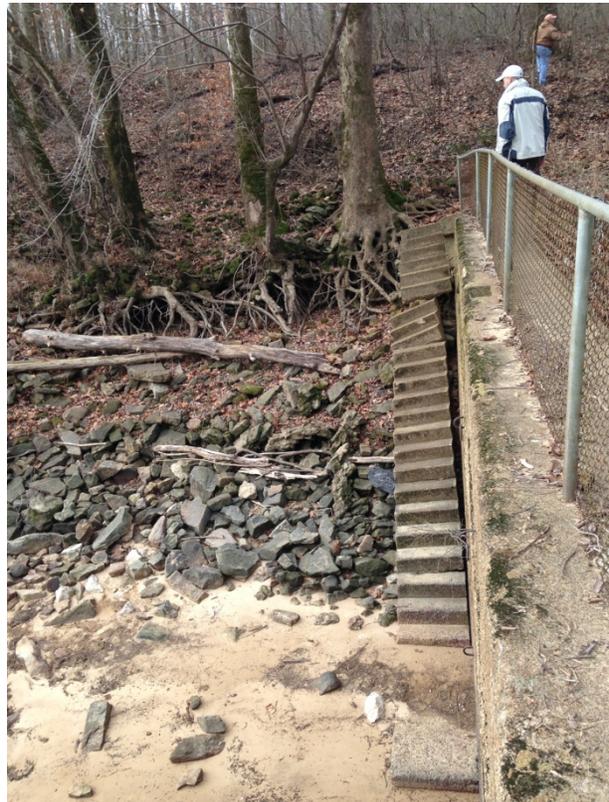
Figure GR6-6: Downstream land wall stairs failure at Green River Lock and Dam #6 (Dec. 2013)

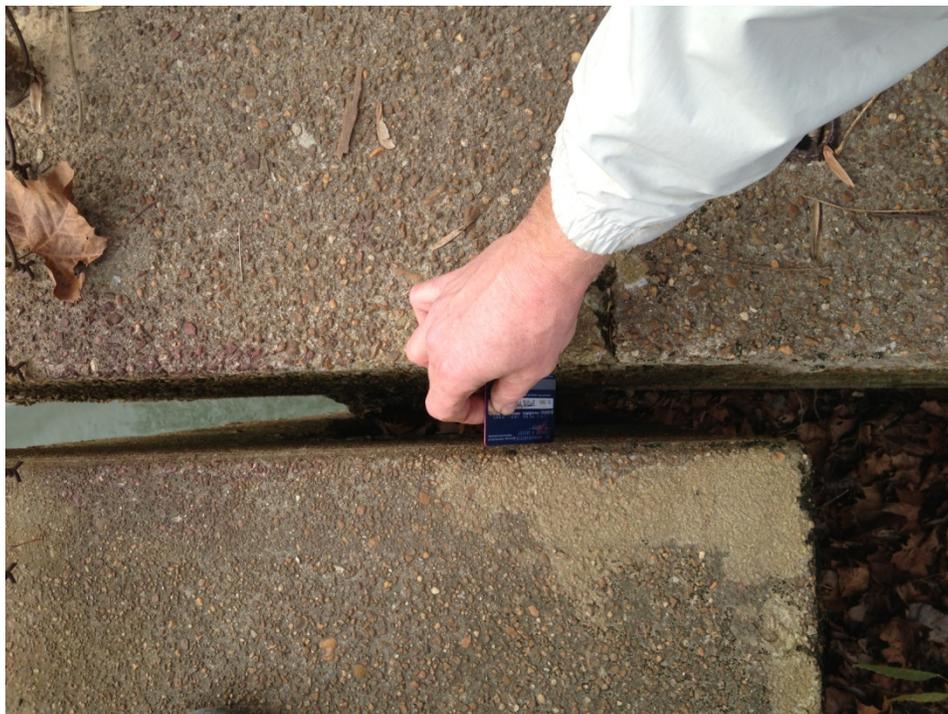
Figure GR6-8: Gap in monolith joint on end of downstream lock wall at Green River Lock and Dam #6 (Dec. 2013)

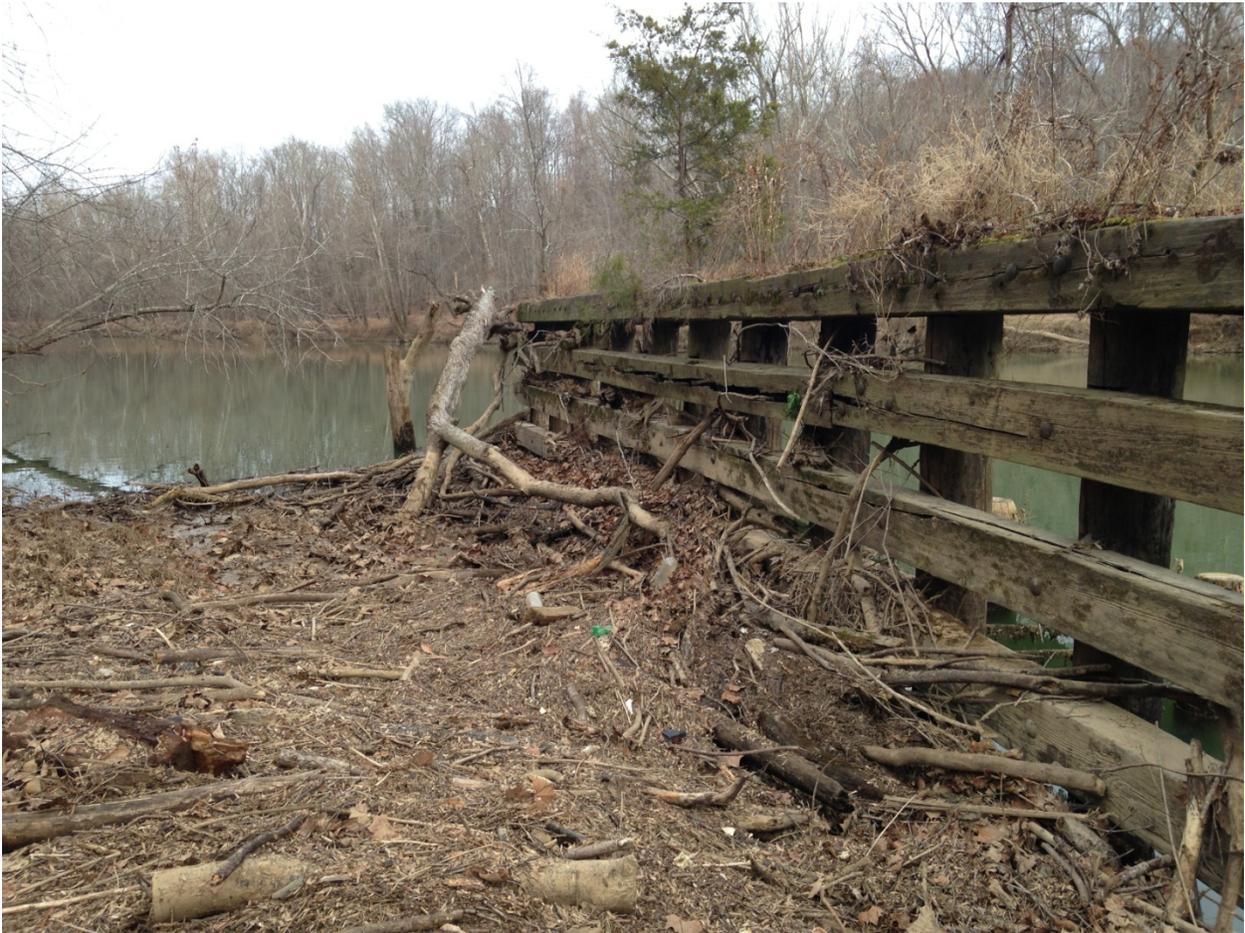
Most of the upper guide and guard walls are made of timber pilings and timber rails. These have been taken over by trees growing through the rails (Figures GR6-5, GR6-9). The complete failure of this wall section will not affect the river flow, or pool. The portion of the upper landside guide wall next to the upper gates is made up of concrete monoliths and is rotating with the growth of trees. A section of this wall was removed for the placement of the sheet pile cutoff wall. The approach channel has become blocked by silt, debris, and vegetation.

Figure GR6-9: Upstream approach channel Guard wall at Green River Lock and Dam #6 (Dec. 2013)

It appears that the guide and guard wall sections will not cause damage or concern should they continue to move. Therefore, no repair action is recommended. Lock walls appear stable with no repair action recommended. Also, egress for this structure is not an issue since the downstream gates have been removed.

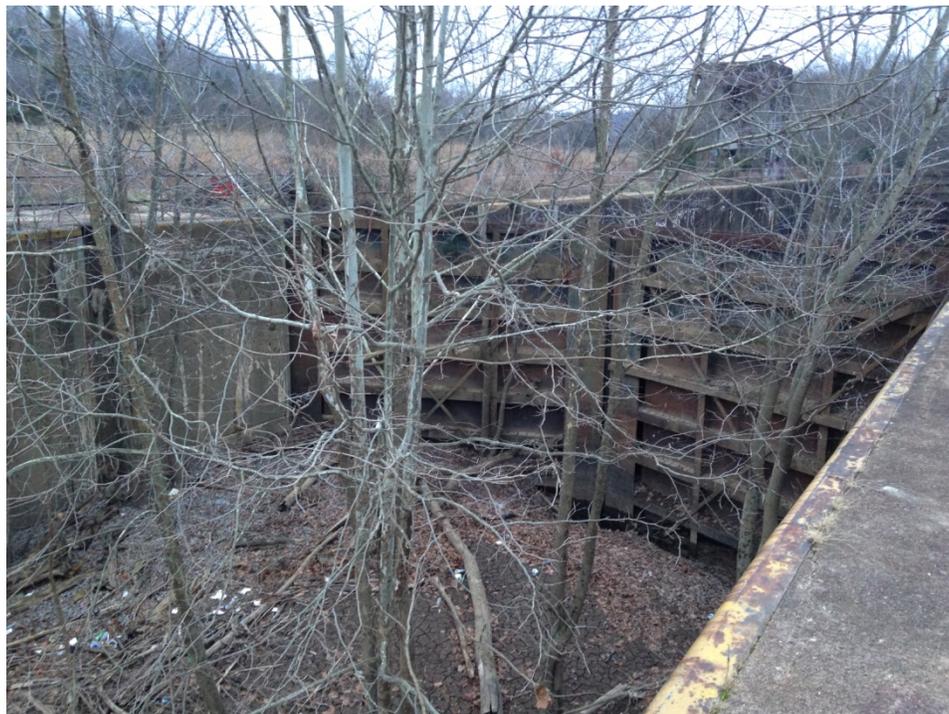
The portions of the miter gates that are visible appear to be in good condition. Approximately 1/3 of the gates have silt against them (Figure BR1-6). All structural members look sound, and all connections and welds appear to be intact.

Figure BR1-6: Siltation downstream of downstream miter gates at Barren River Lock and Dam #1 (Dec. 2013)

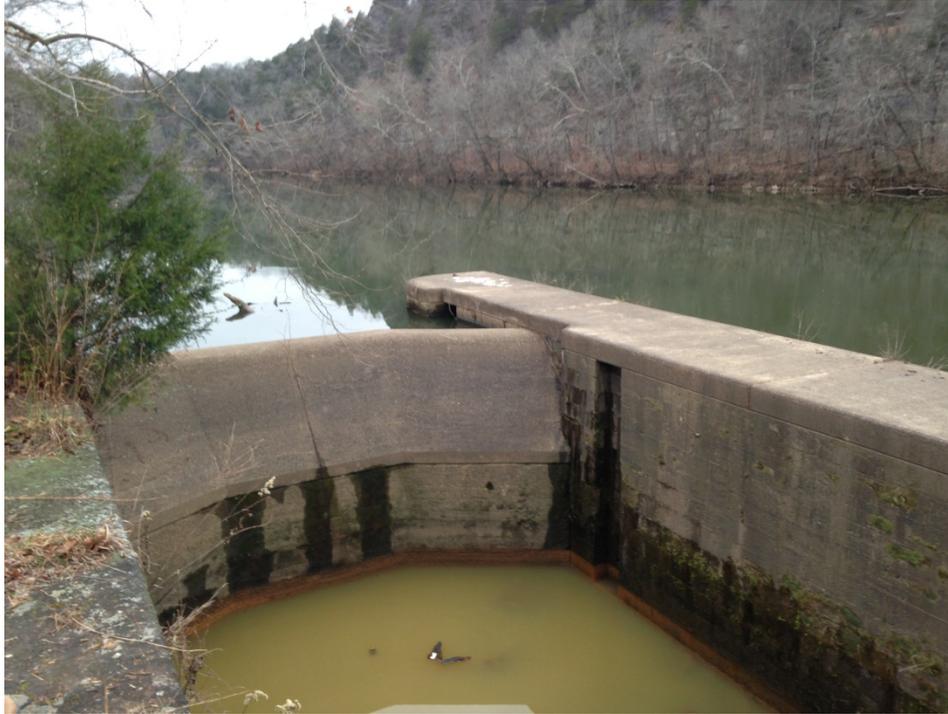
The old lock chamber was put out of service by placing a concrete cutoff wall across the upstream sill, and putting rock fill in the rest of the chamber. This concrete cutoff wall appears to be in good condition (Figure BR1-7). There was not much evidence of the rock fill in the chamber on this visit due to high water. Some of the rock or fill may have settled or washed away (Figure BR1-7).

Figure BR1-7: Concrete cutoff placed across upstream sill of the old lock chamber at Barren River Lock and Dam #1 (Dec. 2013)

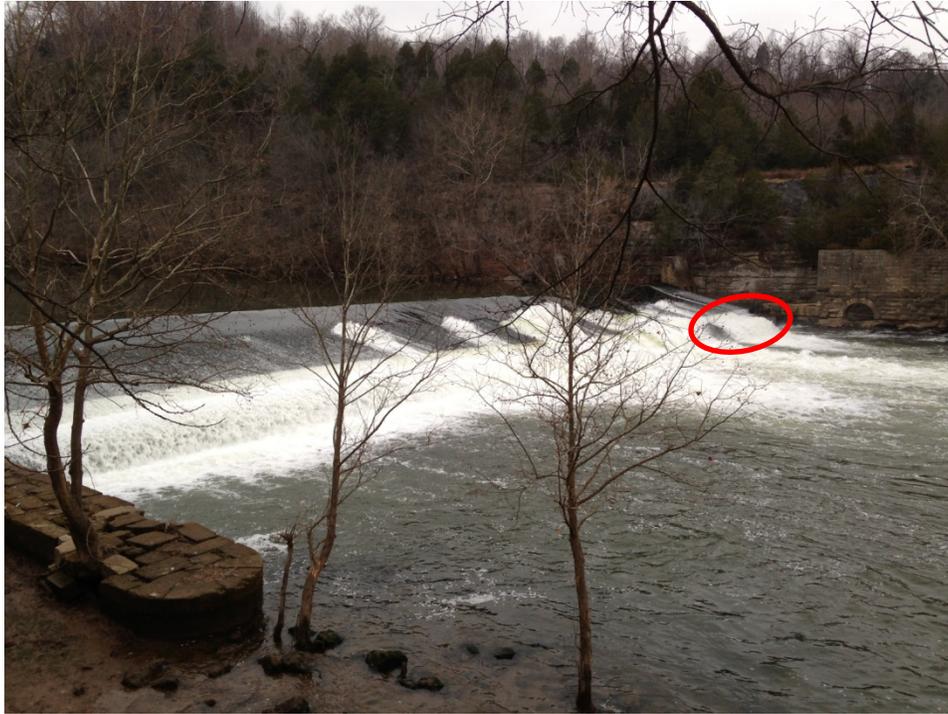
Figure BR1-8: Dam with old lock chamber in the foreground at Barren River Lock and Dam #1. Circled area is of turbulent water flow noted during inspection (Dec. 2013)

At the time of this report, no work is recommended for improving the stability of this project. However, there is some concern about the stability of the dam. To eliminate this concern, a cutoff would need to be established upstream of the dam. The most effective means of cutoff would be a single row of sheet piling driven immediately upstream of the upstream face of the dam. The area between the sheet pile wall and sloping face of the dam would then be filled with large-size stone. This is similar to a repair technique used on the Kentucky River Locks but would prove to be very expensive and not even known to be warranted at this time.

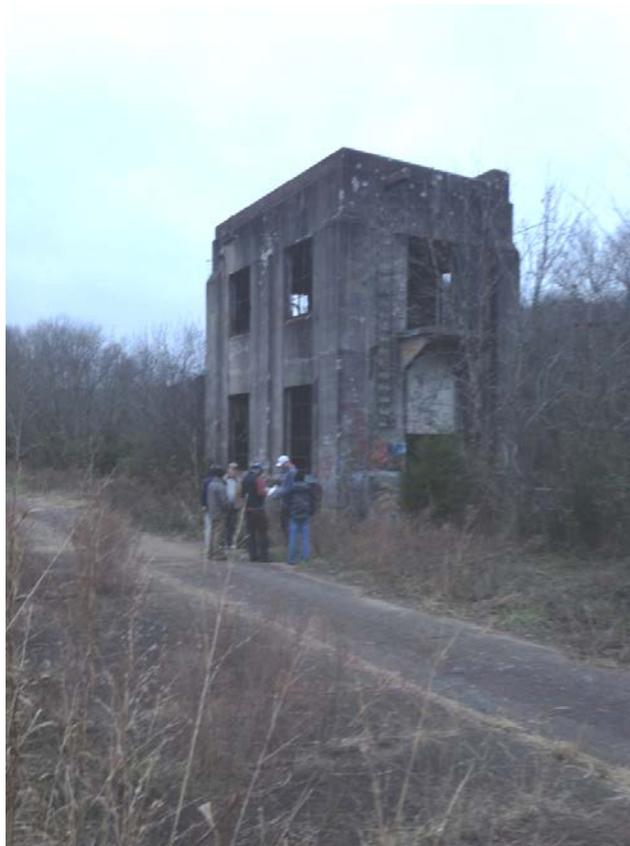
The overall structural condition of Barren River Lock and Dam 1 project appears to be good. The two story control tower is missing window panes and has evidence of bullet holes, but there is no exposed reinforcing and the overall condition of the concrete is good (Figure BR1-2). The esplanade, although cracked, can still adequately support vehicular loads (Figure BR1-9).

Figure BR1-9: Esplanade with control tower in the background at Barren River Lock and Dam #1 (Dec. 2013)

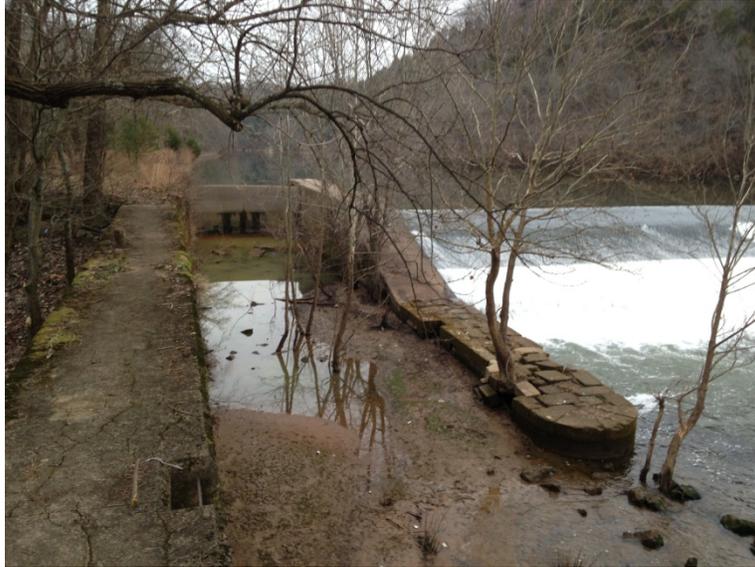
A significant amount of siltation has occurred upstream of the lock, and trees were observed growing in the upstream approach channel. Trees were also observed growing through holes in the old lock walls (Figure BR1-10). Wet spots on the lock land wall indicated water was seeping through cracks in the wall. No changes were noted from the previous inspection in 1998.

Figure BR1-10: Old lock chamber at Barren River Lock and Dam #1 (Dec. 2013)

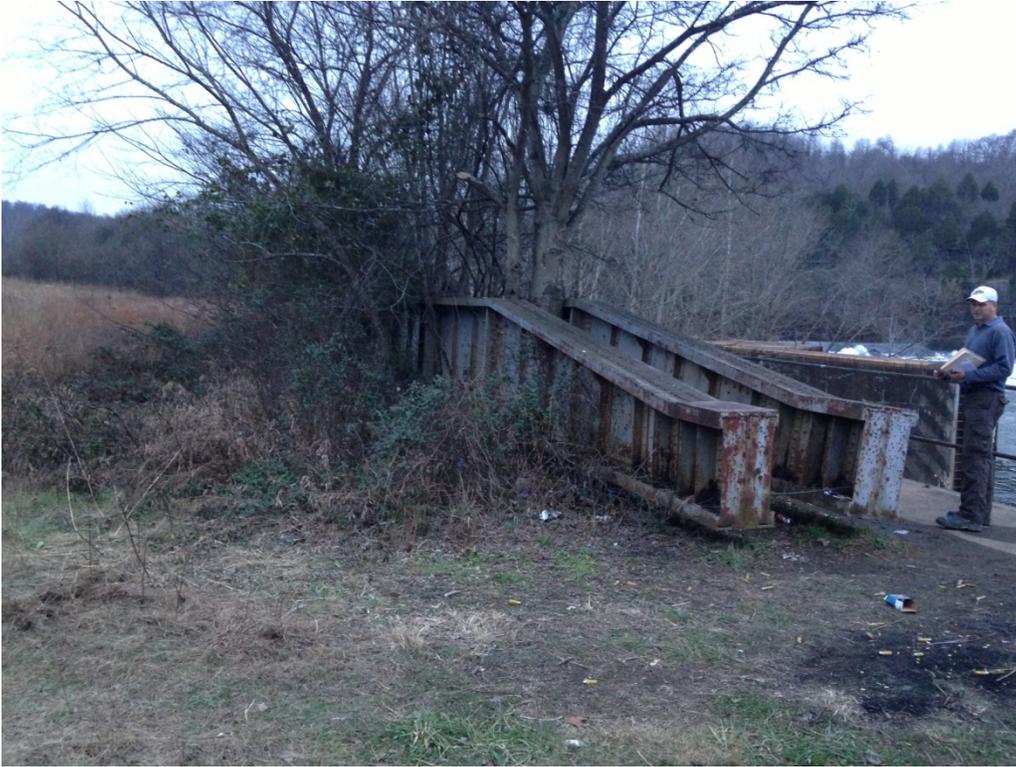
Additionally, two dewatering beams were observed on site that appeared to be in good condition. These could be scrapped, or salvaged and reused at another project site (Figure BR1-12).

Figure BR1-12: dewatering beams at Barren River Lock and Dam #1 (Dec. 2013)
