ROOF ASSESSMENT REPORT
FOR

**US Army Corps
of Engineers.**

020CHS-097 - 9th MSC-HI006

ROOF ASSESSMENT REPORT

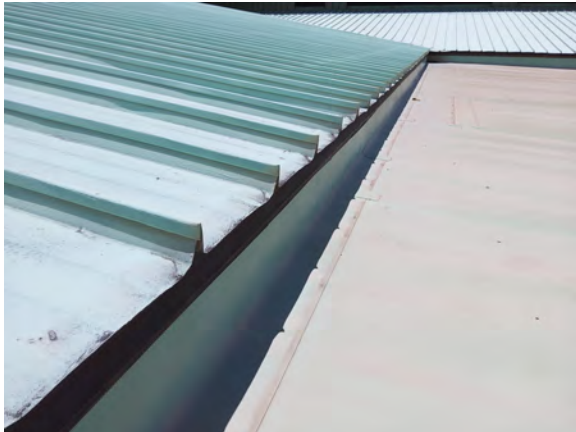
Panel was not terminated at edge. No edge detail was observed. Water intrusion is possible due to void at eave.

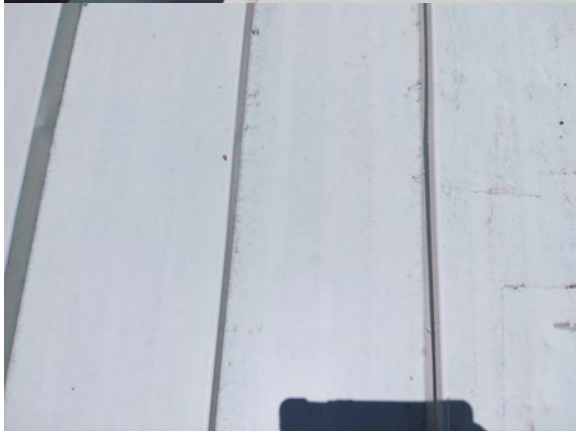
Coating on roof is moderately deteriorated. Blisters and unadhered reinforcement are visible in several areas.

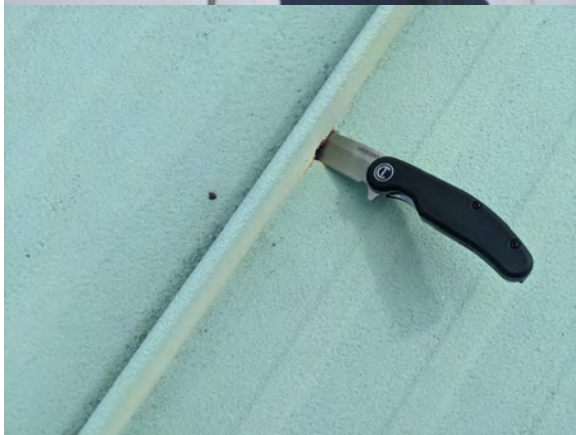
Holes caused by corrosion are visible in several locations.

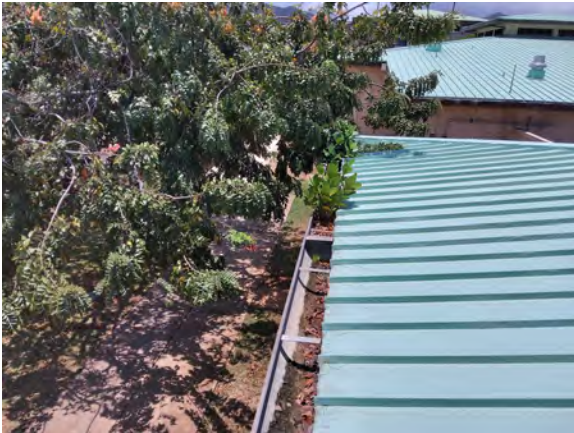
Adjacent trees that overhang the roof can cause algae growth, a build up of debris, and general deterioration of the roof membrane.

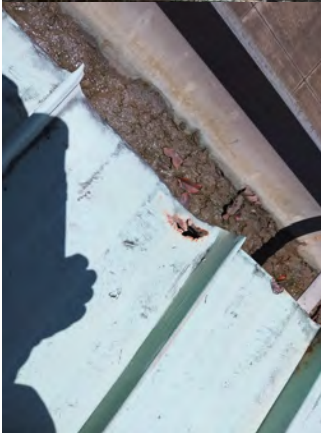
Holes caused by corrosion are visible in several locations.

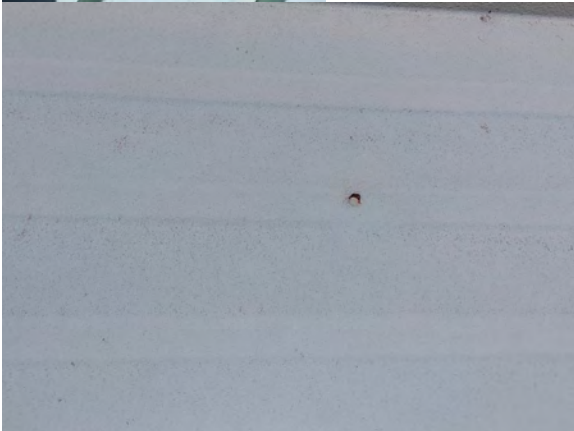
Panel was observed to have a hole caused by corrosion. This may allow water intrusion.

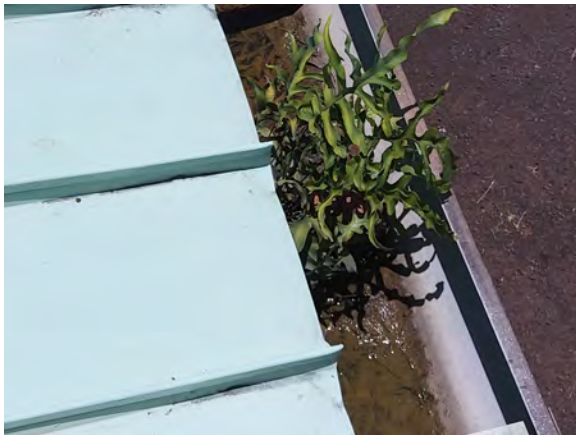
Vegetation growing in the gutter, usually in conjunction with a buildup of dirt and ponding water.

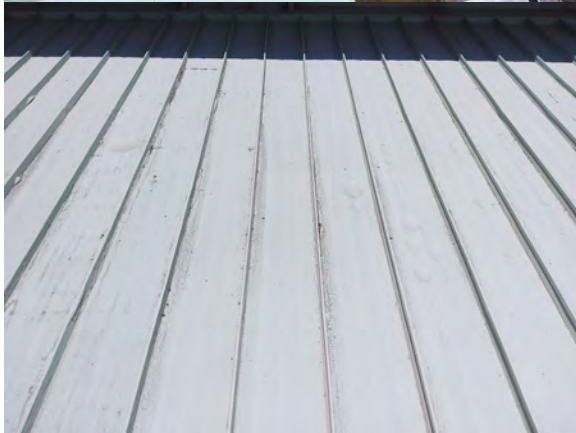
Blistering was observed in the coating on the roof panels in multiple locations.

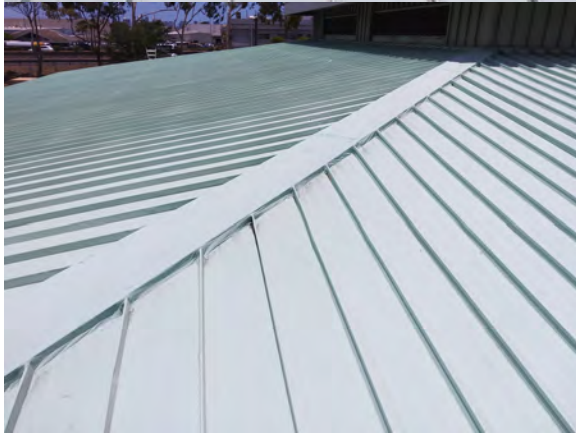
The coating reinforcement at transitions is loose at multiple areas.

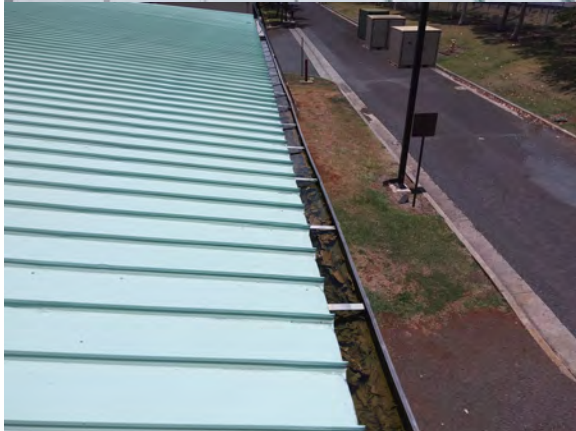
Gutter outlet/downspout is blocked and preventing drainage and causing gutter to remain full.

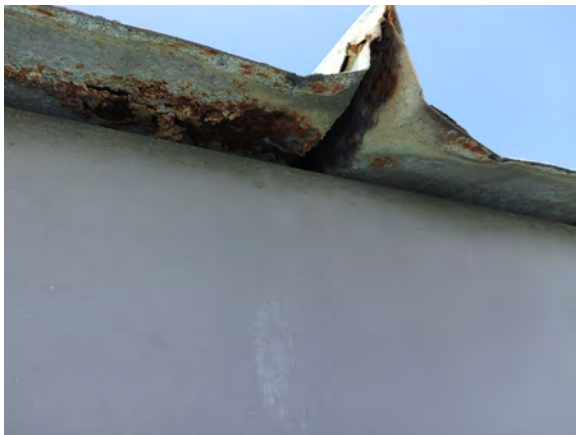
Panel was not terminated at edge. No edge detail was observed. Water intrusion is possible due to void at eave. Visible corrosion was also observed.

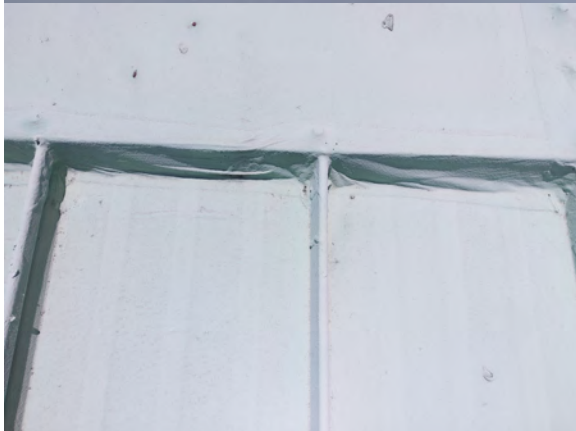
The coating reinforcement at transitions is loose at multiple areas.

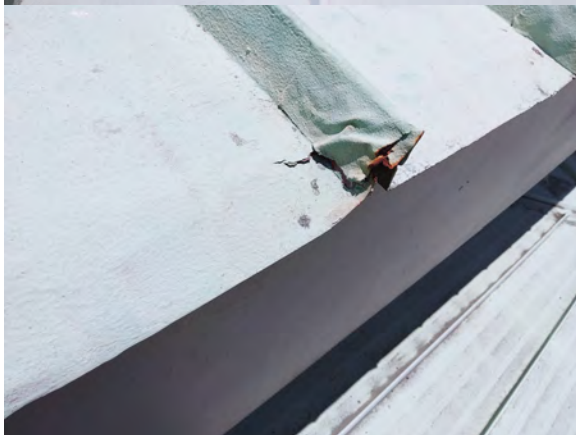
Holes and cracks caused by corrosion are visible in several locations.

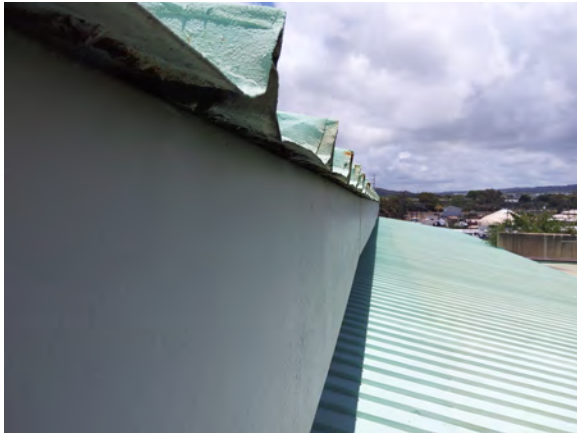
Panel was not terminated at edge. No edge detail was observed. Water intrusion is possible due to void at eave. Visible corrosion was also observed.

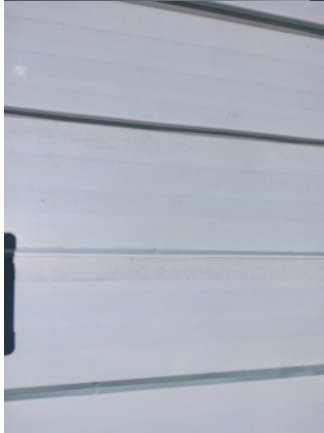
Coating on roof is moderately deteriorated. Blisters and unadhered reinforcement are visible in several areas.

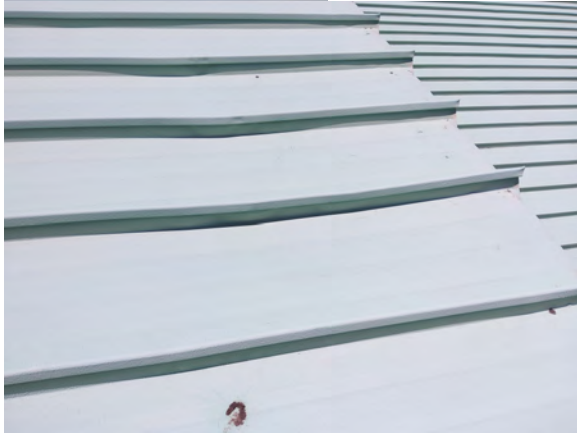
Panels at eave were noted to be loose and clips may have disengaged. Further investigation is needed to confirm the cause.
35-SF

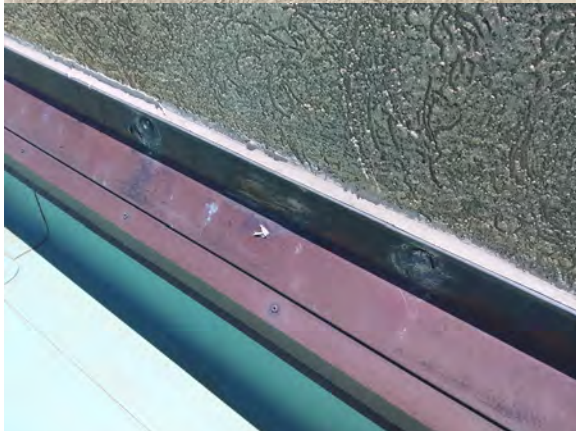
Sealants at sealant tray of counterflashing are deteriorating and should be budgeted for replacement.

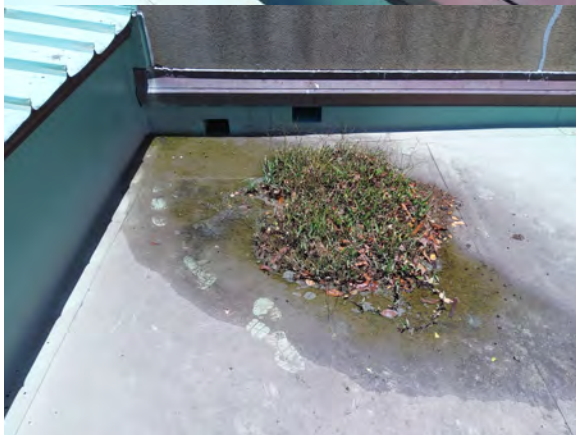
Debris was observed at scuppers and live vegetation is present. Roof should be kept clean to prevent damage to membrane.

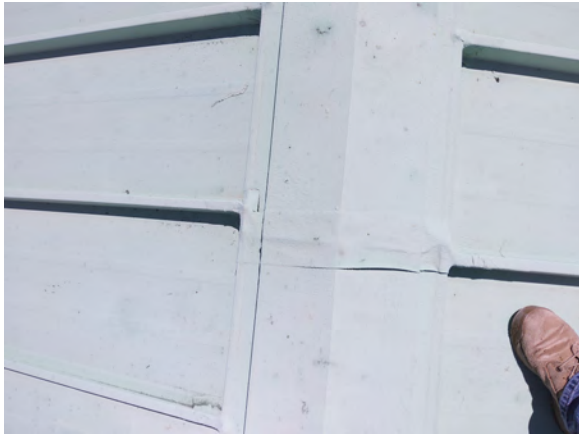
Seam at reinforcement at ridge line is open and unadhered which may allow water intrusion.

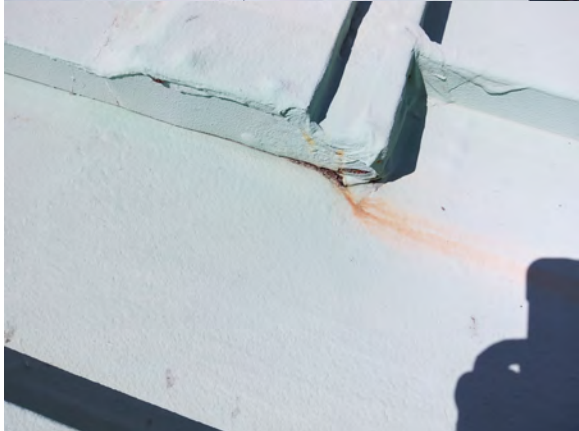
Rust at transition was observed. Coating was incomplete and further investigation is needed to determine cause of corrosion.

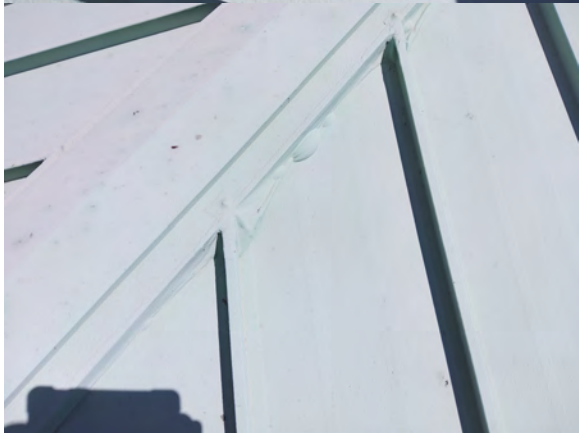
Blistering was observed in the coating on the roof panels in multiple locations.

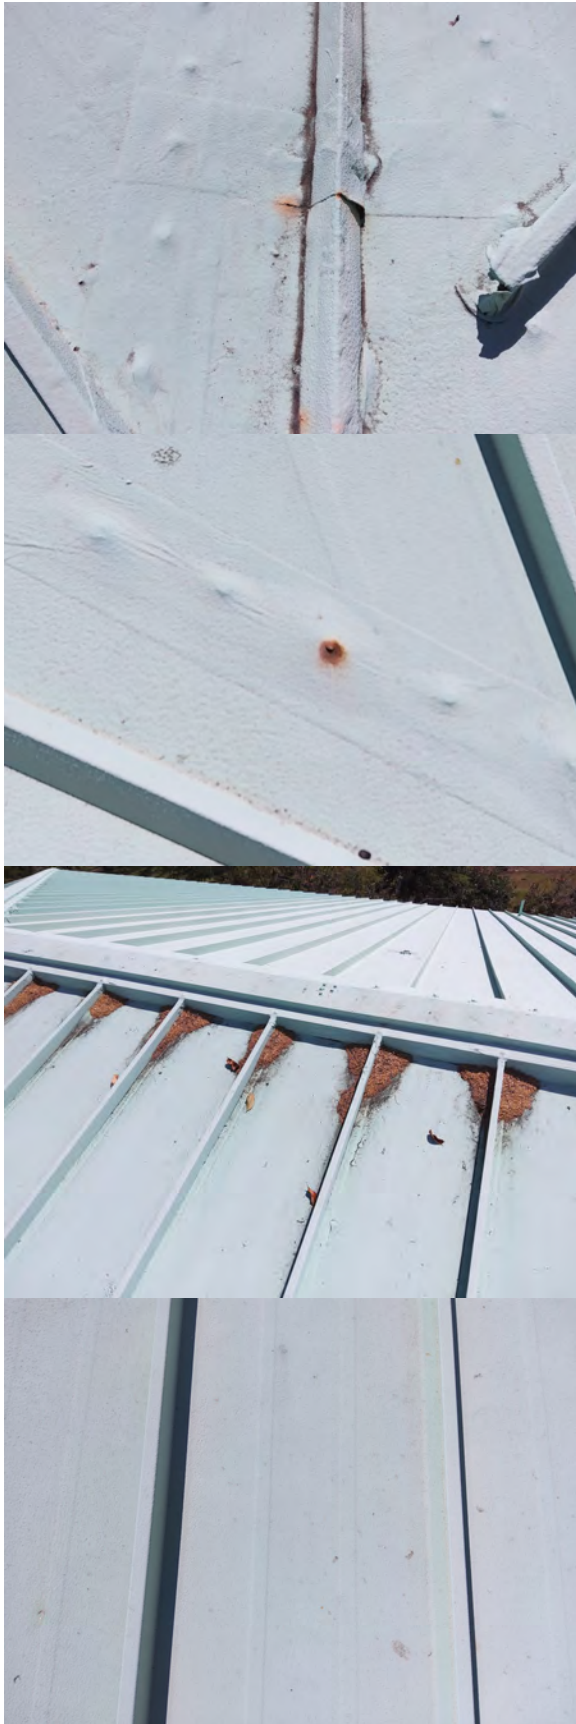
Seam at reinforcement in valley is open and unadhered which may allow water intrusion.

Fastener is backing out through reinforcement and is rusting at several areas.

Minor debris was observed on roof. Roof should be periodically inspected and cleaned.

Coating is in fair condition and should continue to be monitored for deterioration.

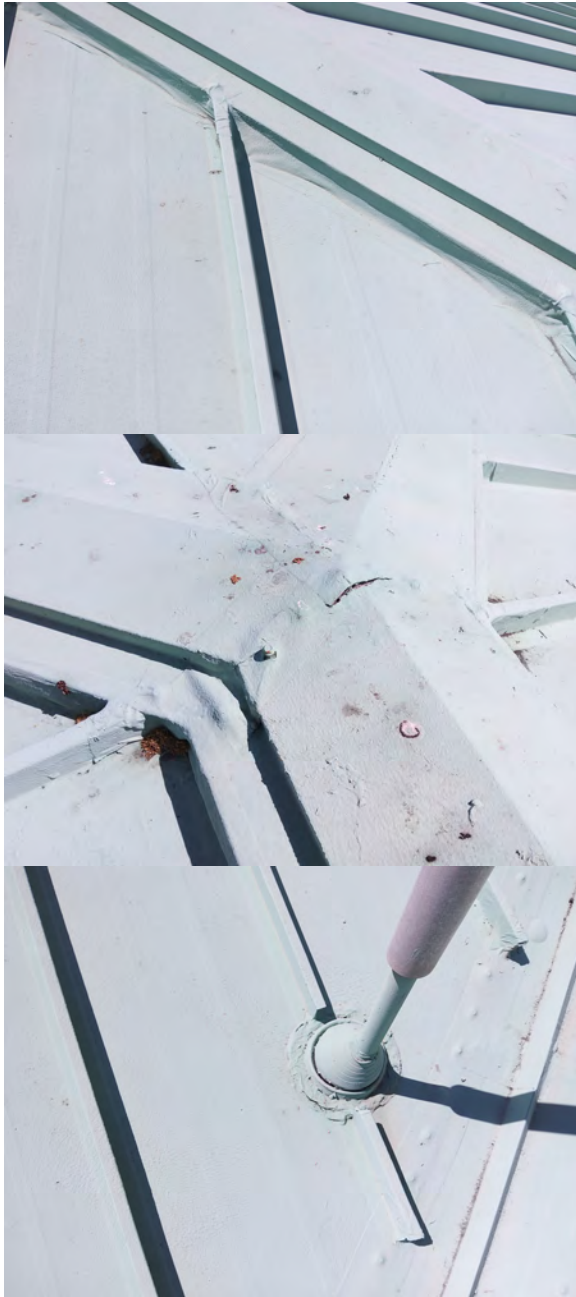
The coating reinforcement at transitions is loose at multiple areas.

Seam at reinforcement at ridge line is open and unadhered which may allow water intrusion. Fastener was also observed to be backing out at same area. 2-Locations

Penetration was installed where rib of panel was removed. This is not a recommended installation. It should be monitored to prevent premature failure.

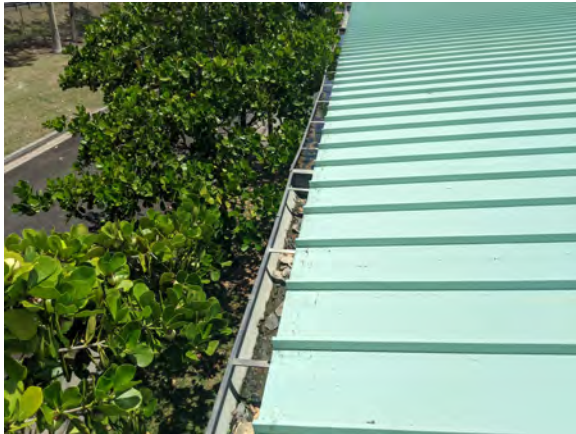
Gutter outlet/downspout is blocked and preventing drainage and causing gutter to remain full.

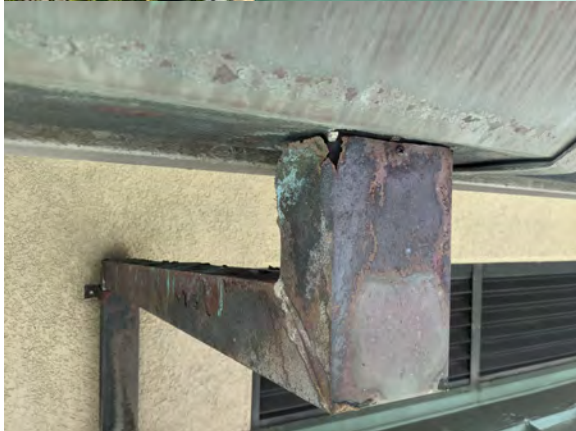
Downspouts on upper roof are deteriorated at connection to outlet.

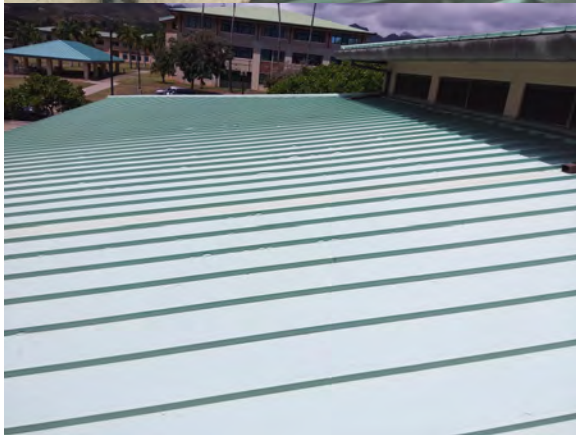
Blistering was observed in the coating on the roof panels in multiple locations.

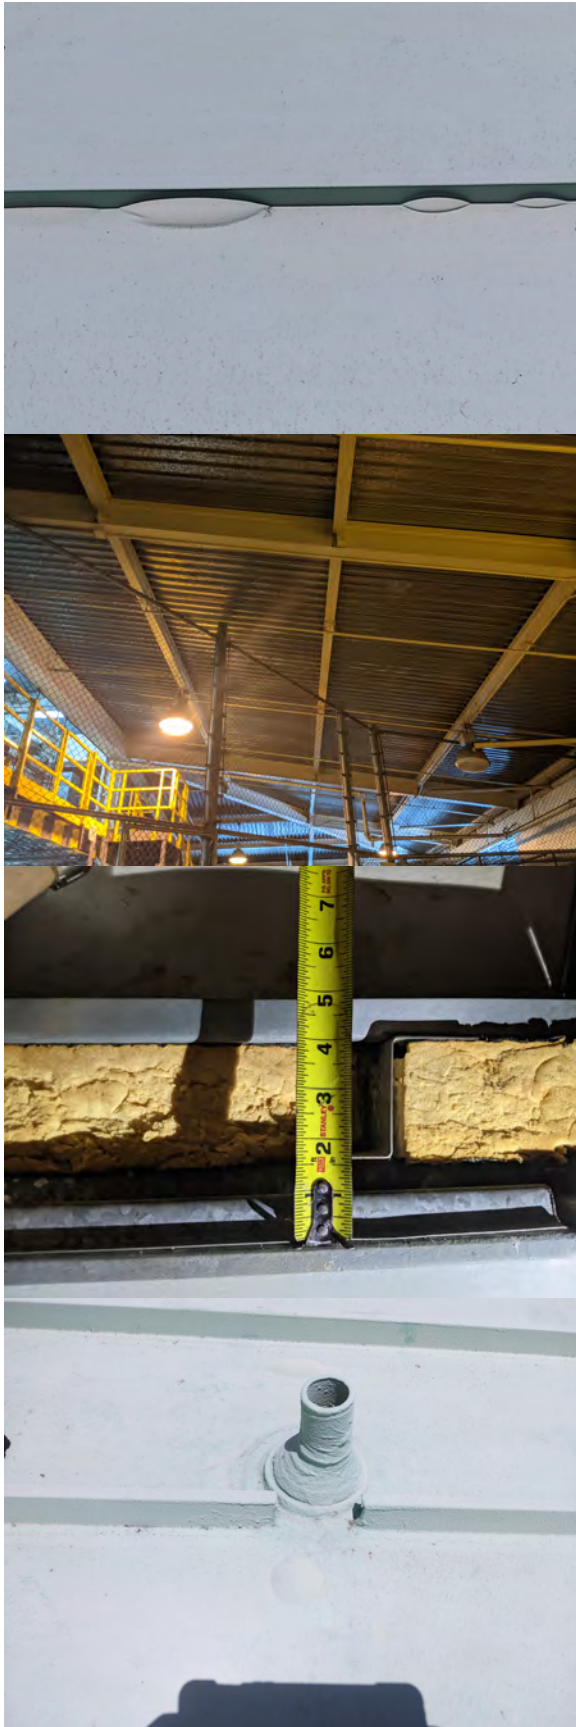
Close up of blistering.

Penetration was installed where rib of panel was removed. This is not a recommended installation.

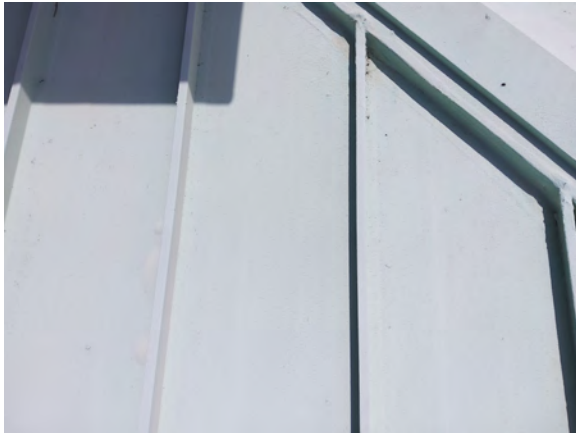
Coating is in fair condition excluding deficiencies found which are recommended to be corrected to extend the life of the coating.

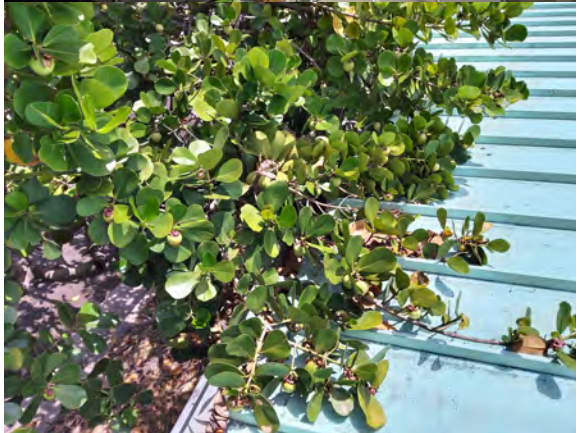
Adjacent trees that overhang the roof can cause algae growth, a build up of debris, and general deterioration of the roof membrane.

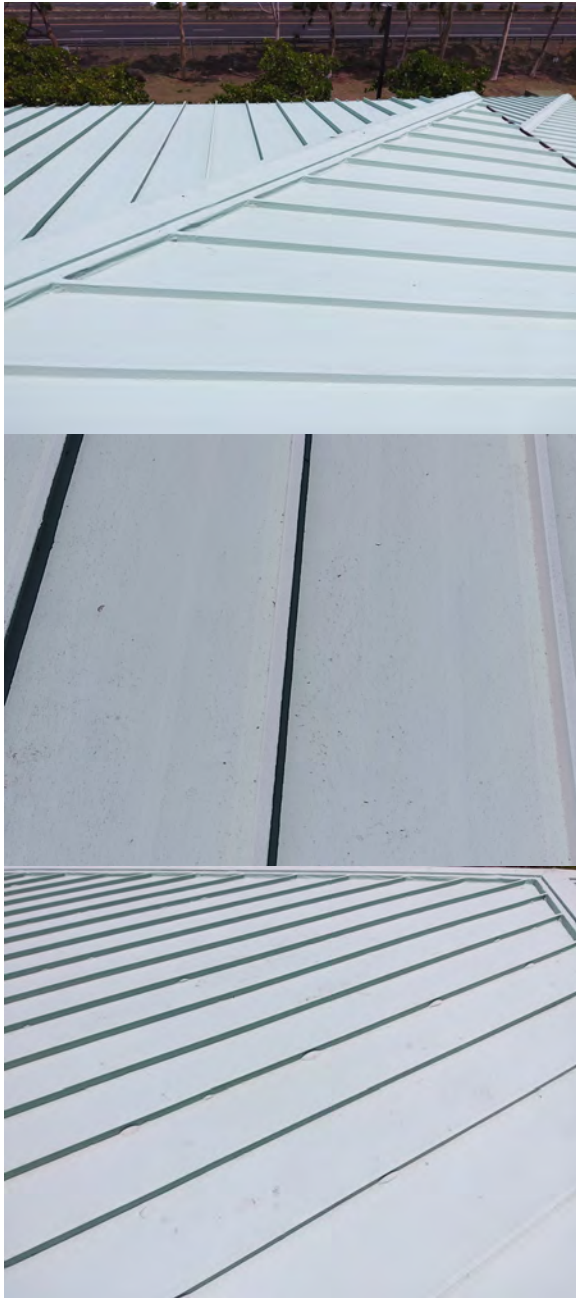
The coating reinforcement at transitions is loose at multiple areas.

Coating is in fair condition excluding deficiencies found which are recommended to be corrected to extend the life of the coating.

Blistering was observed in the coating on the roof panels in multiple locations.
