Fact Sheet

Mississinewa Dam Safety Project

US Army Corps
of Engineers
Louisville District

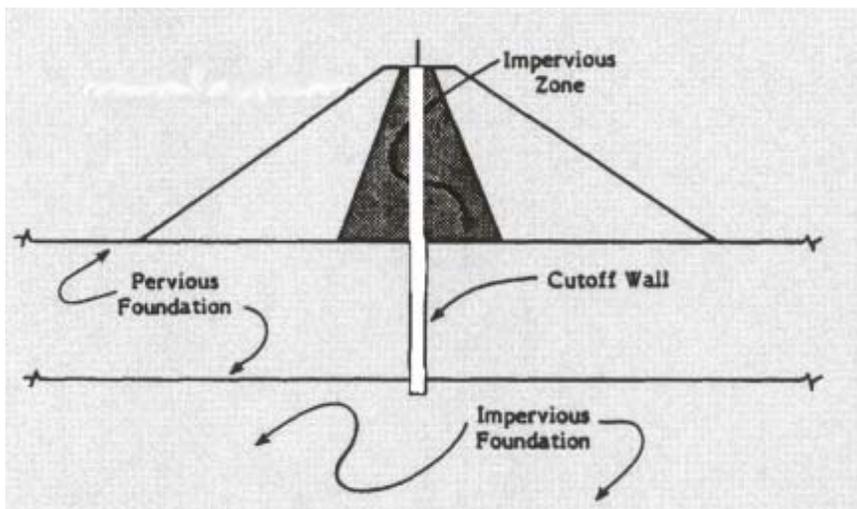
The U.S. Army Corps of Engineers is repairing the Mississinewa Dam. The repair work began in 2002 with drilling and grouting of a test section. To the left, is a cross section of the repair. Note that the cut-off wall extends through the foundation.

A cut-off wall will be constructed within the right side of the dam by a slurry process where concrete is placed into a slot cut into the embankment and foundation. The cut-off wall will prevent deterioration and will safely maintain the storage pools of Mississinewa Lake. The cut-off wall will extend 2,600 in length from the right embankment toward the center. It will be 150-180 ft. deep.

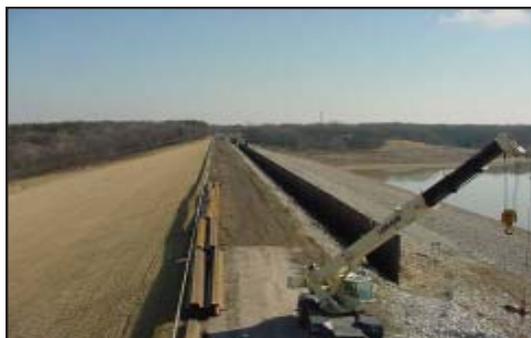
The construction platform is pictured at right. Only a handful of contractors and equipment exist worldwide that can make the necessary repairs at the Mississinewa Dam.

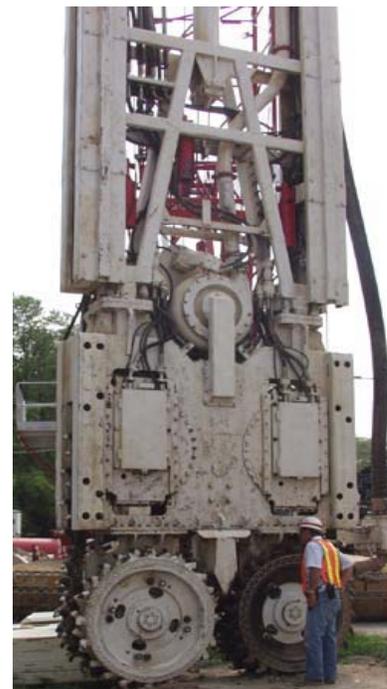
The hydromill has huge teeth that bore down into the geological formations of Mississinewa.
