ROOF ASSESSMENT REPORT
FOR

**US Army Corps
of Engineers.**

72 North Street
Danvers, MA 01923

020CHS-087 - 99th RD-MA008

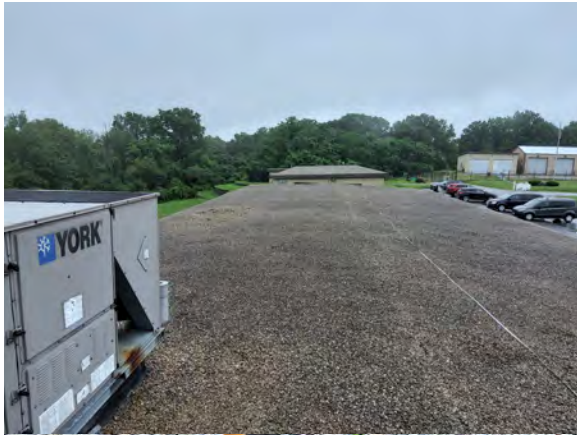
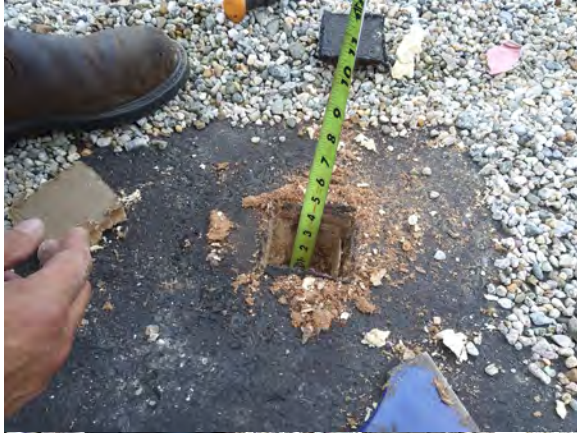
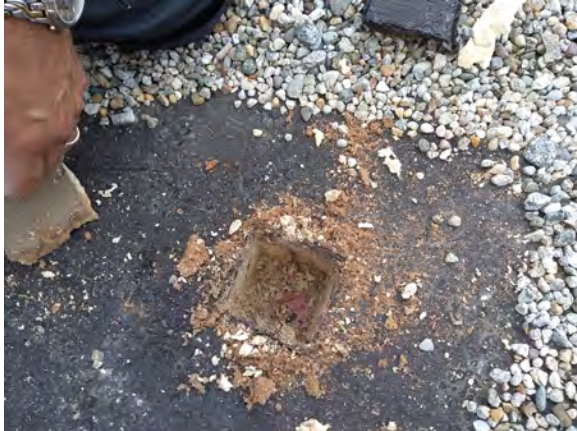
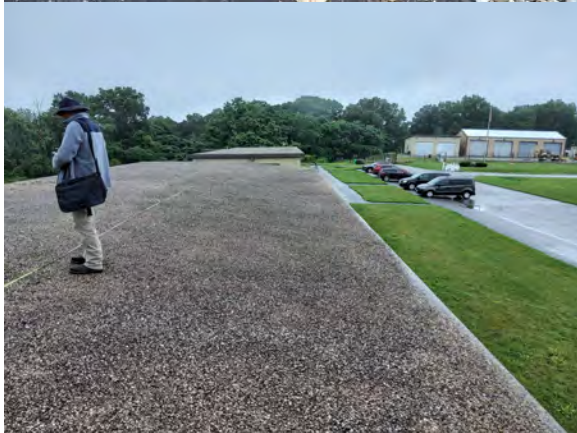
Core Cut:

Gravel

5-Ply Built-up Roof

1/2" Wood Fiber Insulation

3 1/2" Polyisocyanurate Insulation

Red Rosin Paper

Felt

Wood Deck

Wood Deck at Core Cut

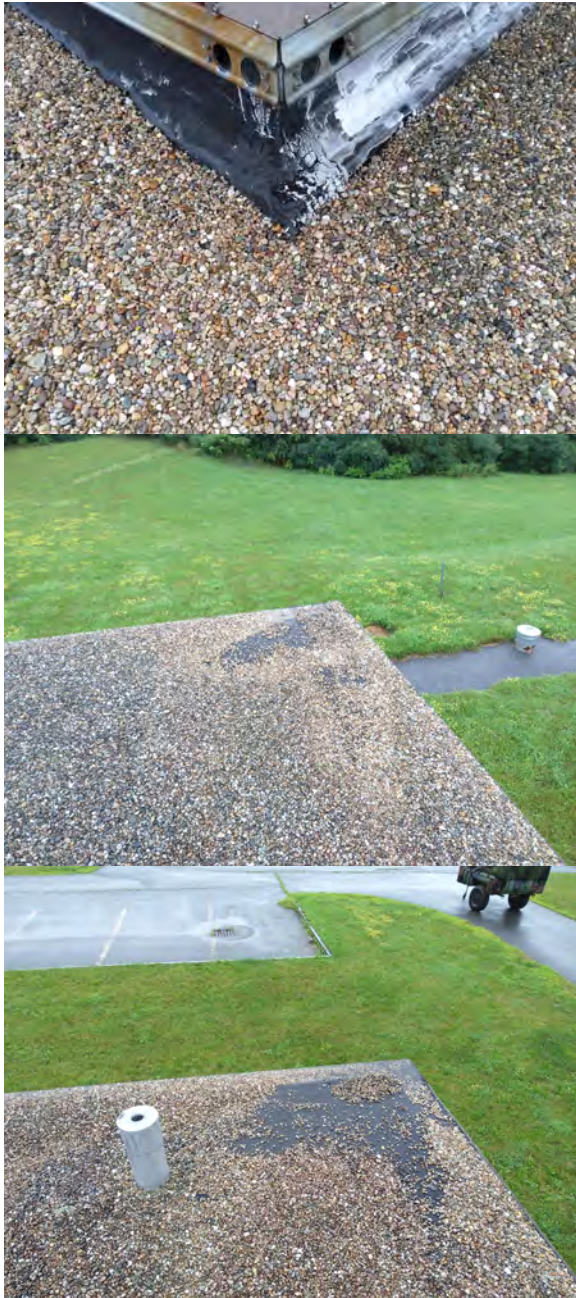
Repairs observed to existing roof system. 2 SF

Displacement of gravel likely due to wind and water erosion, inadequate top pour coat, little or no embedment of aggregate, or moved intentionally by workman. 70 SF

Exposed Felts - Typically wind displaces gravel and exposes the underlying waterproofing membrane. As the membrane is exposed to UV and the elements it quickly breaks down allowing water in the system. 70 SF

Gravel built-up roof is in poor to fair condition and should be replaced in 3-4 years. Deficiencies found in this report should be repaired to extend life cycle of the roof system until roof can be replaced.

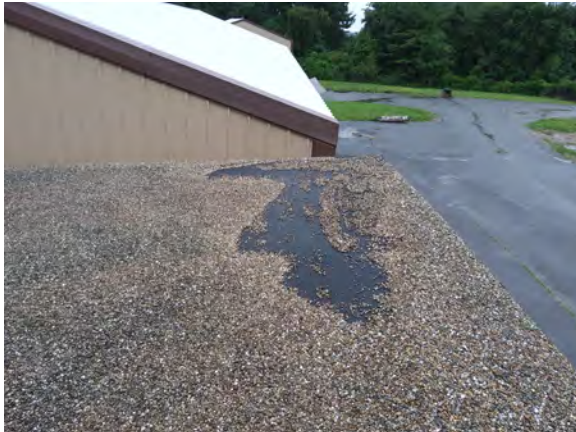
Exposed Felts - Typically wind displaces gravel and exposes the underlying waterproofing membrane. As the membrane is exposed to UV and the elements it quickly breaks down allowing water in the system. 80 SF

Gravel built-up roof is in poor to fair condition and should be replaced in 1-2 years. Deficiencies found in this report should be repaired to extend life cycle of the roof system until roof can be replaced.

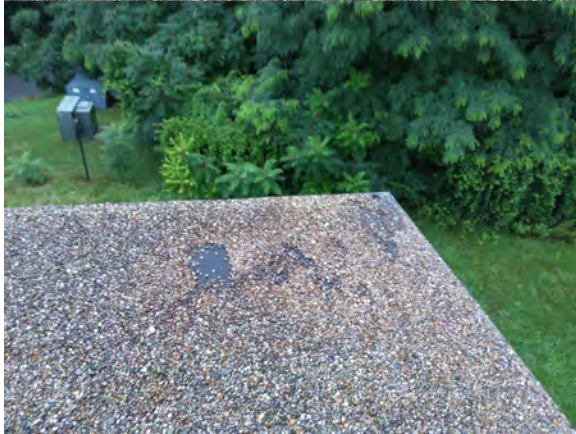
Displacement of gravel likely due to wind and water erosion, inadequate top pour coat, little or no embedment of aggregate, or moved intentionally by workman. 80 SF

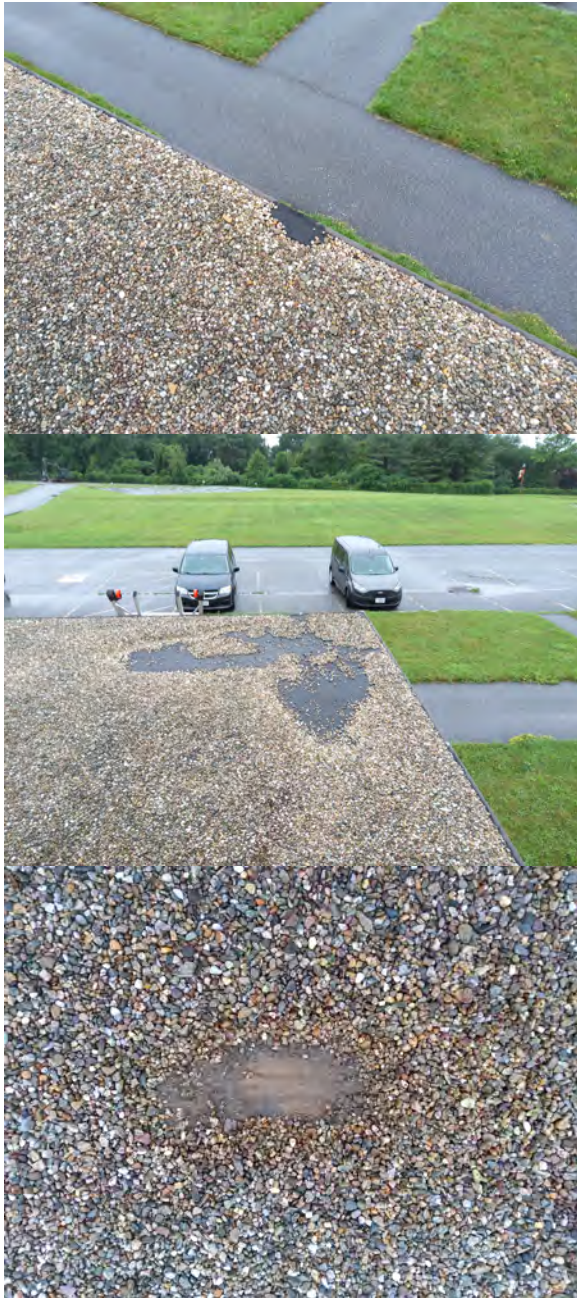
Repairs observed to existing roof system. 1 SF

Exposed Felts - Typically wind displaces gravel and exposes the underlying waterproofing membrane. As the membrane is exposed to UV and the elements it quickly breaks down allowing water in the system. 50 SF

Displacement of gravel likely due to wind and water erosion, inadequate top pour coat, little or no embedment of aggregate, or moved intentionally by workman. 50 SF

Gravel built-up roof is in poor to fair condition and should be replaced in 1-2 years. Deficiencies found in this report should be repaired to extend life cycle of the roof system until roof can be replaced.

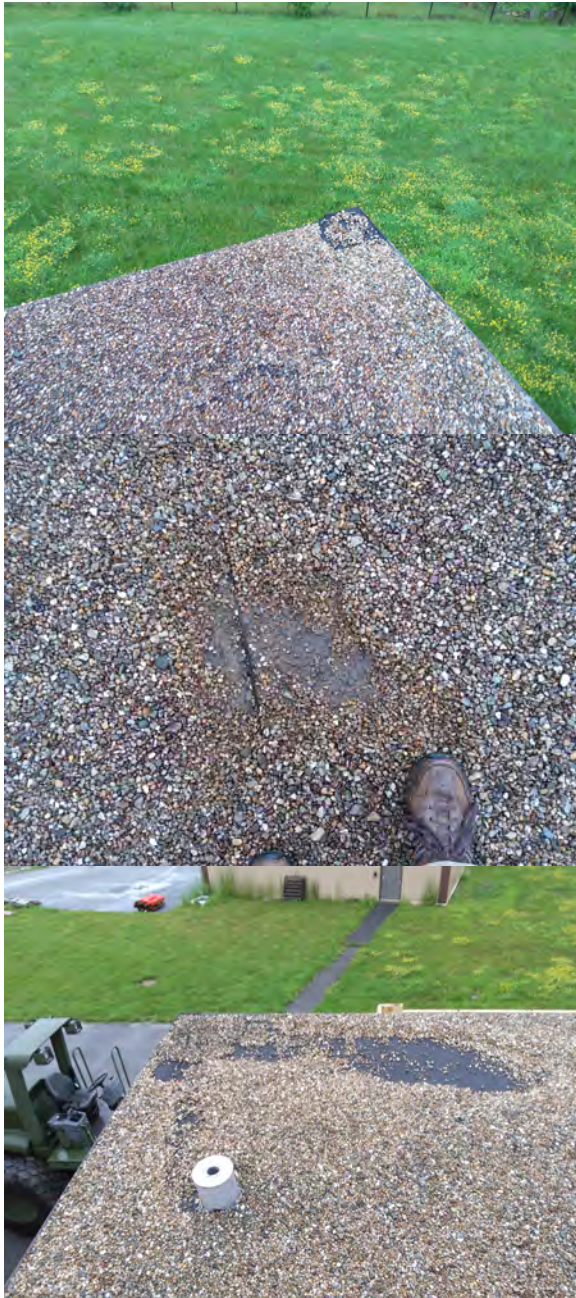
Repairs observed to existing roof system. 1 SF

Exposed Felts - Typically wind displaces gravel and exposes the underlying waterproofing membrane. As the membrane is exposed to UV and the elements it quickly breaks down allowing water in the system. 40 SF

Displacement of gravel likely due to wind and water erosion, inadequate top pour coat, little or no embedment of aggregate, or moved intentionally by workman. 40 SF

Gravel built-up roof is in poor to fair condition and should be replaced in 1-2 years. Deficiencies found in this report should be repaired to extend life cycle of the roof system until roof can be replaced.
