Louisville District Water Quality Program

CY2016 Annual Report

11 SEPT 2017

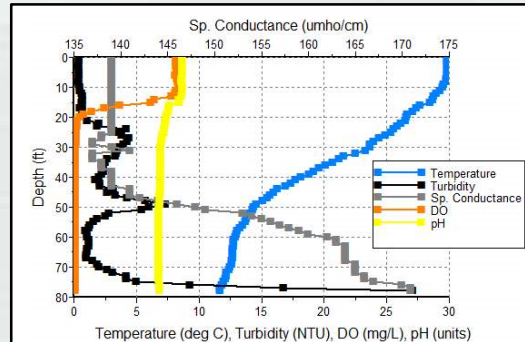
Figure 3. Field data taken at the dam site (2GRR20001; Figure 5) on 8/30/2016 at 07:00.

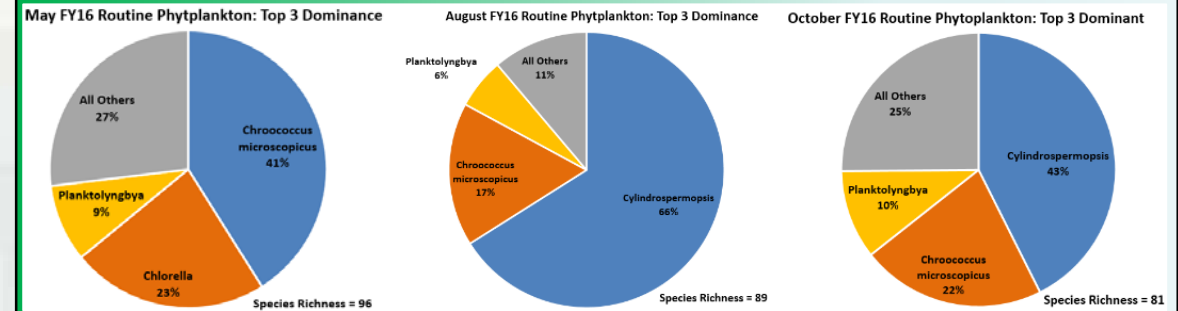
Figure 4. 2016 relative abundance of the entire phytoplankton community at GRR in May, August, and October.

Figure 4 illustrates the relative abundance for the entire phytoplankton community at GRR. The relative abundance percentage was calculated using the density of phytoplankton species from all sample sites, at all depths for each sampling event. **Chroococcus microscopicus** was the dominant species in May, while **Cyndrospermopsis** was the dominant genera in August and October. Both dominant taxa are genera of cyanobacteria.

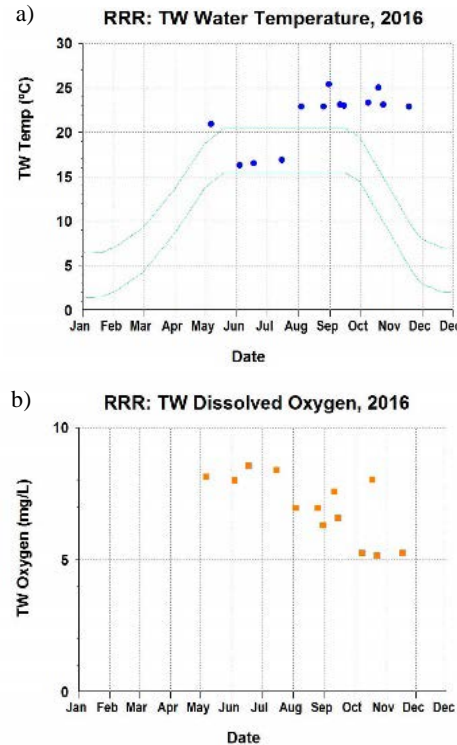
Figure 1. RRR time series data collected from the tailwater (2RRR10000; Figure 3): a) water temperature; and b) dissolved oxygen.

WQ in the Tailwater is assessed by analyzing exceedances of WQ criteria established by the KY Division of Water (KDOW). **No criteria were exceeded in the tailwater (2RRR10000; Figure 3). However, RRR exceeded the USEPA’s recommended criteria for total phosphorus (Criteria: 36.56 µg/L; Measurements: 110.0 and 134.0 µg/L), total nitrogen (Criteria: 0.69 mg/L; Measurements: 1.25, 1.45, and 0.99 mg/L), and turbidity (Criteria: 5.7 FTU; Measurements: 22.9, 32.5, 14.2 NTU). All exceedances have been reported to KDOW.**

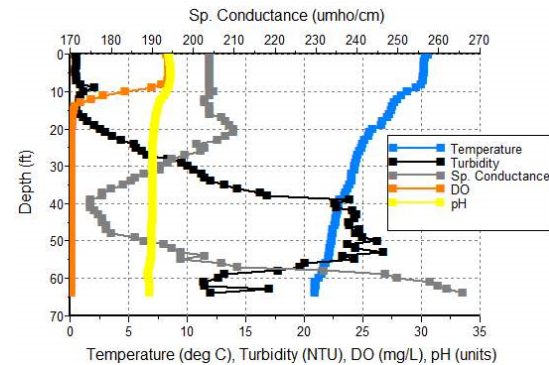
Figure 2. Field data taken at the dam site (2RRR20001; Figure 3) on 8/31/2016 at 09:00.

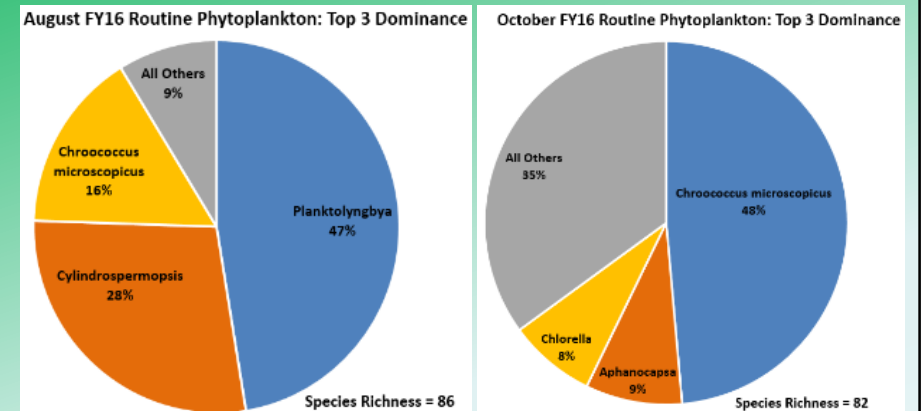
Figure 4. 2016 relative abundance of the entire phytoplankton community at RRR in August (left) and October (right).

Figure 4 illustrates the relative abundance for the entire phytoplankton community at RRR. The relative abundance percentage was calculated using the density of phytoplankton species from all sample sites, at all depths. *Planktolyngbya* was the most dominant genera in August and *Chroococcus microscopicus* was the dominant species in October found at RRR. Both dominant taxa are genera of cyanobacteria.

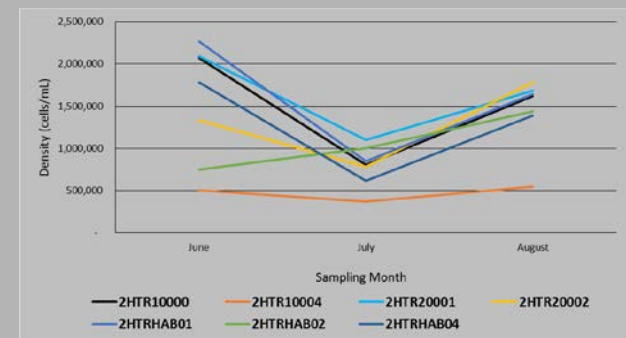
Figure 6. Monthly cyanobacteria cell count data summary from HTR.

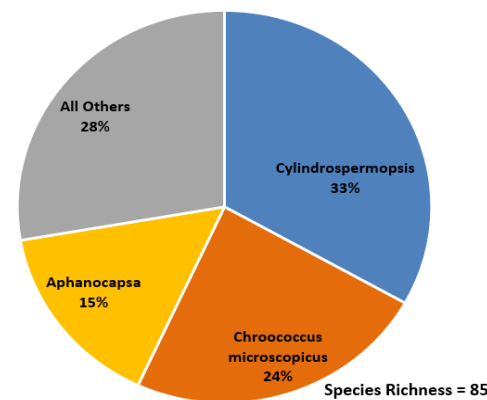
Figure 4. 2016 relative abundance of the entire phytoplankton community at MSR.

Figure 4 illustrates the relative abundance for the entire phytoplankton community at MSR. The relative abundance percentage was calculated using the density of phytoplankton species from all sample sites, at all depths. *Cylindrospermopsis*, a genera of cyanobacteria, was the dominant genera found at MSR.

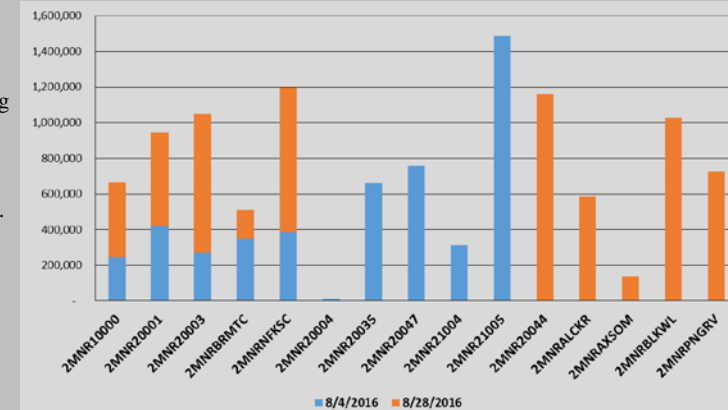
Figure 6. Cyanobacteria cell count data summary from MNR.

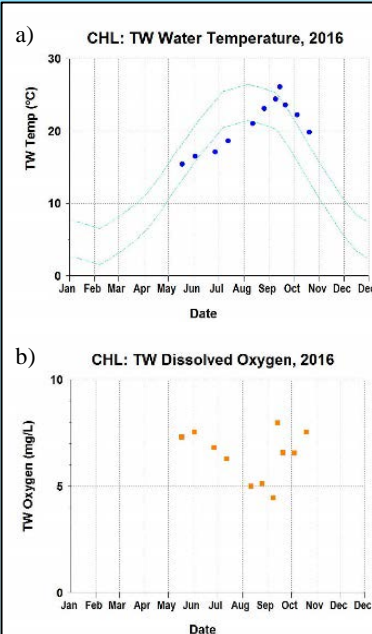
Figure 1. CHL time series data collected from the tailwater (2CHL10000; Figure 2): a) water temperature; and b) dissolved oxygen.

WQ in the Tailwater is assessed by analyzing exceedances of WQ criteria established by the IN Department of Environmental Management (IDEM). **No criteria were exceeded in the tailwater (2CHL10000; Figure 2).** However, acute dissolved oxygen was measured as 4.44 mg/L on 9/9/2016 (Acute criteria: 4.0 mg/L; Daily minimum average: 5.0 mg/L). Also, CHL exceeded the USEPA’s recommended criteria for total phosphorus (Criteria: 36.56 µg/L; Measurement: 99.0 µg/L) and total nitrogen (Criteria: 0.69 mg/L; Measurement: 1.50 mg/L). All exceedances have been reported to IDEM.

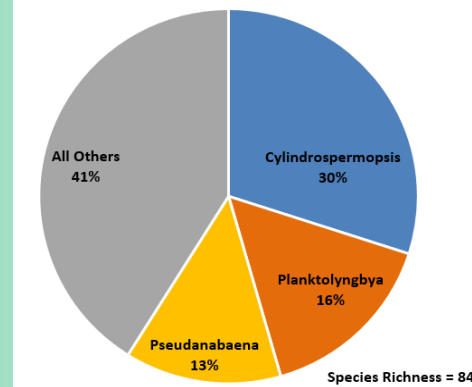
Figure 3. 2016 relative abundance of the entire phytoplankton community at CHL.

Figure 3 illustrates the relative abundance for the entire phytoplankton community at CHL. The relative abundance percentage was calculated using the density of phytoplankton species from all sample sites, at all depths. *Cylindrospermopsis*, a genera of cyanobacteria, was the dominant genera found at CHL.

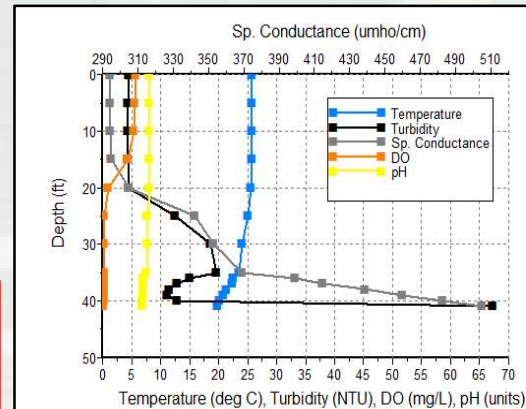
Figure 3. Field data taken at the dam site (2CMR20001; Figure 2) on 9/15/2016 at 10:00.

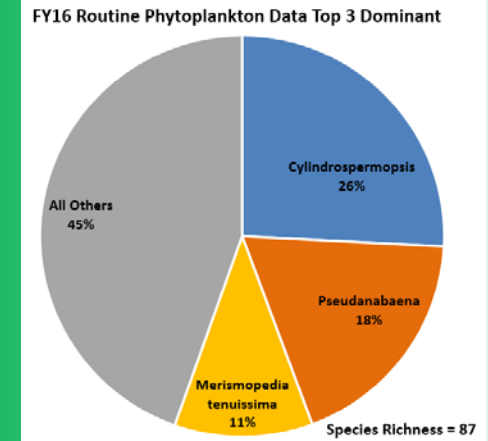
Figure 4. 2016 relative abundance of the entire phytoplankton community at CMR

Figure 4 illustrates the relative abundance for the entire phytoplankton community at CMR. The relative abundance percentage was calculated using the density of phytoplankton species from all sample sites, at all depths. ***Cylindrospermopsis*, a genera of cyanobacteria, was the dominant genera found at CMR.** While HABs have not previously been a reported WQ issue at CMR, the results from the phytoplankton sampling indicate that HABs have the potential to become problematic at CMR.

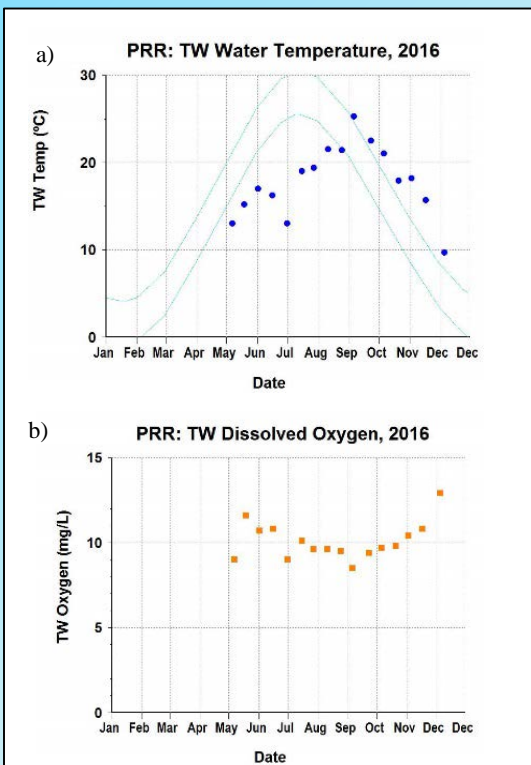
Figure 1. PRR time series data collected from the tailwater (2PRR10000; Figure 2): a) water temperature; and b) dissolved oxygen.

WQ in the Tailwater is assessed by analyzing exceedances of WQ criteria established by the IN Department of Environmental Management (IDEM). **No criteria were exceeded in the tailwater (2PRR10000; Figure 2).** However, PRR exceeded the USEPA’s recommended criteria for total phosphorus (Criteria: 36.56 ug/L; Measurement: 37.0 ug/L), total nitrogen (Criteria: 0.69 mg/L; Measurement: 0.802 mg/L), and turbidity (Criteria: 5.7 FTU; Measurement: 29.5 NTU). All exceedances have been reported to IDEM.

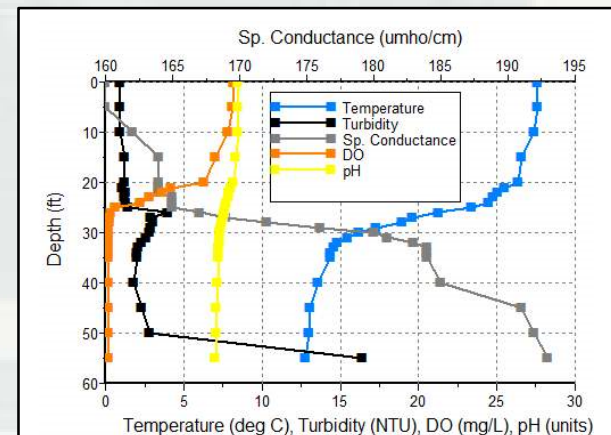
Figure 4. Field data taken at the dam site (2PRR20001; Figure 2) on 9/7/2016 at 08:00.

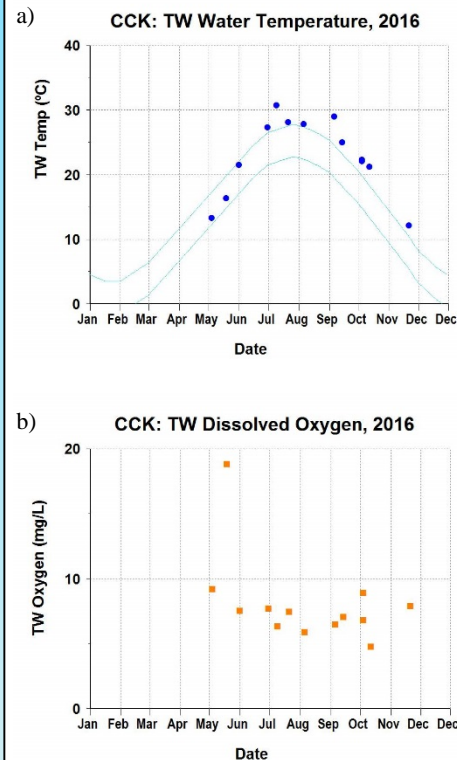
Figure 1. CCK time series data collected from the tailwater (2CCK10000; Figure 2): a) water temperature; and b) dissolved oxygen.

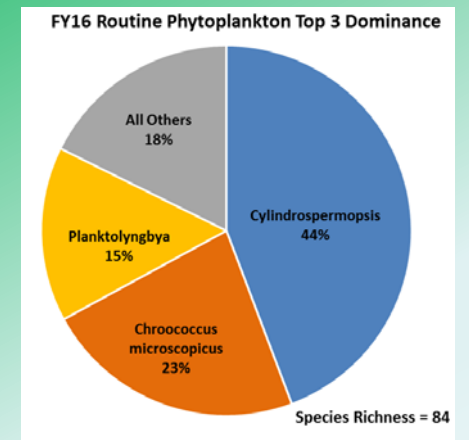
Figure 4. 2016 relative abundance of the entire phytoplankton community at CCK.

***Cylindrospermopsis*, a genera of cyanobacteria, was the dominant genera found at CCK.**

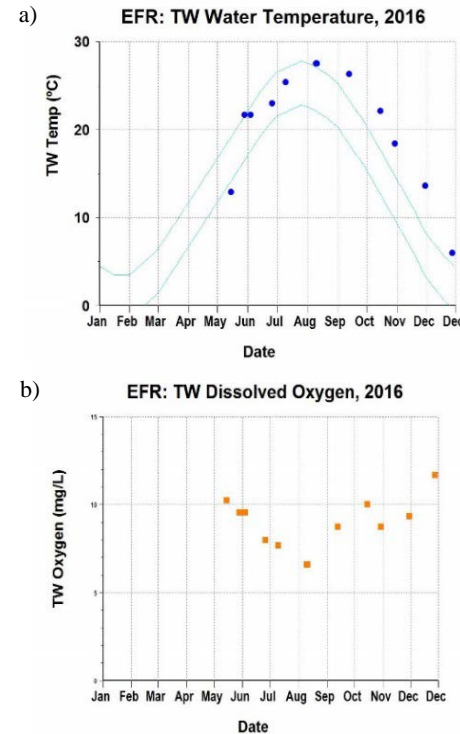
Figure 1. EFR time series data collected from the tailwater (2EFR10000; Figure 2): a) water temperature; and b) dissolved oxygen.

WQ in the Tailwater is assessed by analyzing exceedances of WQ criteria established by the OH Environmental Protection Agency (OHEPA). **No criteria were exceeded in the tailwater (2EFR10000; Figure 2). However, EFR exceeded the USEPA’s recommended criteria for turbidity (Criteria: 6.36 FTU; Measurements: 8.06 and 7.5 NTU). All exceedances have been reported to OHEPA.**

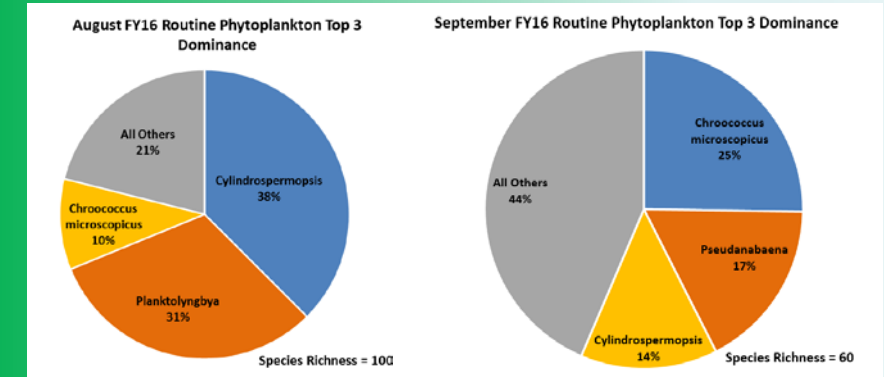
Figure 4. 2016 relative abundance of the entire phytoplankton community at EFR for collections made in August and September.

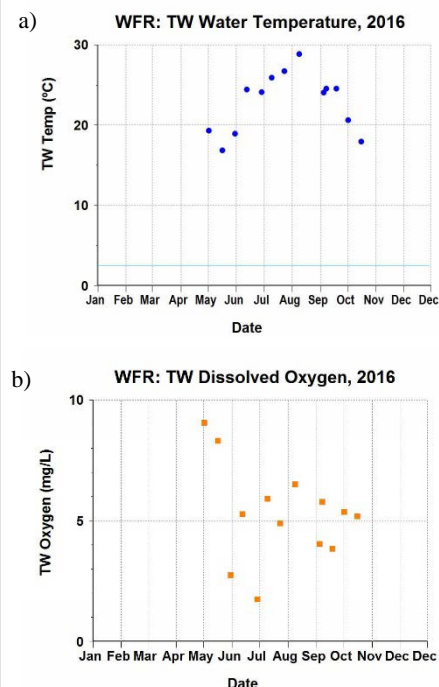
Figure 1. WFR time series data collected from the tailwater (2WFR10000; Figure 2): a) water temperature; and b) dissolved oxygen.

WQ in the Tailwater is assessed by analyzing exceedances of WQ criteria established by the OH Environmental Protection Agency (OHEPA). The tailwater (2WFR10000; Figure 2) exceeded criteria for dissolved oxygen (Acute criteria: 4.0 mg/L; Acute measurements: 2.73, 1.73, and 3.83 mg/L). Also, WFR exceeded the USEPA’s recommended criteria for total phosphorus (Criteria: 76.25 ug/L; Measurement: 156.0 ug/L) and turbidity (Criteria: 6.36 FTU; Measurement: 13.8 NTU). All exceedances have been reported to OHEPA.

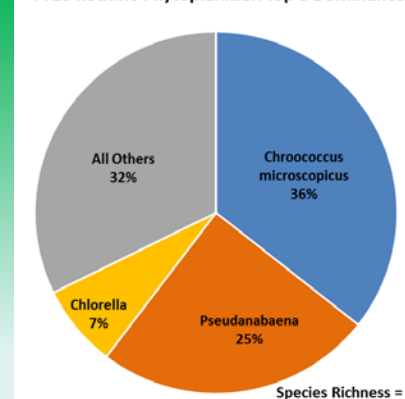
Figure 3. 2016 relative abundance of the entire phytoplankton community at WFR.

Figure 3 illustrates the relative abundance for the entire phytoplankton community at WFR. The relative abundance percentage was calculated using the density of phytoplankton species from all sample sites, at all depths. *Chroococcus microscopicus*, a species of cyanobacteria, was the most dominant species found at WFR.

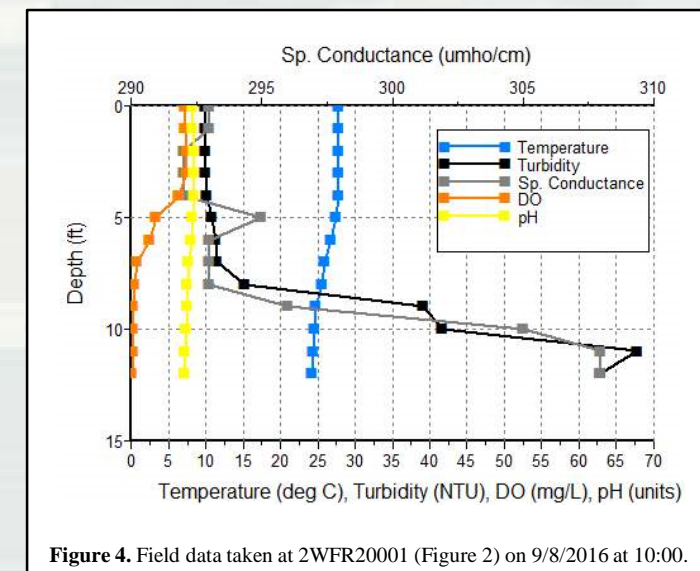
Figure 4. Field data taken at 2WFR20001 (Figure 2) on 9/8/2016 at 10:00.

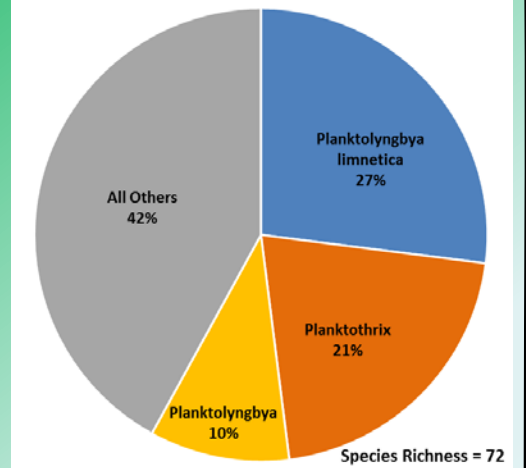
Figure 5. 2016 relative abundance of the entire phytoplankton community at CBR.

Figure 5 illustrates the relative abundance for the entire phytoplankton community at CBR. The relative abundance percentage was calculated using the density of phytoplankton species from all sample sites, at all depths. *Planktolyngbya limnetica*, a species of cyanobacteria, was the dominant species found at CBR.

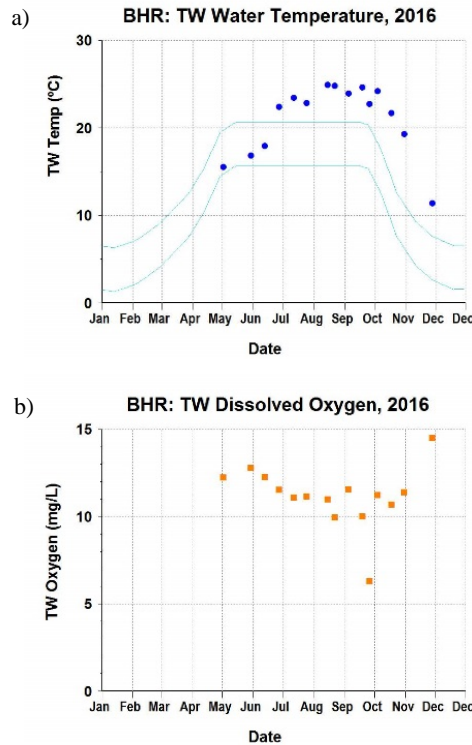
Figure 1. BHR time series data collected from the tailwater (2BHR10000; Figure 2): a) water temperature; and b) dissolved oxygen.

WQ in the Tailwater is assessed by analyzing exceedances of WQ criteria established by the KY Division of Water (KDOW). **No criteria were exceeded in the tailwater (2BHR10000; Figure 2).** However, BHR exceeded the USEPA’s recommended criteria for total phosphorus (Criteria: 10.0 ug/L; Measurement: 17.0 ug/L), total nitrogen (Criteria: 0.31 mg/L; Measurement: 0.36 mg/L), and turbidity (Criteria: 2.3 NTU; Measurement: 2.3 NTU). All exceedances have been reported to KDOW.

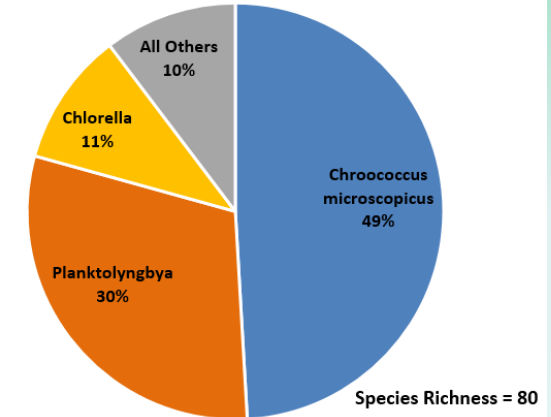
Figure 4. 2016 relative abundance of the entire phytoplankton community at BHR.

Figure 4 illustrates the relative abundance for the entire phytoplankton community at BHR. The relative abundance percentage was calculated using the density of phytoplankton species from all sample sites, at all depths. *Chroococcus microscopicus*, a species of cyanobacteria was the most dominant species found at BHR. While HABs have not previously been a reported WQ issue at BHR, the results from the phytoplankton sampling indicate that HABs have the potential to become problematic at BHR.

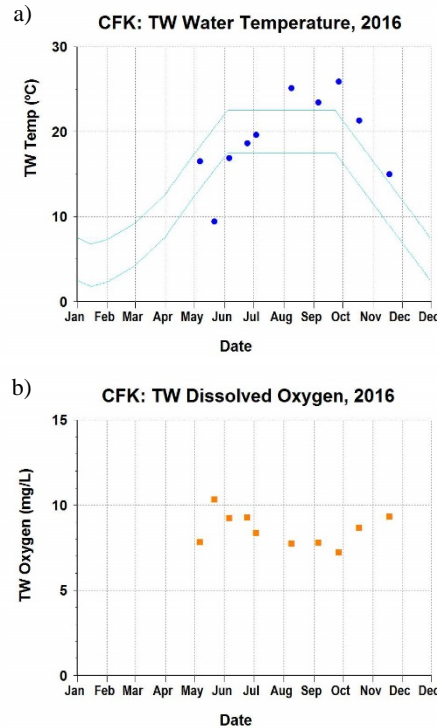
Figure 1. CFK time series data collected from the tailwater (2CFK10000; Figure 2) a) water temperature; and b) dissolved oxygen.

WQ in the Tailwater is assessed by analyzing exceedances of WQ criteria established by the KY Division of Water (KDOW). **No criteria were exceeded in the tailwater (2CFK10000; Figure 2). However, CFK exceeded the USEPA’s recommended criteria for total phosphorus (Criteria: 10.0 ug/L; Measurement: 28.0 ug/L), total nitrogen (Criteria: 0.31 mg/L; Measurement: 2.81 mg/L), and turbidity (Criteria: 2.3 NTU; Measurement: 7.86 NTU). All exceedances have been reported to KDOW.**

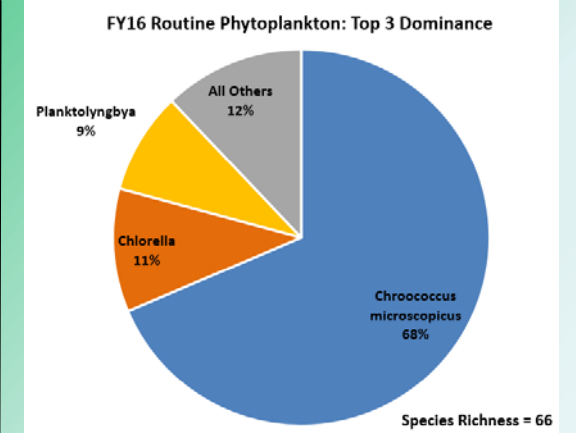
Figure 4. 2016 relative abundance of the entire phytoplankton community at CFK.

Figure 4 illustrates the relative abundance for the entire phytoplankton community at CFK. The relative abundance percentage was calculated using the density of phytoplankton species from all sample sites, at all depths. ***Chroococcus microscopicus*, a species of cyanobacteria, was the dominant species found at CFK.** While HABs have not previously been a reported WQ issue at CFK, the results from the phytoplankton sampling indicate that HABs have the potential to become problematic at CFK.

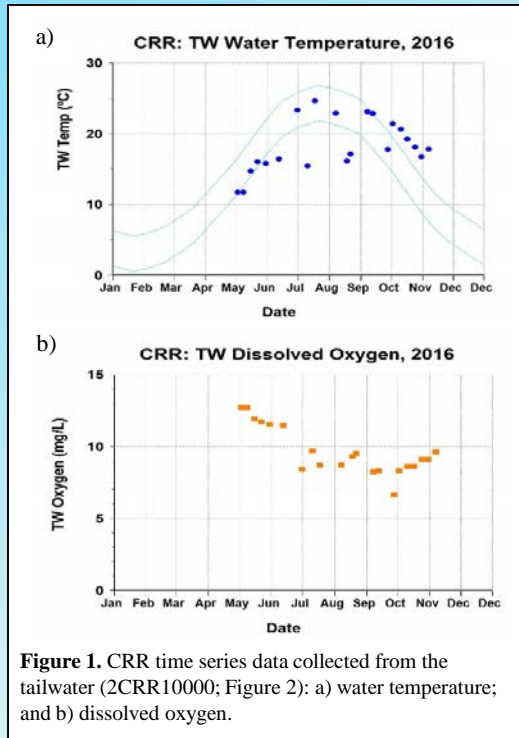
Figure 1. CRR time series data collected from the tailwater (2CRR10000; Figure 2): a) water temperature; and b) dissolved oxygen.

WQ in the Tailwater is assessed by analyzing exceedances of WQ criteria established by the KY Division of Water (KDOW). No criteria were exceeded in the tailwater (2CRR10000; Figure 2). However, CRR exceeded the USEPA’s recommended criteria for total phosphorus (Criteria: 10.0 ug/L; Measurement: 26.0 ug/L), total nitrogen (Criteria: 0.31 mg/L; Measurement: 0.78 mg/L), and turbidity (Criteria: 2.3 NTU; Measurement: 40.9 NTU). All exceedances have been reported to KDOW.

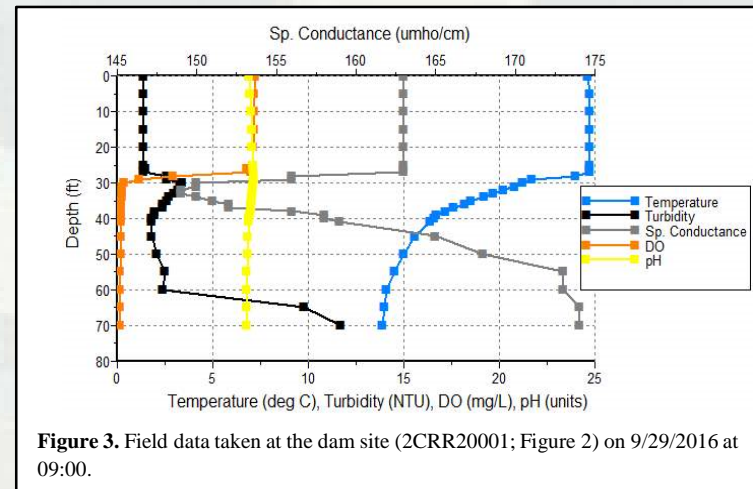
Figure 3. Field data taken at the dam site (2CRR20001; Figure 2) on 9/29/2016 at 09:00.

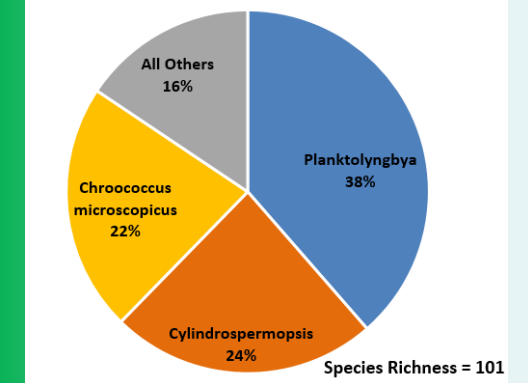
Figure 4. 2016 relative abundance of the entire phytoplankton community at CRR.

Figure 4 illustrates the relative abundance for the entire phytoplankton community at CRR. The relative abundance percentage was calculated using the density of phytoplankton species from all sample sites, at all depths. *Planktolyngbya*, a genera of cyanobacteria, was the dominant genera found at CRR. While HABs have not previously been a reported WQ issue at CRR, the results from the phytoplankton sampling indicate that HABs have the potential to become problematic at CRR.

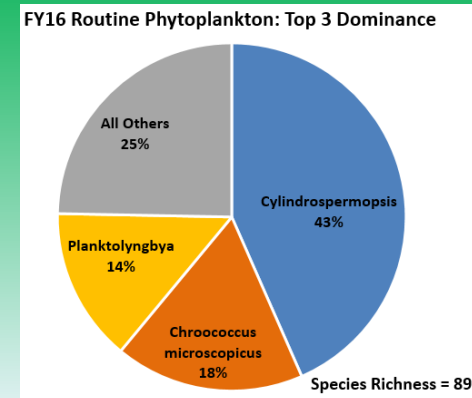
Figure 3. 2016 relative abundance of the entire phytoplankton community at TAR.

Figure 3 illustrates the relative abundance for the entire phytoplankton community at TAR. The relative abundance percentage was calculated using the density of phytoplankton species from all sample sites, at all depths. *Cyndrospermopsis*, a genera of cyanobacteria, was the most dominant genera found at TAR.

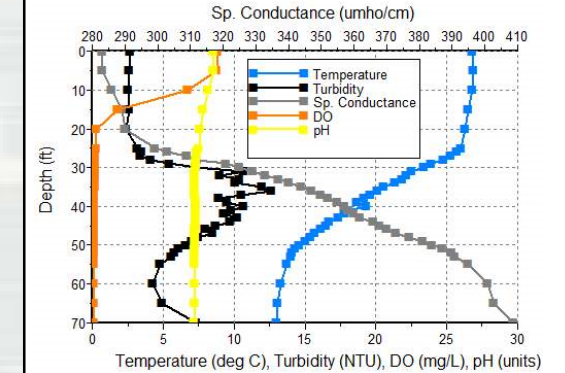
Figure 4. Field data taken at the dam site (2TAR20001; Figure 2) on 9/22/2016 at 09:00.

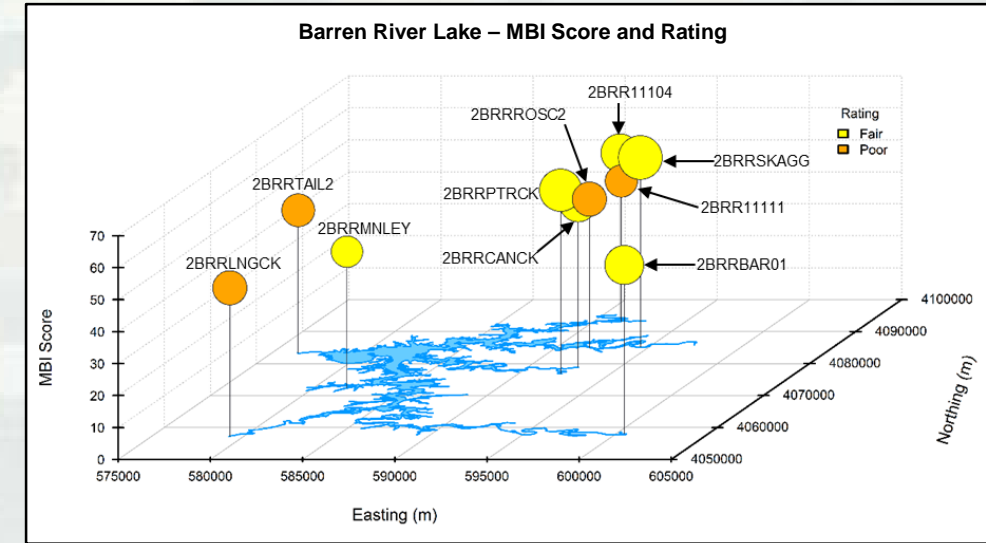
Figure 3. Lollipop chart of MBI scores and ratings. Lollipop height and circle size corresponds to MBI score. Circle color corresponds to MBI rating.

One of the most comprehensive methods for assessing water quality conditions is evaluating the benthic macroinvertebrate community (i.e., bottom-dwelling animals that lack a backbone). The KY Division of Water (KDOW) evaluates streams by using the Macroinvertebrate Bioassessment Index (MBI) developed specifically for KY streams. The MBI calculates a score (0-100) that is used to assign a rating based on the size and location of the stream. MBI ratings, in order of decreasing stream health, are: Excellent, Good, Fair, Poor, and Very Poor.

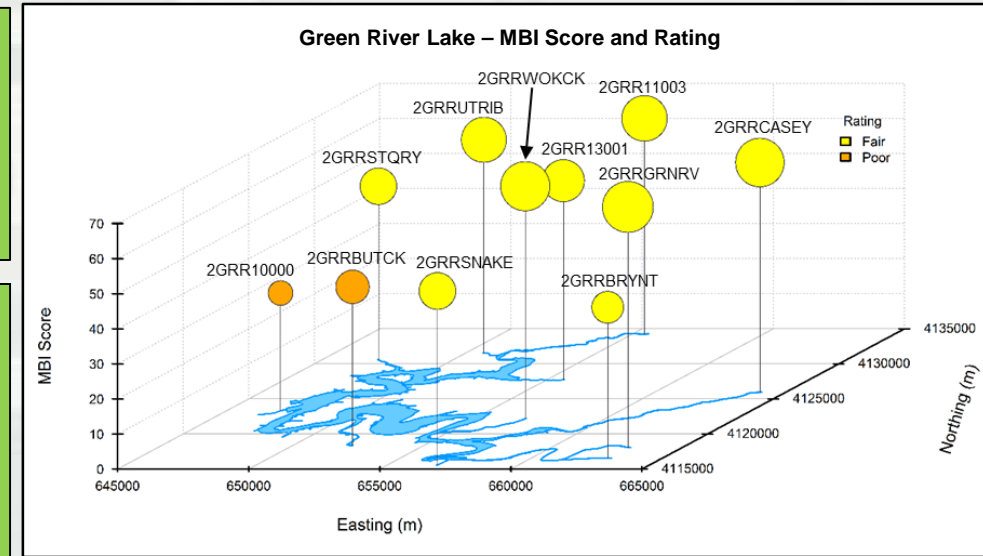
Figure 3. Lollipop chart of MBI scores and ratings. Lollipop height and circle size corresponds to MBI score. Circle color corresponds to MBI rating.

One of the most comprehensive methods for assessing water quality conditions is evaluating the benthic macroinvertebrate community (i.e., bottom-dwelling animals that lack a backbone). The KY Division of Water (KDOW) evaluates streams by using the Macroinvertebrate Bioassessment Index (MBI) developed specifically for KY streams. The MBI calculates a score (0-100) that is used to assign a rating based on the size and location of the stream. MBI ratings, in order of decreasing stream health, are: Excellent, Good, Fair, Poor, and Very Poor.

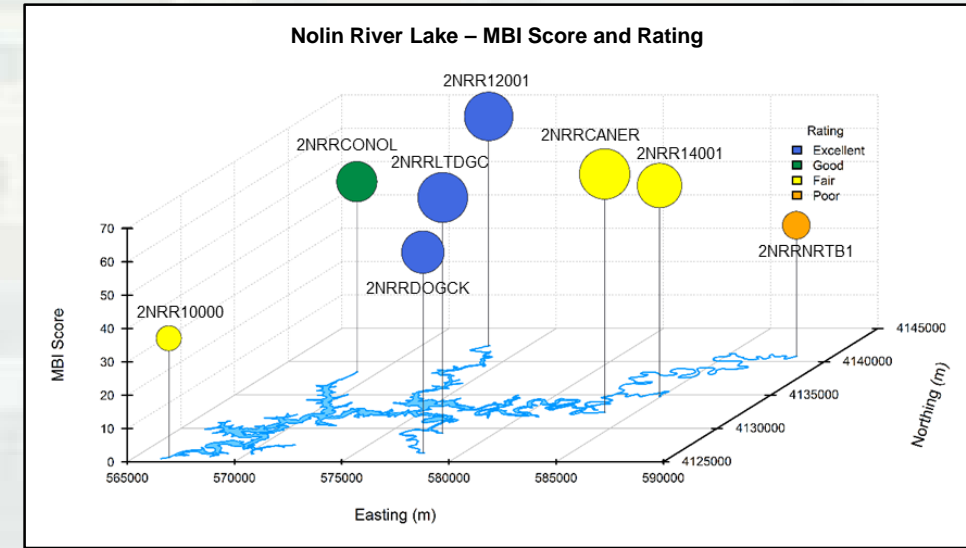
Figure 3. Lollipop chart of MBI scores and ratings. Lollipop height and circle size corresponds to MBI score. Circle color corresponds to MBI rating.

One of the most comprehensive methods for assessing water quality conditions is evaluating the benthic macroinvertebrate community (i.e., bottom-dwelling animals that lack a backbone). The KY Division of Water (KDOW) evaluates streams by using the Macroinvertebrate Bioassessment Index (MBI) developed specifically for KY streams. The MBI calculates a score (0-100) that is used to assign a rating based on the size and location of the stream. MBI ratings, in order of decreasing stream health, are: Excellent, Good, Fair, Poor, and Very Poor.

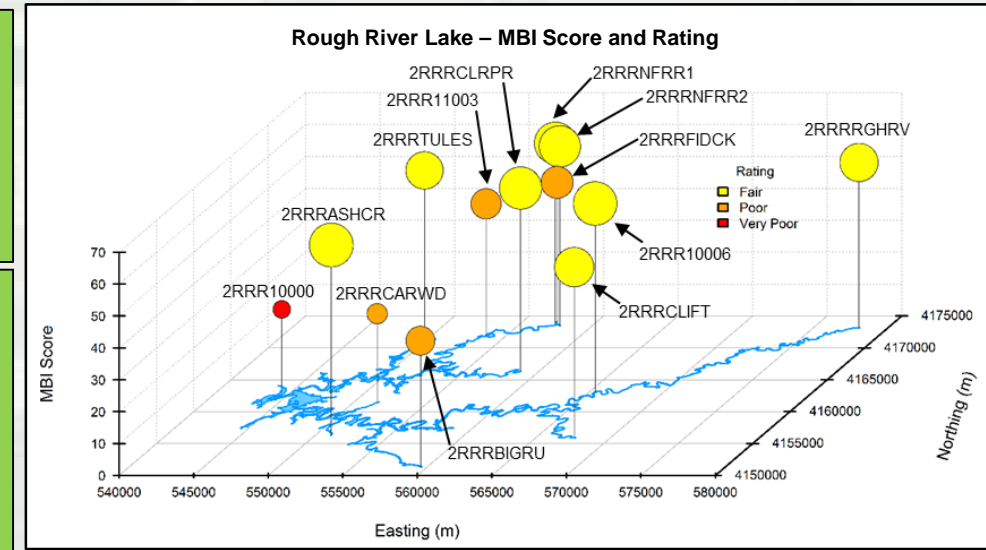
Figure 3. Lollipop chart of MBI scores and ratings. Lollipop height and circle size corresponds to MBI score. Circle color corresponds to MBI rating.

One of the most comprehensive methods for assessing water quality conditions is evaluating the benthic macroinvertebrate community (i.e., bottom-dwelling animals that lack a backbone). The KY Division of Water (KDOW) evaluates streams by using the Macroinvertebrate Bioassessment Index (MBI) developed specifically for KY streams. The MBI calculates a score (0-100) that is used to assign a rating based on the size and location of the stream. MBI ratings, in order of decreasing stream health, are: Excellent, Good, Fair, Poor, and Very Poor.

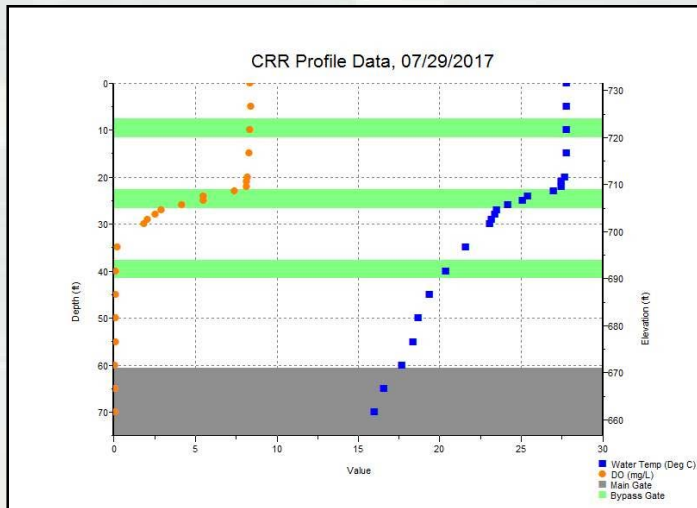
Figure 2. Profile data collected from Cave Run Lake.
