# Appendix E: Environmental Baseline Survey

**ENVIRONMENTAL BASELINE STUDY (EBS)  
DISPOSAL OF GREEN RIVER LOCK AND DAM  
NOS. 3, 4, 5, AND 6, AND BARREN RIVER  
LOCK AND DAM NO. 1, KENTUCKY**

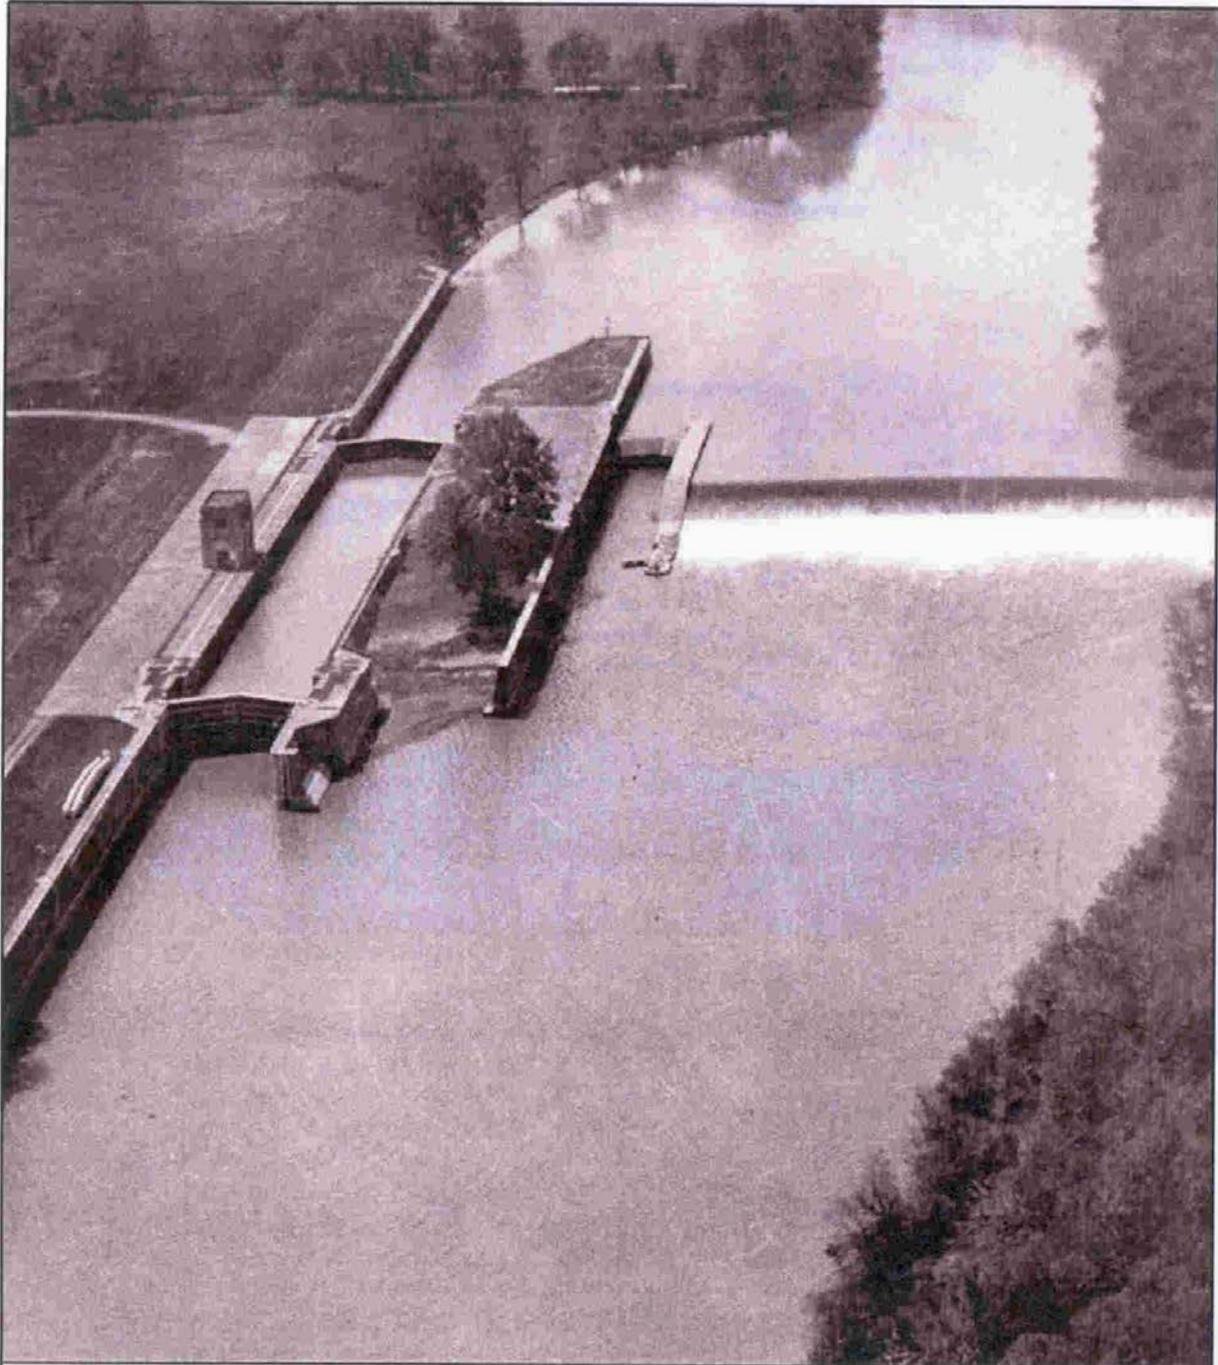
Figure B1-2. Aerial Photograph

AERIAL PHOTOGRAPH  
Barren River Lock and Dam No. 1  
Warren County, Kentucky

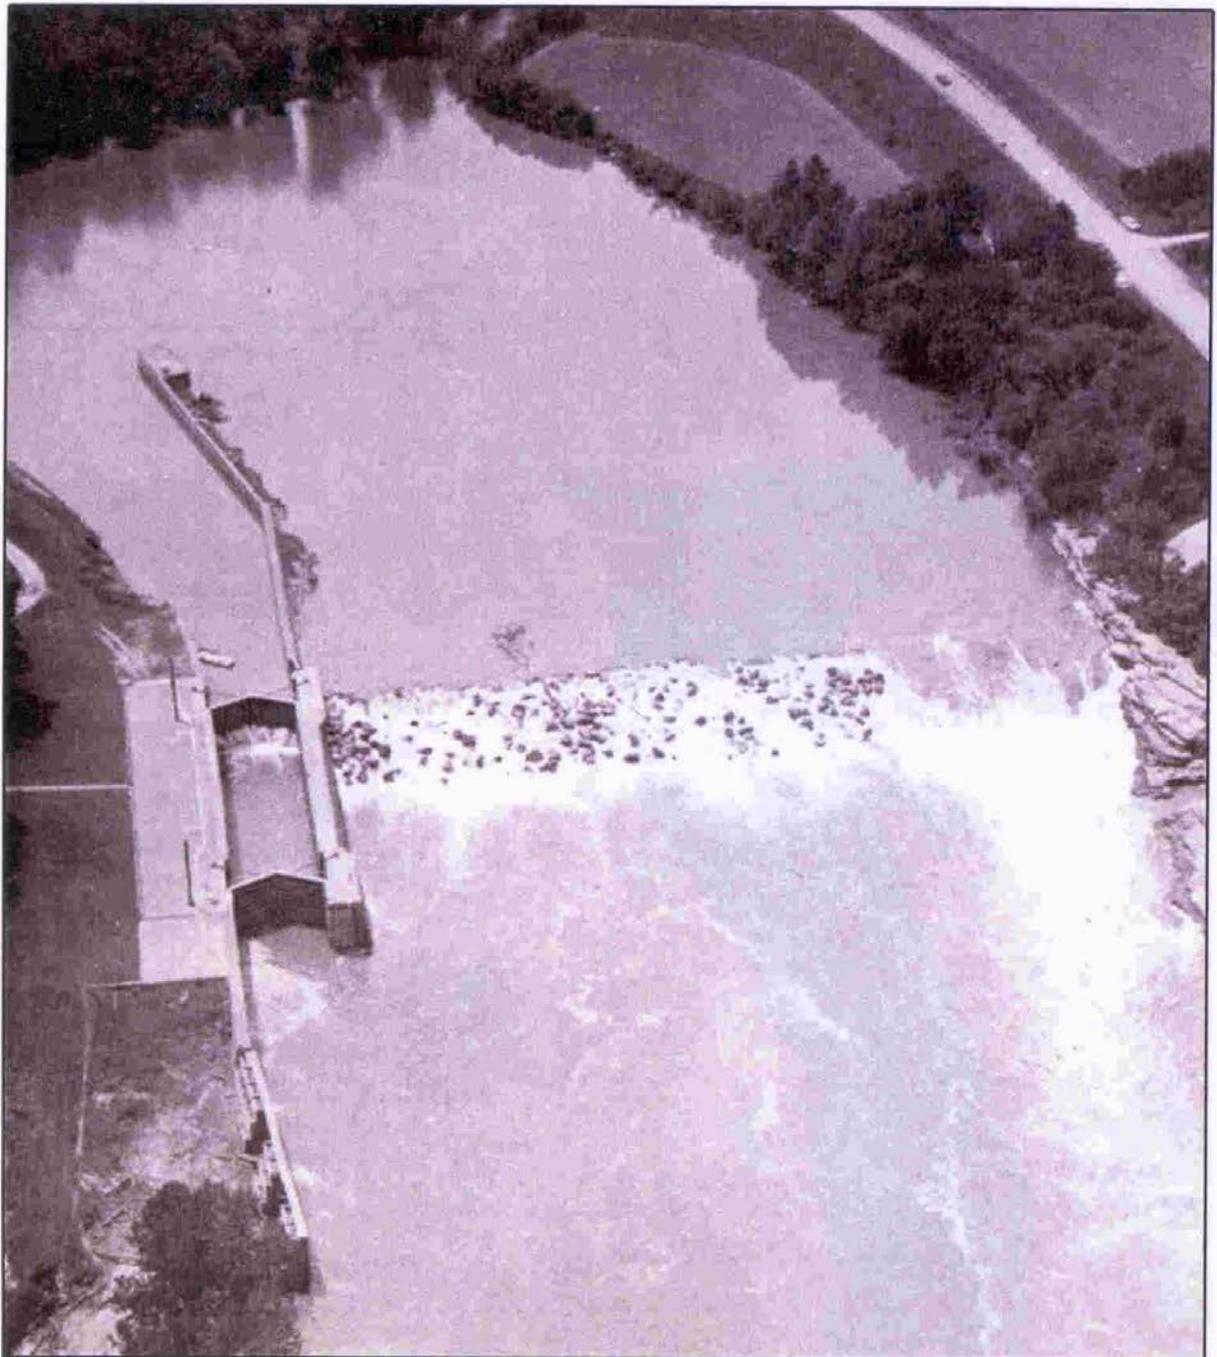
Figure G3-2. Aerial Photograph

AERIAL PHOTOGRAPH  
Green River Lock and Dam No. 3  
Muhlenberg and Ohio Counties, Kentucky

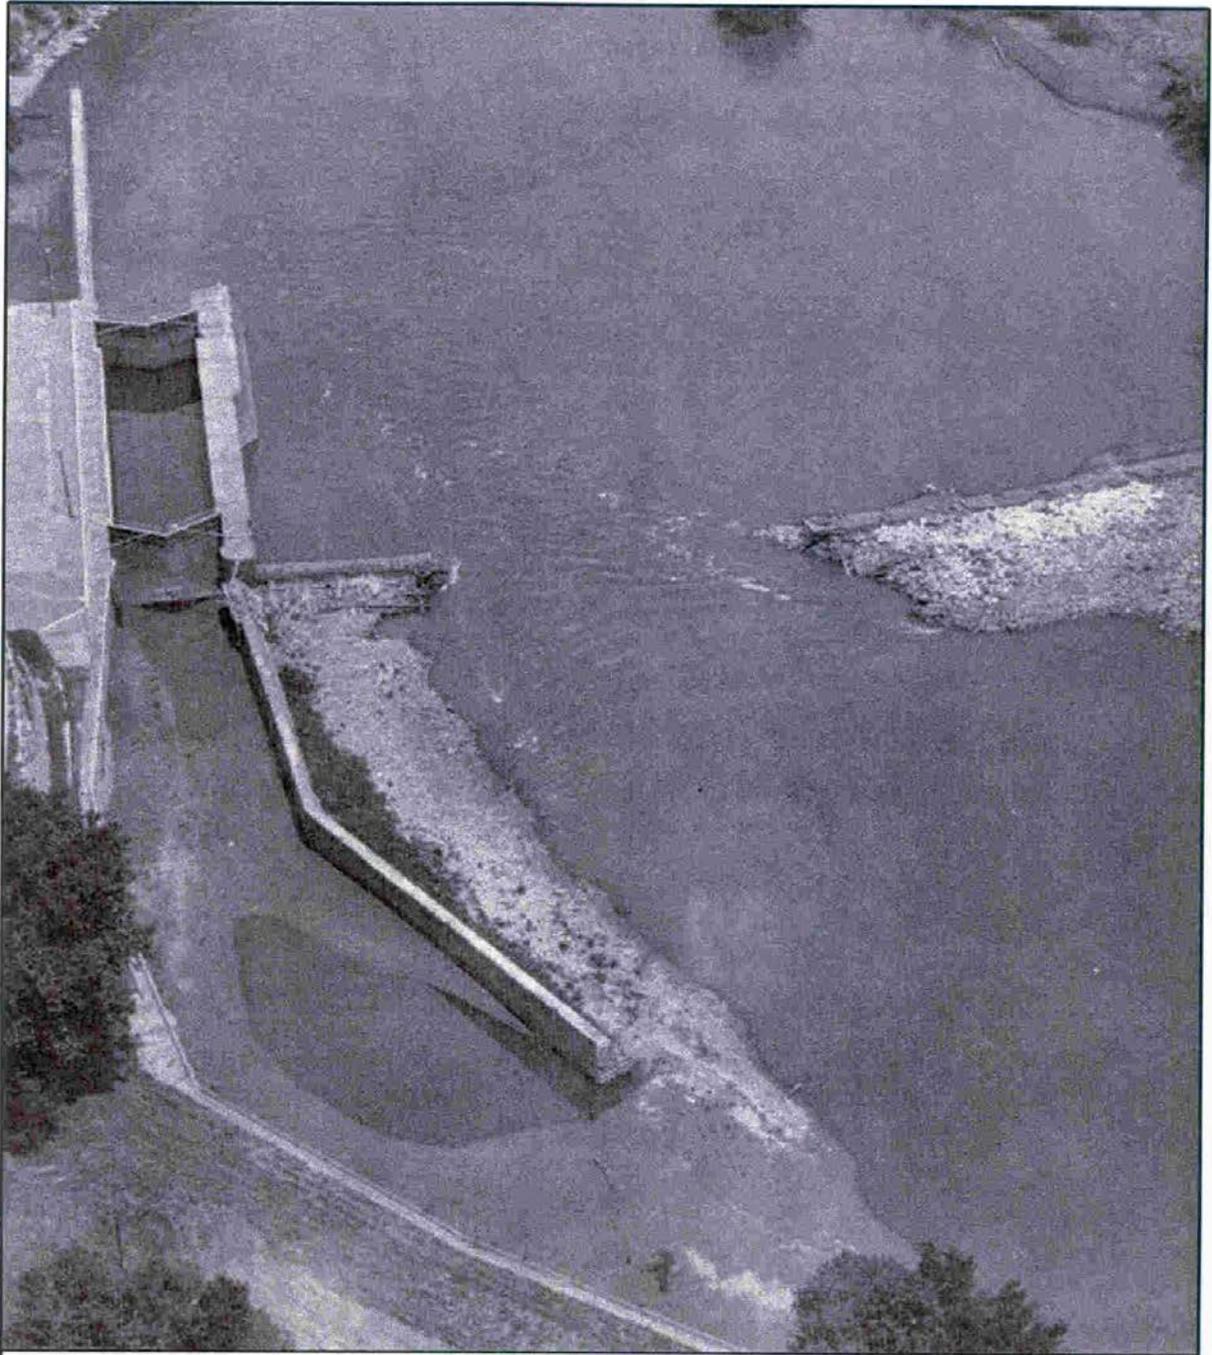
Figure G4-2. Aerial Photograph

AERIAL PHOTOGRAPH  
Green River Lock and Dam No. 4  
Butler County, Kentucky

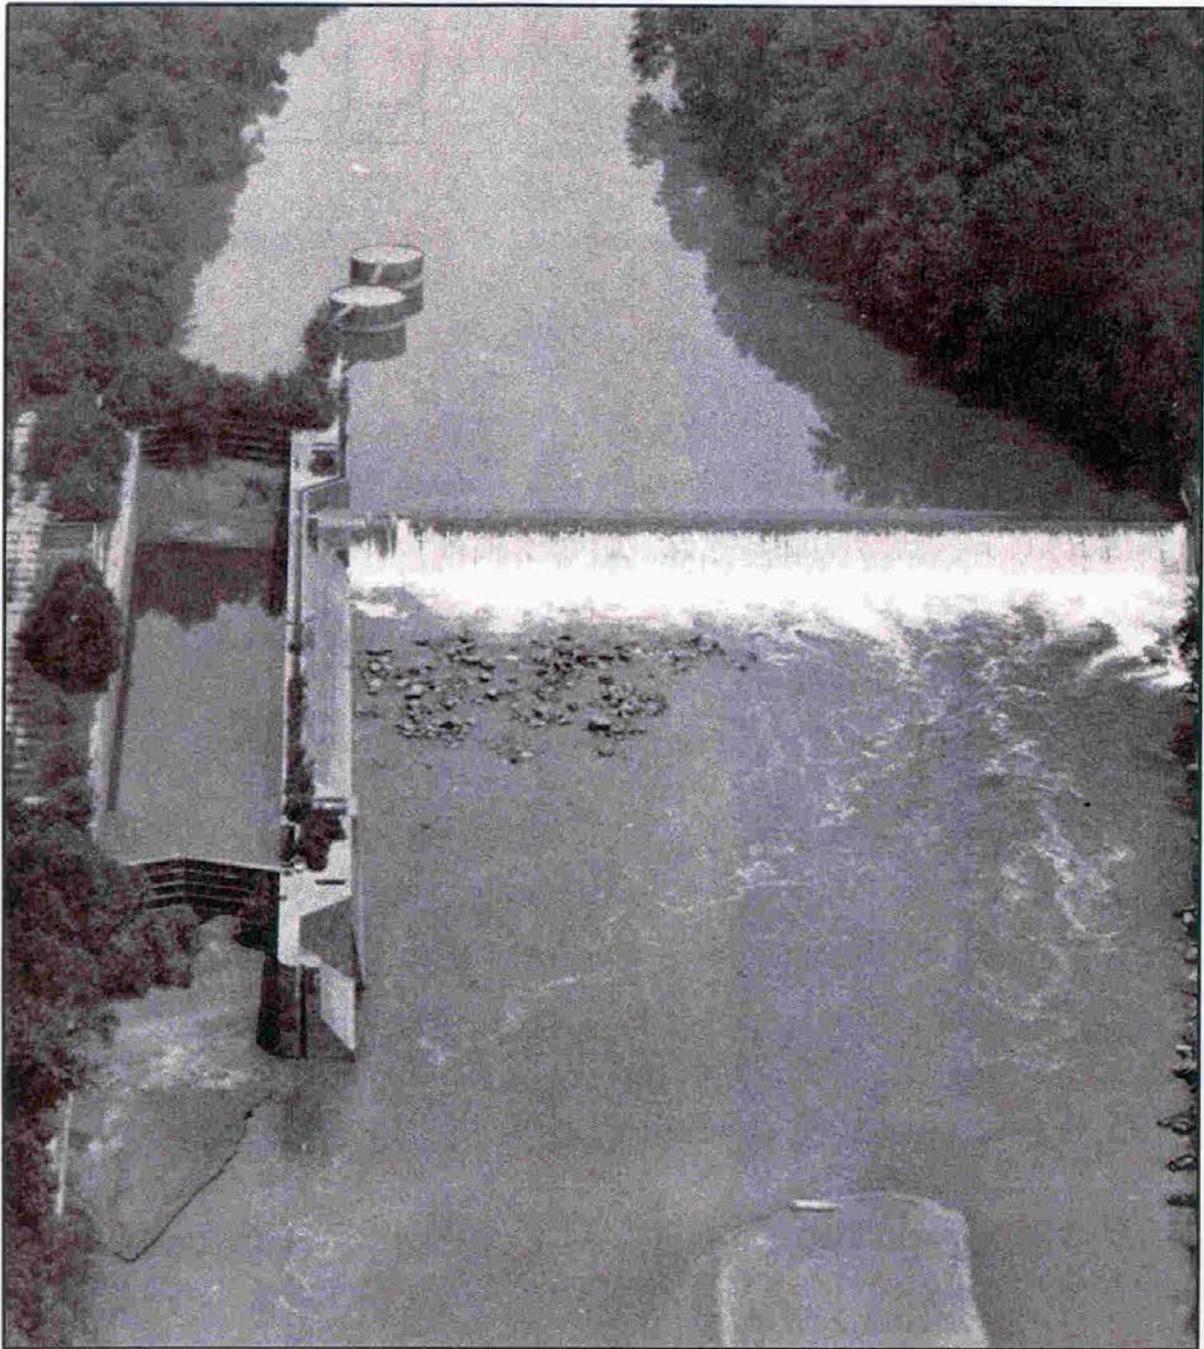
Figure G5-2. Aerial Photograph

AERIAL PHOTOGRAPH  
Green River Lock and Dam No. 5  
Butler and Warren Counties, Kentucky

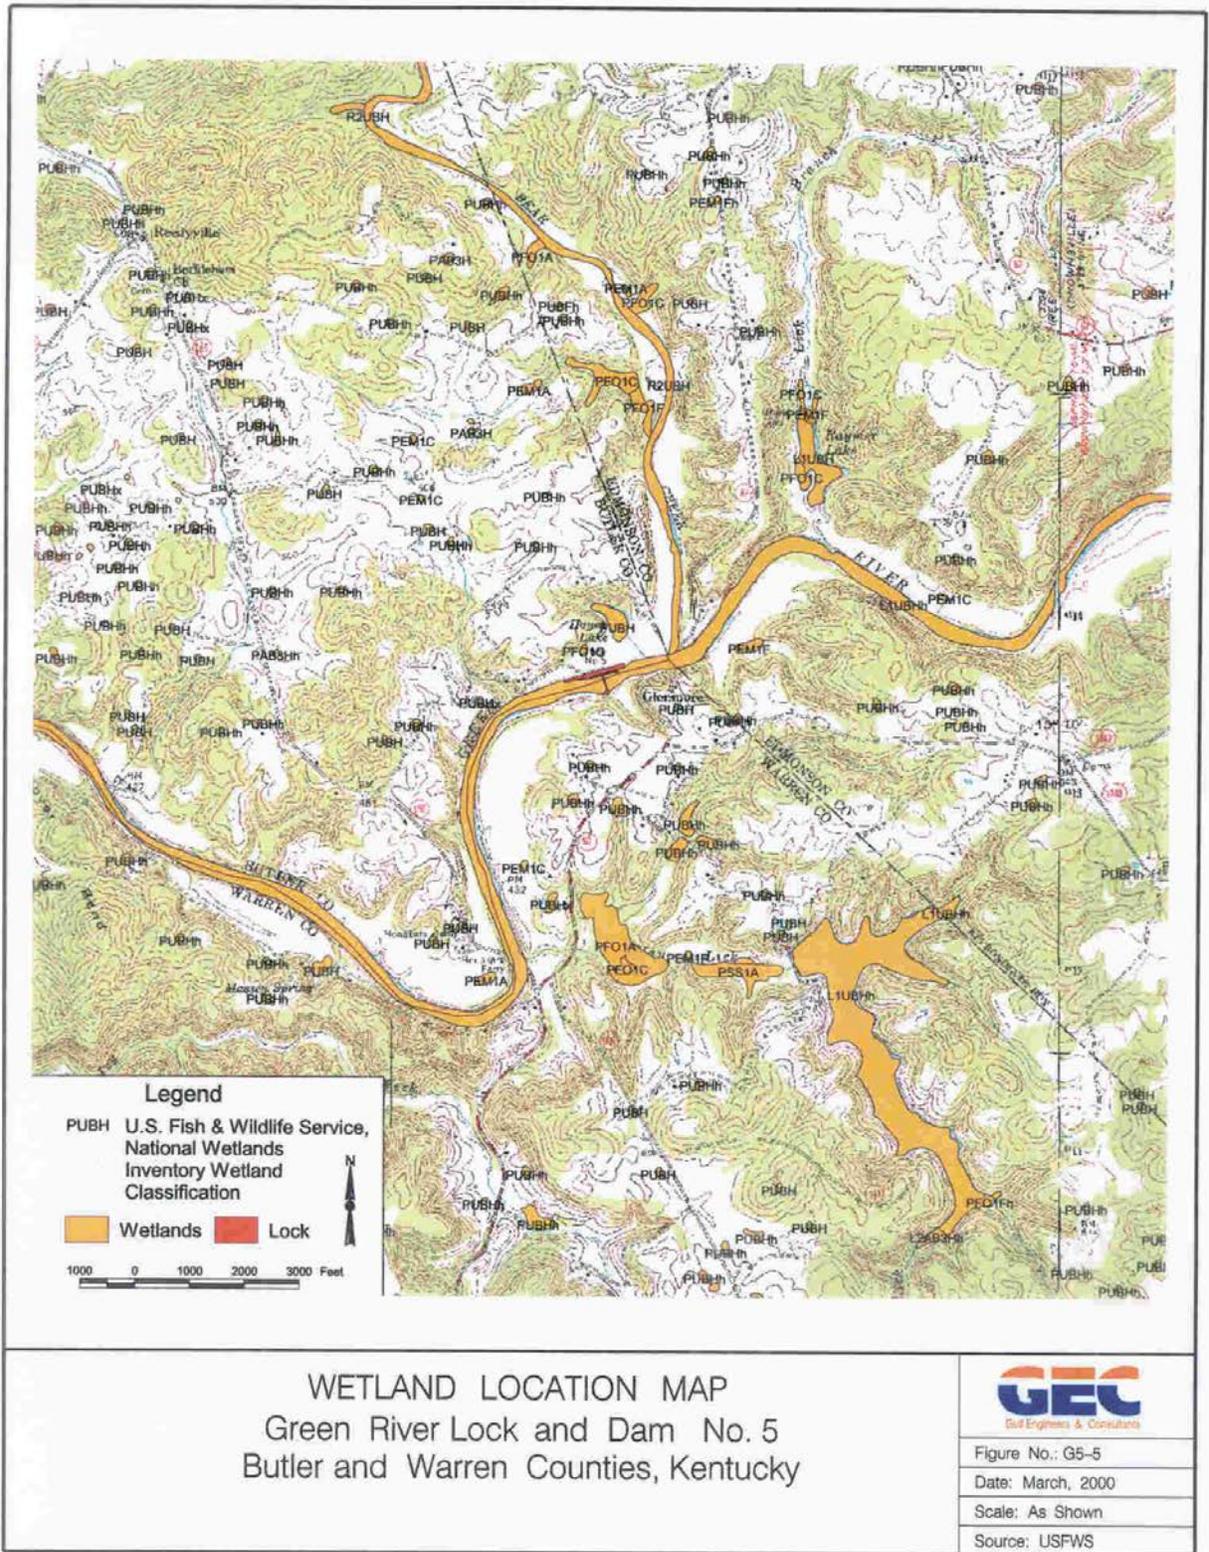
Figure G5-5. NWI Map

A Department of the Interior National Wetlands Inventory Map dated 1988, a portion of which is presented in Figure G5-5, indicates a forested palustrian wetland at the site, in the form of narrow riparian zones adjacent to the river. G.E.C. confirmed this during the field investigation.

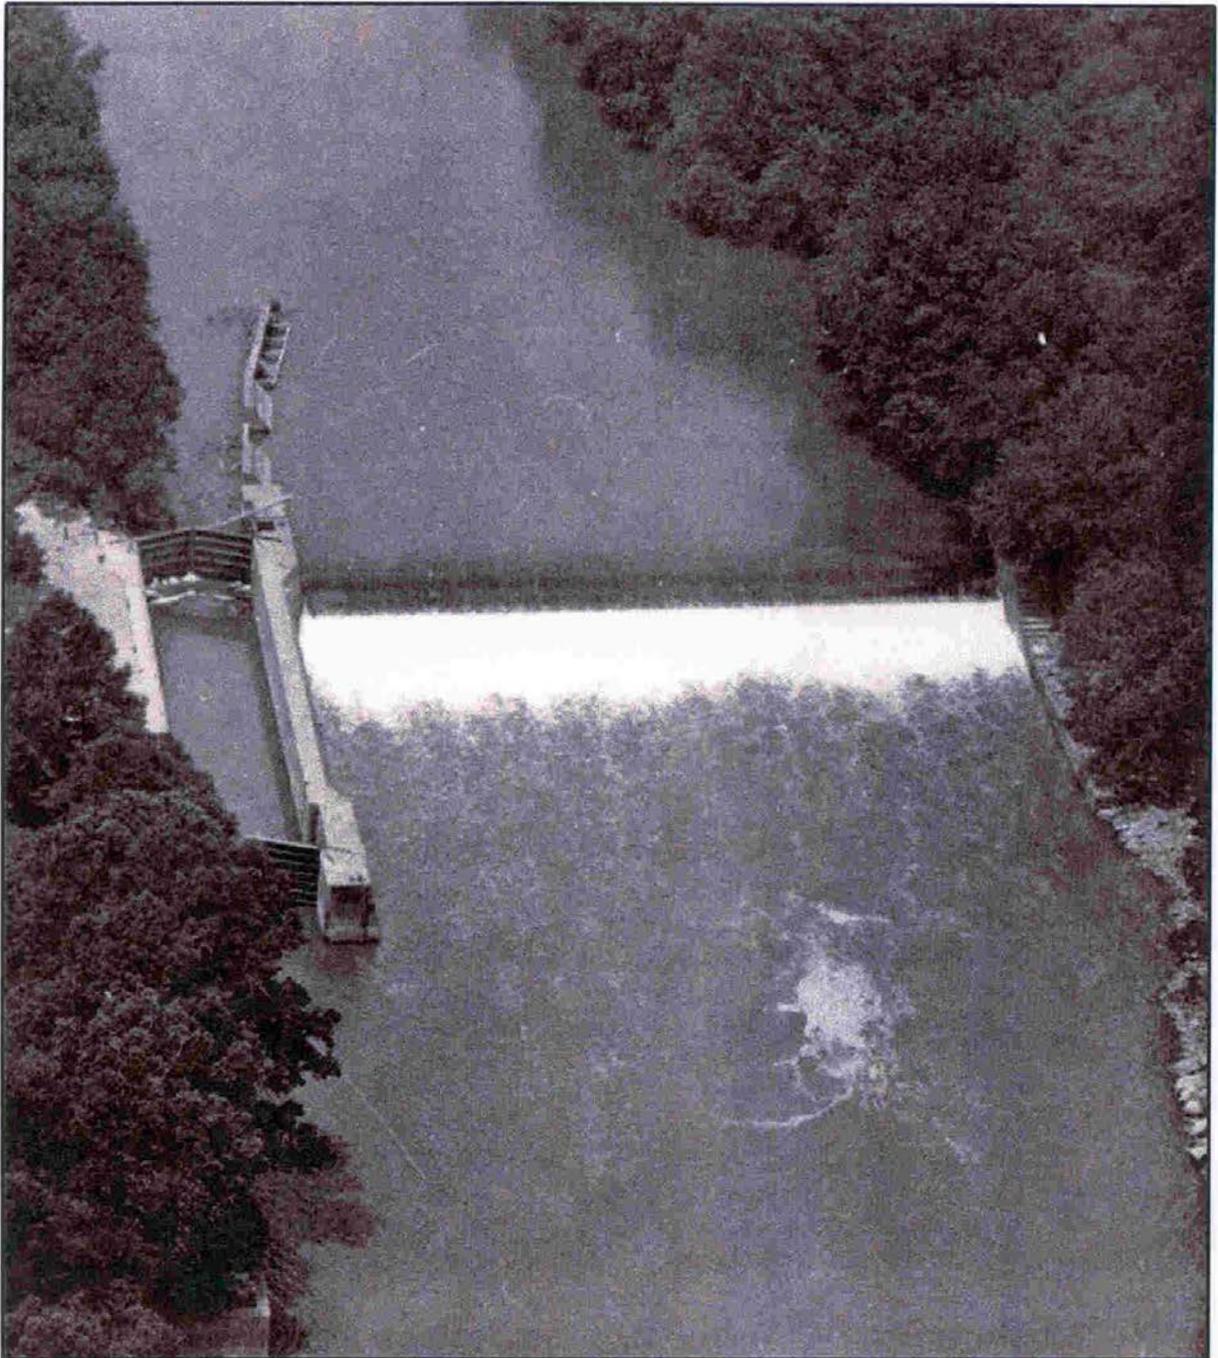
Figure G6-2. Aerial Photograph

AERIAL PHOTOGRAPH  
Green River Lock and Dam No. 6  
Edmonson County, Kentucky
