ACTION MEMORANDUM
for
TIME-CRITICAL REMOVAL ACTION

FORMER LOCKBOURNE AFB
INDOOR FIRING RANGE
(AREA OF CONCERN #75)
COLUMBUS, OHIO
FUDS Site No. : G05OH0007

U.S. Army Corps of Engineers
Louisville District
600 Dr. M.L. King Jr. Pl.
Louisville, KY 40202-2230

August 2010

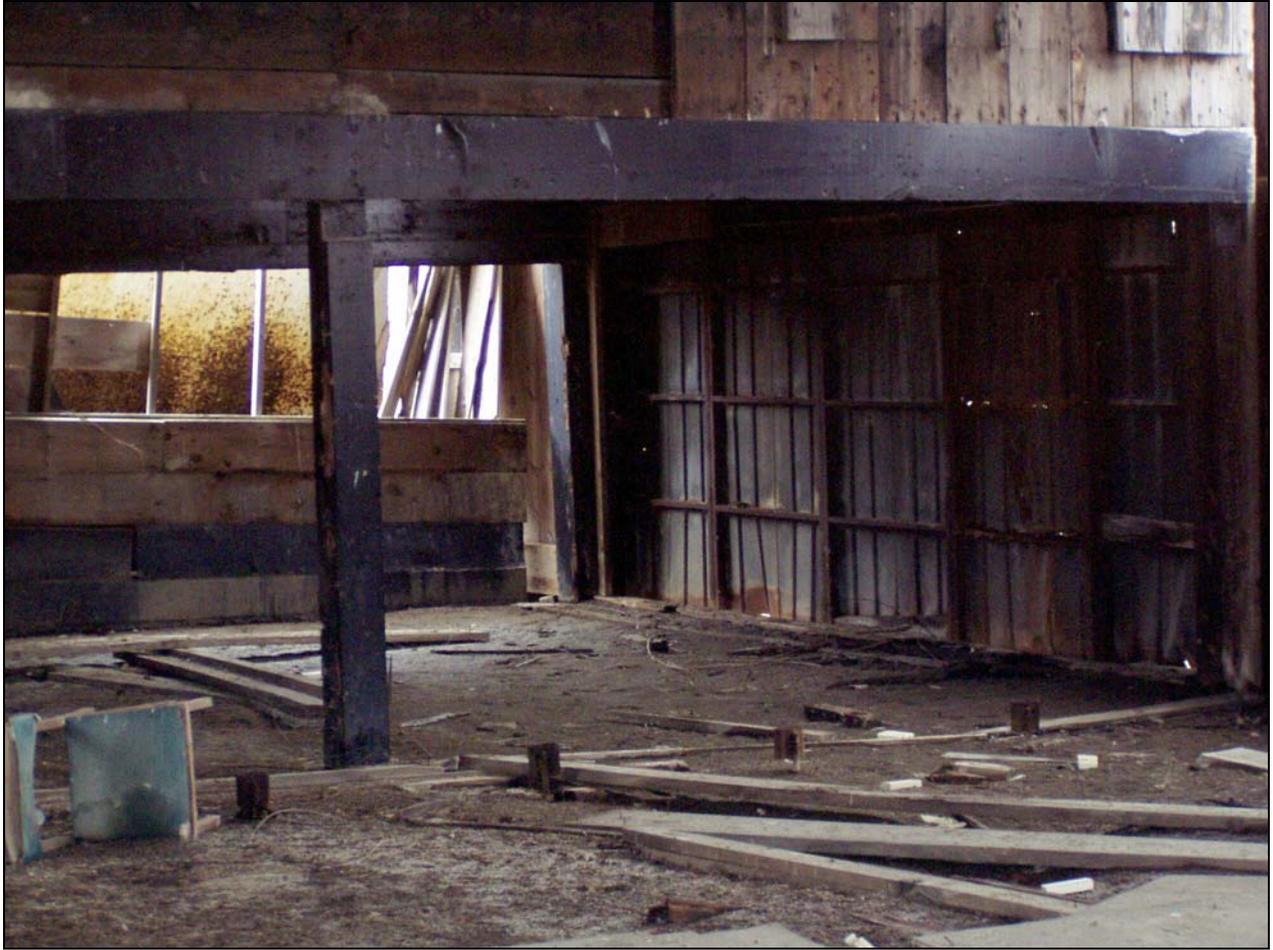
FIGURE 5. PHOTOGRAPH OF AOC #75 INTERIOR

The AOC #75 building is approximately 40 feet wide by 80 feet long (see Figure 3) and consists of an unpainted wooden and metal frame structure covered with corrugated metal siding. The building is in disrepair, is unsecured (i.e., open door and windows), and the floor is covered with approximately 6 inches to 3 feet of sand. The building was constructed on top of the former concrete runway. A new floor was poured on top of the runway, in portions of the building, for construction of the building. The building is partially surrounded by an earthen berm along portions of the north, east, and south sides. Photographs of the building exterior and interior are provided in Figures 4 and 5. The Archives Search Report (USACE, 1997) concluded that the indoor firing range was an “area with potential, but not likely to contain ordnance”; and therefore was not subject to the requirements of the military munitions response program (MMRP).

Hazards within AOC #75 (Building 687) were confirmed during the site investigation. Eighteen metals were detected in the sand on the floor in the building. Copper, magnesium, thallium, and zinc were detected above background but below their respective preliminary remediation goals (PRGs), if available. Antimony was detected above both background and the PRG. Arsenic was detected above the PRG but below background. Lead was detected above

both background and the PRG. A composite sample collected of the sand material was analyzed for toxicity characteristic leaching procedure (TCLP) metals and Pb was detected above the regulatory limit, making the sand characteristically hazardous for waste disposal purposes. Given the prior use of the building, Pb dust was assumed to exist on the interior building surfaces.

- Preparation of project WP for review and approval by the CELRL, CRAA, and Ohio EPA.
- Removal and proper off-site disposal of the hazardous sand from Building 687.
- Wash-down and rinse of existing building floor (concrete overlay and/or runway surface).
- Demolition, removal and proper offsite disposal or recycle of Building 687, including pre-demolition asbestos abatement in order to safely and cost-effectively address contaminants.
- Removal and proper offsite disposal of contaminated soil, from building apron, to levels that are consistent with the screening levels established for the previous site investigation, or other appropriate screening levels.
- Sampling and analysis for assessment, post-removal verification, and waste management.
- Construction completion reporting.
