FORMER NIKE SITE CL-59
PARMA, CUYAHOGA COUNTY, OHIO
FUDS PROJECT NUMBER G05OH005301

PRELIMINARY ASSESSMENT

March 2002

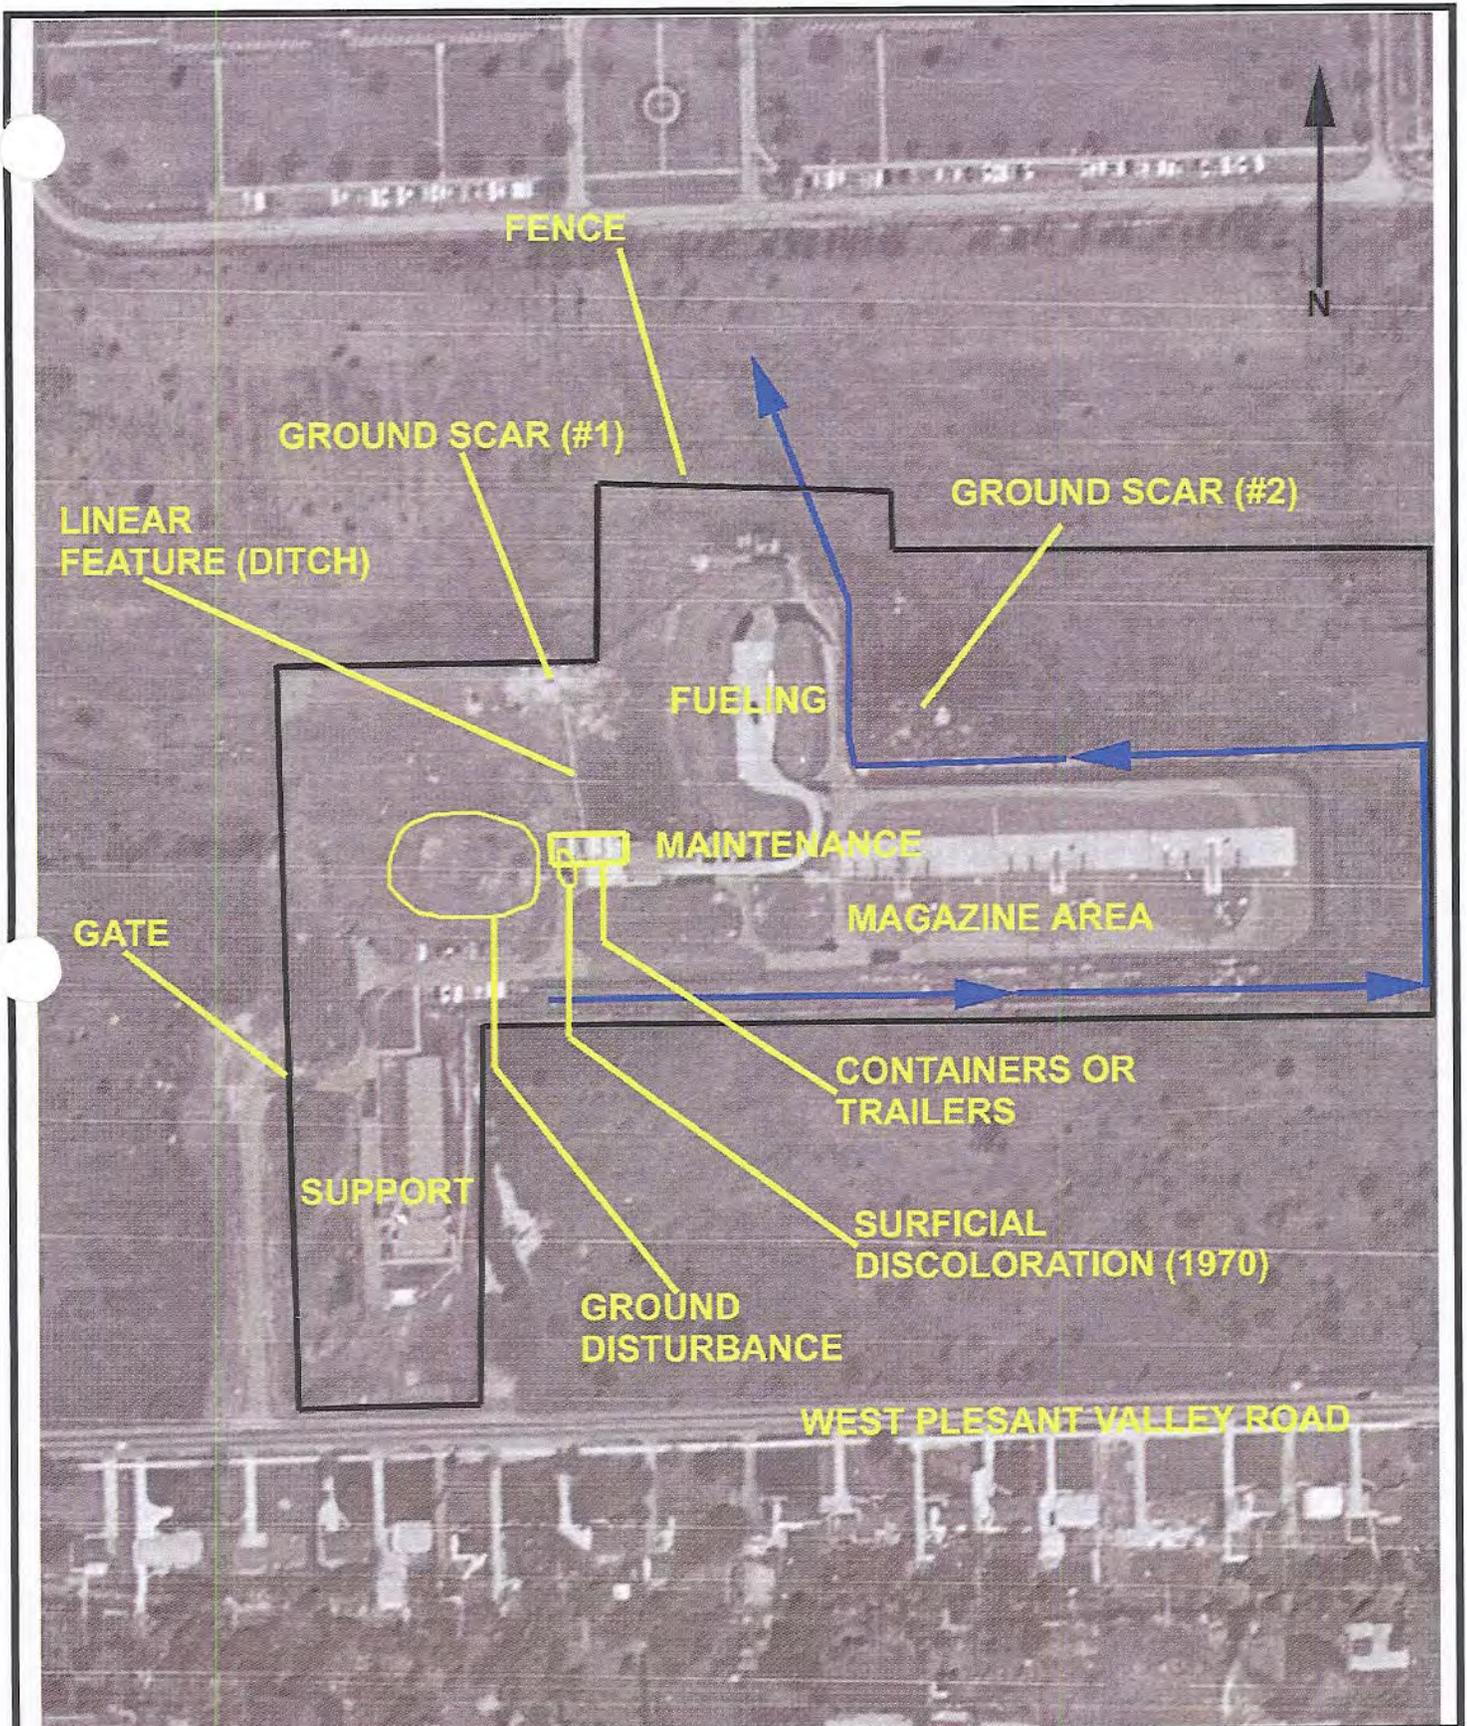
FIGURE 2-3
 ANNOTATED AERIAL PHOTOGRAPH OF NIKE MISSILE SITE CL-59
 LAUNCH AREA
 MAY 3, 1962
 PARMA, CUYAHOGA COUNTY, OHIO

1962 The two ground scars remain readily identifiable, as is seen in Figure 2-3. Scar #1 remains devoid of vegetative cover; the linear feature previously observed linking this area to the probable Missile Assembly and Test Building is very distinct. This feature now appears to be a shallow ditch. Numerous narrow containers or trailer-like vehicles are currently situated on the pad to which this ditch leads.

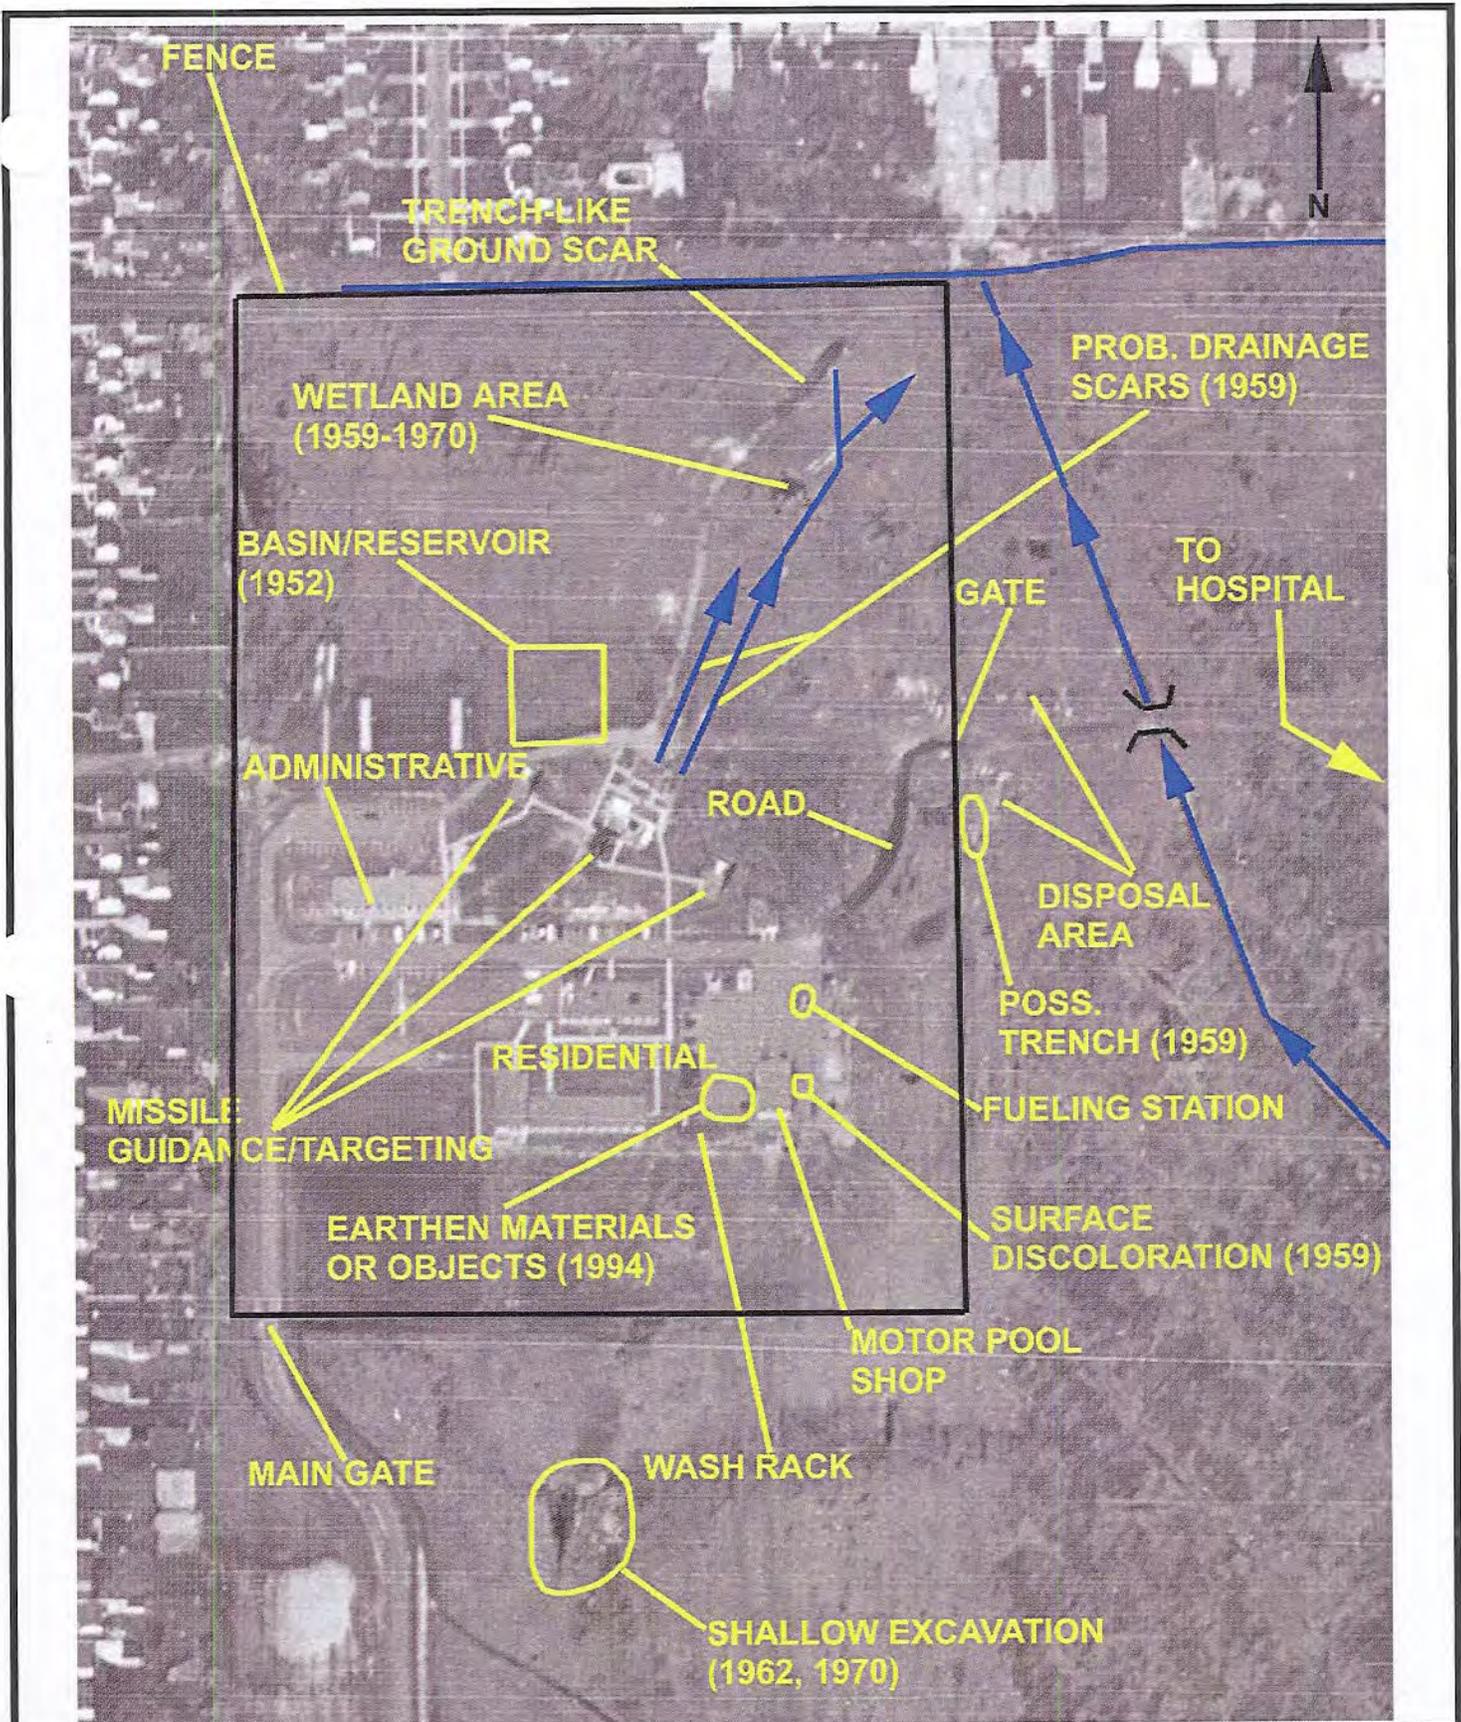
FIGURE 2-4
 ANNOTATED AERIAL PHOTOGRAPH OF NIKE MISSILE SITE CL-59
 CONTROL AREA
 MAY 3, 1962
 PARMA, CUYAHOGA COUNTY, OHIO

1962 The darkened roadbed, visible in Figure 2-4, that leads between the disposal site and the motor pool clearly illustrates the access and presumed current and historical use of the disposal area by the missile installation. The disposal site exhibits a somewhat less disturbed appearance than previously observed in 1959. Additionally, it is unclear whether the trench previously observed in this area has been filled in. The poor resolution of the photography, coupled with the uneven surface and vegetative cover that appears to have established itself in the area, preclude a clear view of the presence (or absence) of the trench.

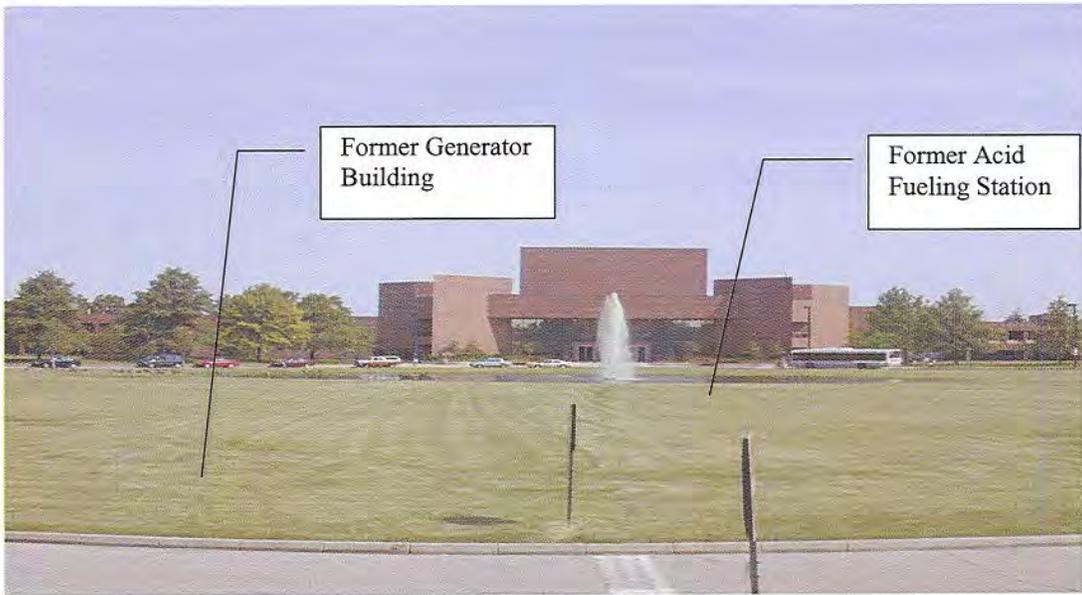
1. Facing north, this is a view of the main entrance of the Cuyahoga County Community College. The Fueling Station, earthen berm, and Generator Building were located within the traffic circle, south of the fountain.

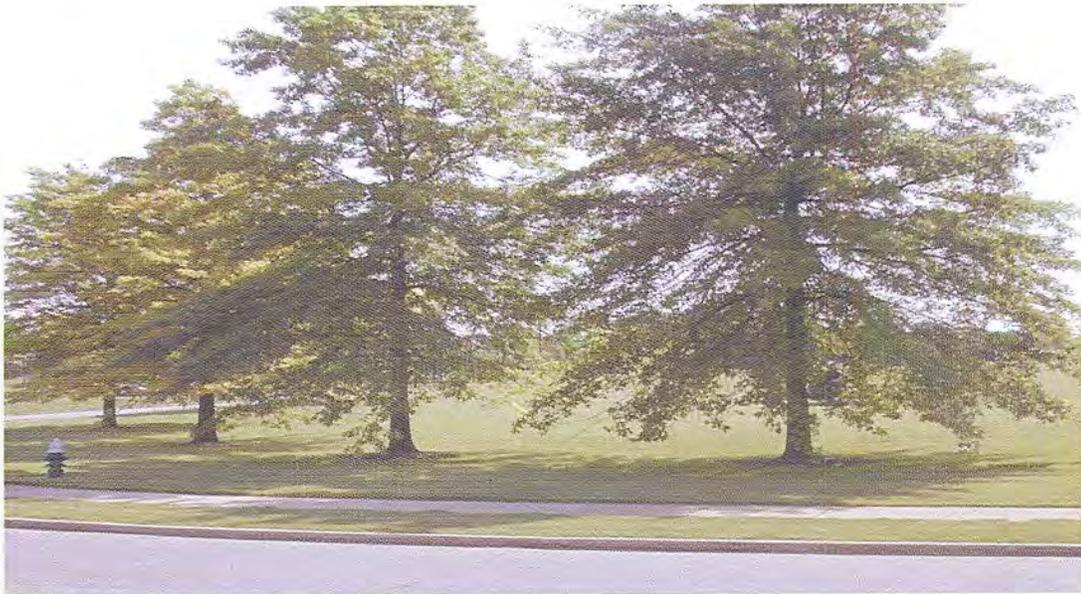
2. Facing west, the field beyond the trees contains the remaining 2 magazine structures at Cuyahoga Community College. The underground structures have been in-filled and buried. The western most magazine, which was demolished, was in the area of the trees, sidewalk and street of this photograph.

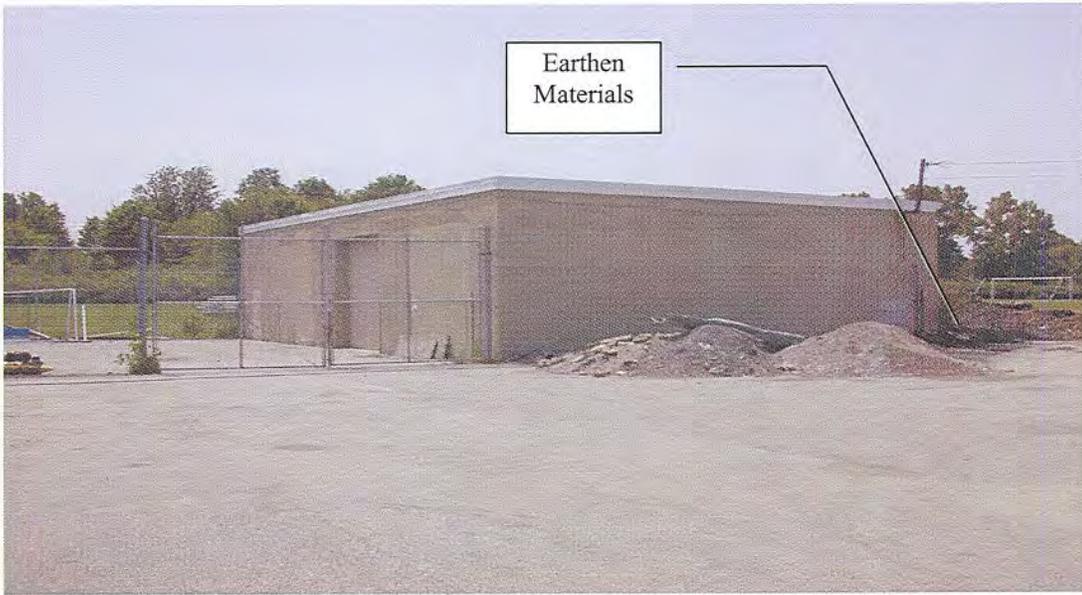
3. Facing southeast at Nathan Hale Park, this is a view of the former motor pool building of CL-59. Parma Heights stores the piles of earthen material on site.

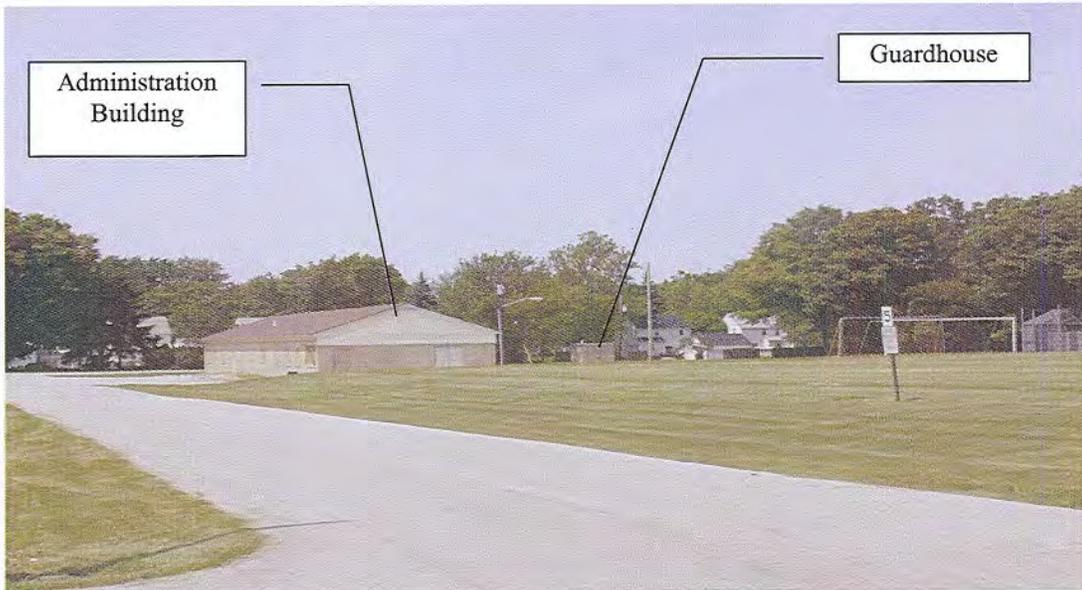
4. Facing northwest, this is a view of the former Administration Building and Sentry Guardhouse of CL-59. The entry to Nathan Hale Park is located to the north (right) of the guardhouse. The residential properties located along Parma Park Boulevard can be seen in the background.

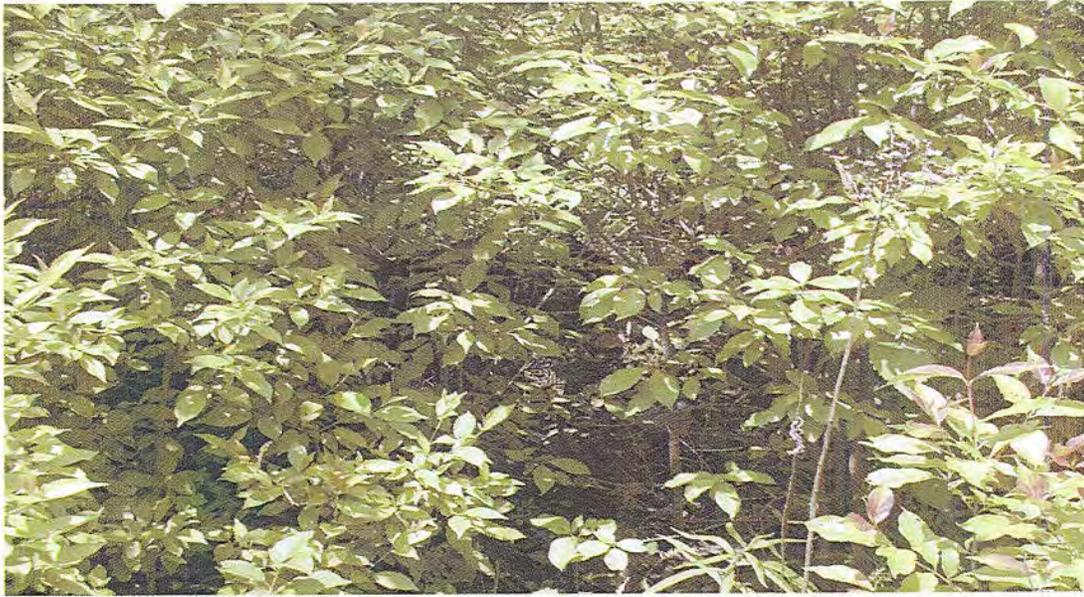
5. Facing northwest, this is a view of a debris pile overgrown with weeds. This debris pile is located outside of the fence along the east perimeter of Nathan Hale Park.
