C.J. Brown Dam & Reservoir (2017)

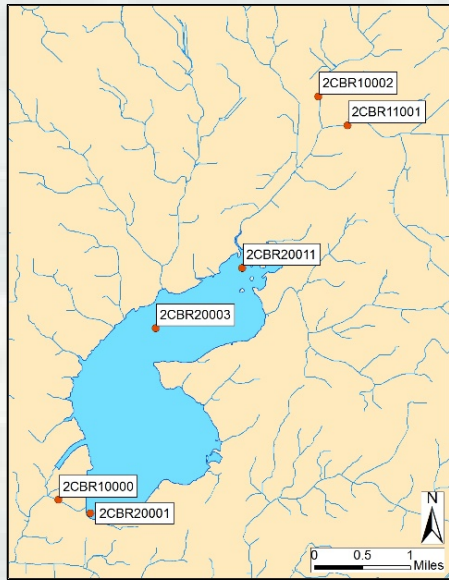
Figure 1. CBR sample sites in 2017.

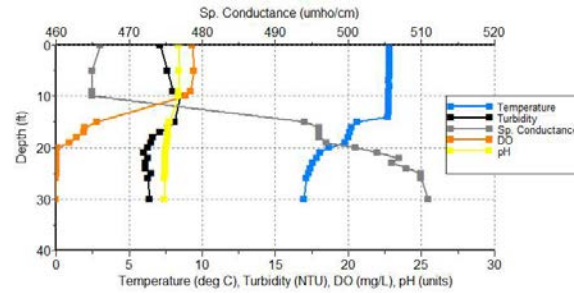
Figure 2. Field data taken at the dam site (2CBR20001; Figure 1) on 6/5/2017 at 08:00.

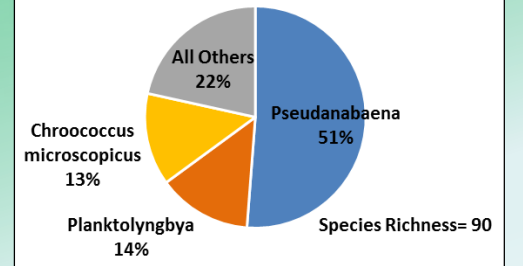
Figure 4 illustrates the relative abundance and species richness for the entire phytoplankton community at CBR. The relative abundance percentage was calculated using the density of phytoplankton species from all sample sites, at all depths. *Pseudanabaena*, a genera of cyanobacteria, was the dominant species found at CBR during the June sampling event.

Figure 4. 2017 relative abundance of the entire phytoplankton community at CBR.

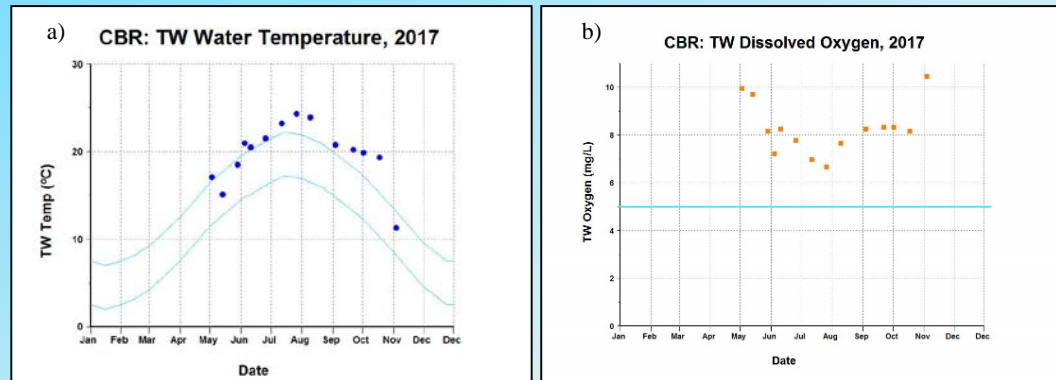
Figure 3. CBR time series data collected from the tailwater (2CBR10000; Figure 1): a) water temperature; and b) dissolved oxygen.

Temperature and dissolved oxygen (DO) profile data are regularly collected from LRL lakes. This data informs water control engineers on how to best use existing selective withdrawal capabilities to meet downstream water quality (WQ) targets established by each lake’s Water Control Plan (WCP) and state criteria. Figure 3a shows a time series graph of the 2017 tailwater water temperature compared with the guide curve from the lake’s WCP. Figure 3b shows a 2017 time series graph of the lake’s tailwater dissolved oxygen data with the applicable state criteria (blue line).

WQ in the Tailwater is assessed by analyzing exceedances of WQ criteria established by the OH Environmental Protection Agency (Ohio EPA). **No criteria were exceeded in the tailwater (2CBR10000; Figure 1).**

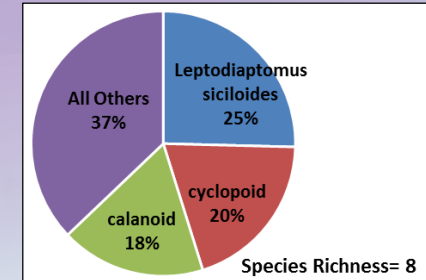
Figure 5. 2017 relative abundance of the zooplankton community at CBR.

Zooplankton are microscopic animals that live in the water column and are an important part of the food chain. The LRL WQ Program sampled the zooplankton community at the dam site (2CBR20001; Figure 1) using a Wisconsin net pull of 20 vertical feet. Figure 5 illustrates the relative abundance and species richness at CBR. Species richness is an indicator of community health, with greater community health as species richness increases. The top 3 dominant zooplankton were *Leptodiatomus siciloides*, sub-adult Cyclopoida, and sub-adult Calanoida.
