Detailed Project Report with Integrated Environmental Assessment

**Continuing Authorities Program (CAP)
City of Ledbetter, Livingston County, Kentucky
Section 14 Emergency Streambank Stabilization Project**

May 2021

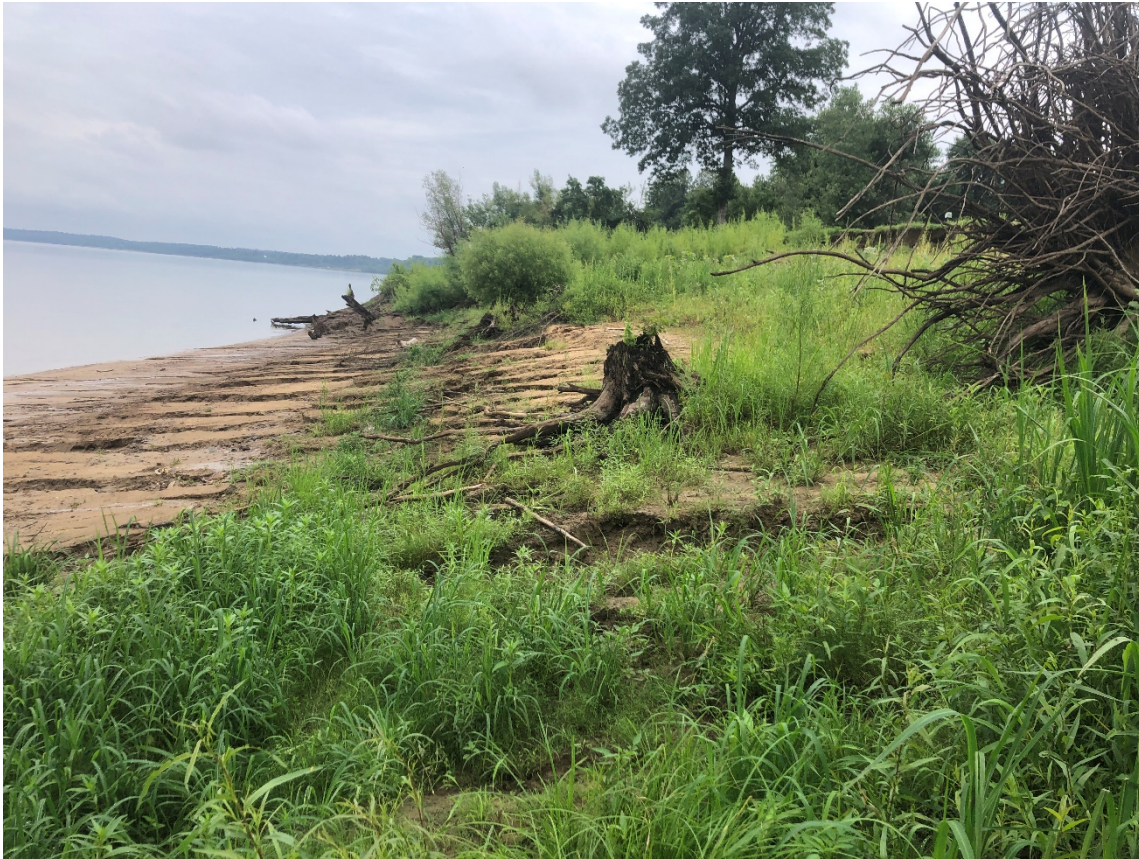
Figure 5. Photo of Lower Ohio River Shoreline Habitat within the Ledbetter Emergency Streambank Stabilization Project Area (August 13, 2020)

The only discernable natural habitat within the project area is a degraded Lower Ohio River Shoreline habitat (Figure 5). This community is characterized by frequent flooding events that maintain high levels of disturbance. This community is typically dominated by rushes (*Juncus* spp.), sedges (*Carex* spp.), and spike rushes (*Eleocharis* spp.), as well as hedge hyssop (*Gratiola viscidula*), mermaidweed (*Proserpinaca palustris*), small-flowered St. John's-wort (*Hypericum mutilum*), and tooth-cup (*Ammannia coccinea*) (Jones, 2005). These various species were present; however, a number of exotic invasive species were present as well including Johnson grass (*Sorghum halepense*), purple loosestrife (*Lythrum salicaria*), and

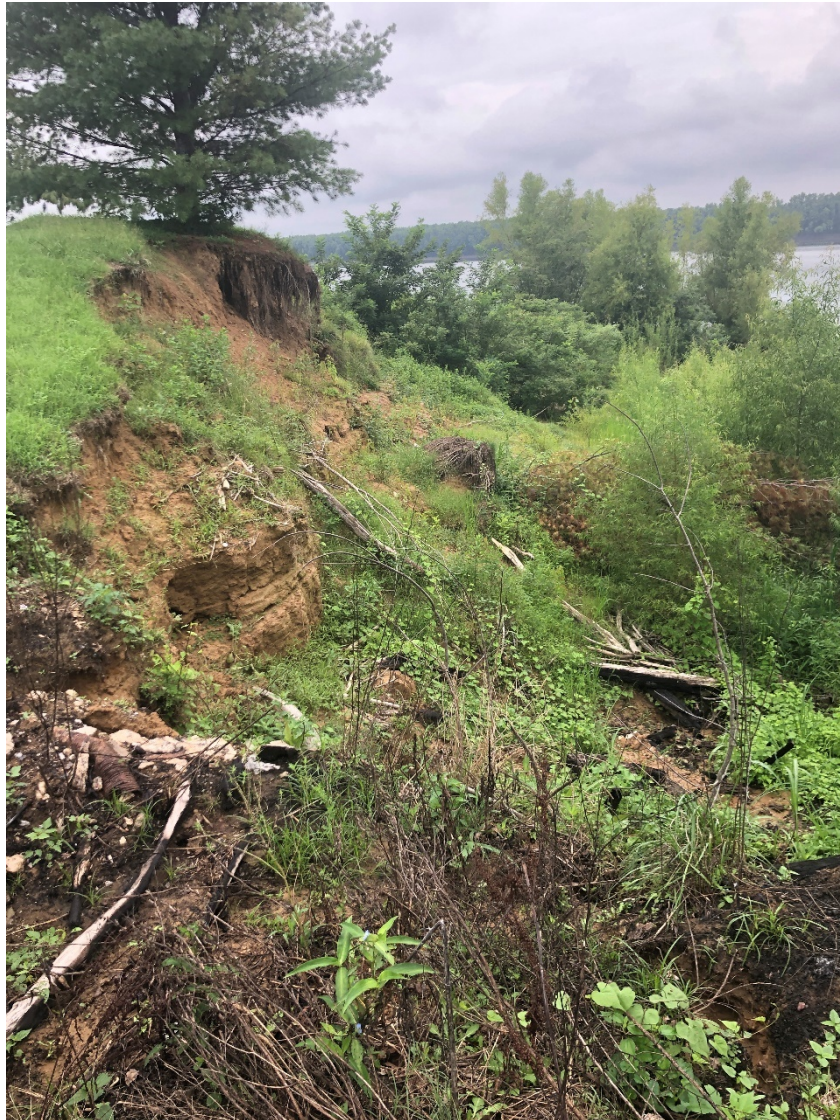
Figure 6. Photo of erosion threatening fragment floodplain forest in the Ledbetter Emergency Streambank Project Area (August 13, 2020)

The area above the shoreline was likely a floodplain forest habitat prior to residential development, with a floral community consisting of black willow (*Salix nigra*), boxelder maple (*Acer negundo*), eastern cottonwood (*Populus deltoides*), false indigo-bush (*Amorpha fruticosa*), green ash (*Fraxinus pennsylvanica*), river birch (*Betula nigra*), silver maple (*Acer saccharinum*), and sycamore (*Platanus occidentalis*) (Jones, 2005). However, since development occurred along Riverview Drive this community has all but been destroyed with only a heavily degraded remnant remaining. Only a few species typical of this community remain including black willow, boxelder maple, and false-indigo-bush. This remnant community appears to be further stressed by the extreme loss of soil within the project area, which is causing trees to be washed away (Figure 6). No fauna including amphibians, birds, mammals, or reptiles were observed utilizing this habitat fragment on an USACE site visit conducted on August 13, 2020.

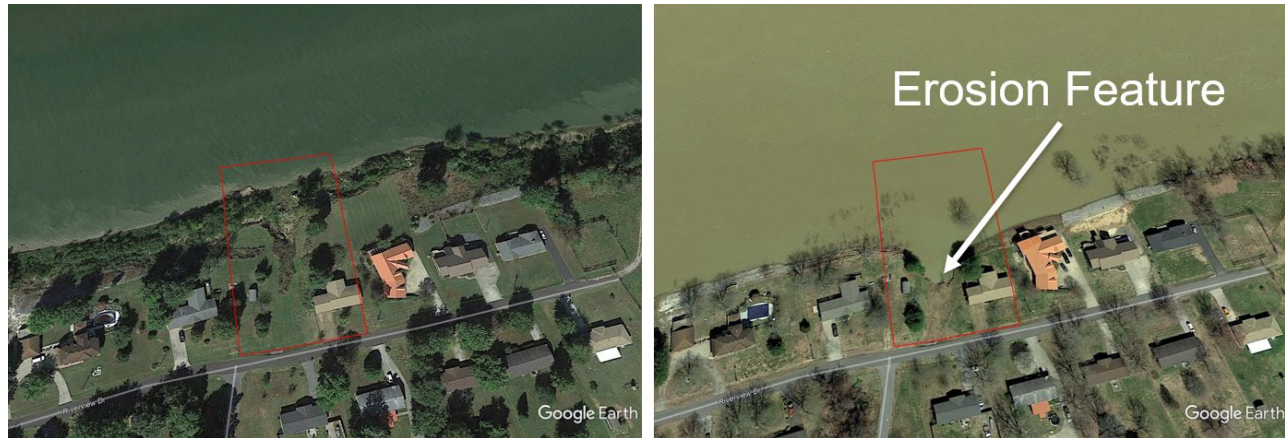
Figure 8. Comparison between October 15, 2015 (left) and March 15, 2019 (right)

Based on a comparison between the 2015 and 2019 aerial images (Figure 8), the rate of bank loss in the direction of Riverview Drive is approximately 6 feet per year. However, based on measurements taken during the site inspection the erosion rate within the last year (2020) in the direction of the road has increased to approximately 8 feet per year. This is likely the result of a number of high water events during early 2020 that would have impacted the area. It is expected that this trend will continue.

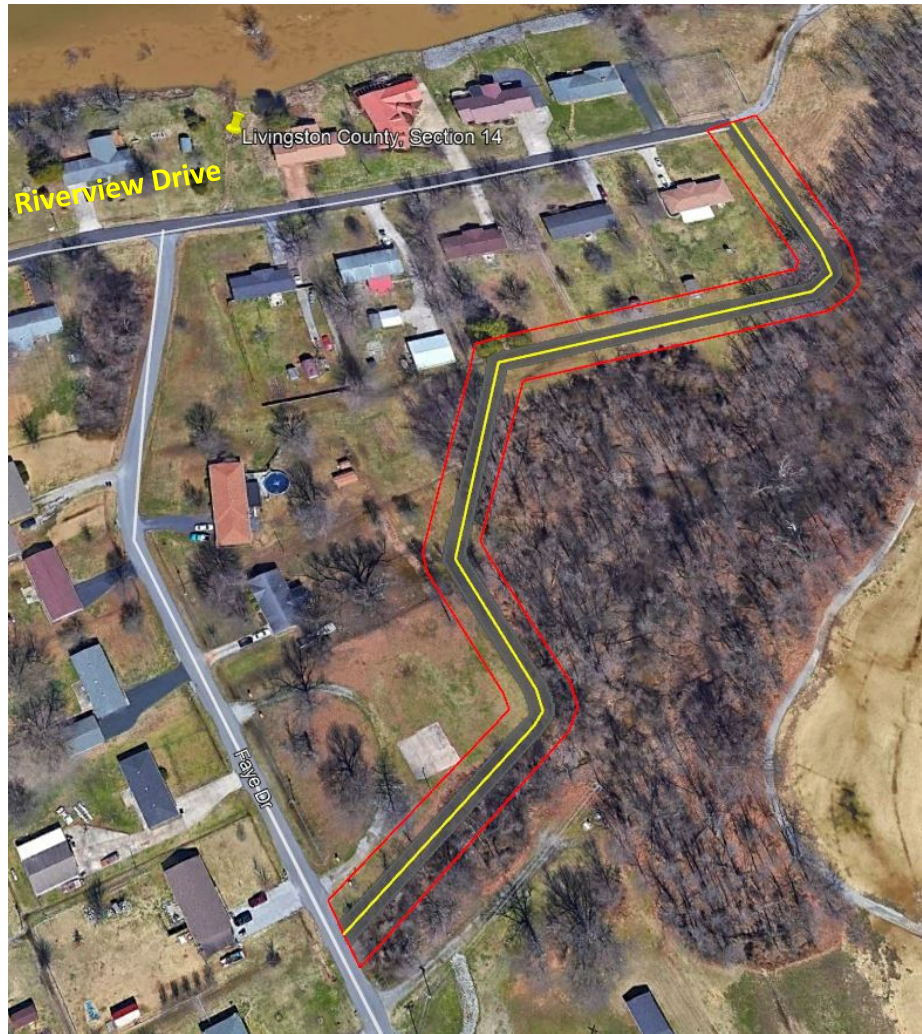
Figure 10. Road Alignment 2

Alternative Plan 2 (Road Alignment 2) – Re-aligning Riverview Drive by moving it to the south away from the area of erosion on a route slightly longer than Road Alignment 1 does not solve the erosion issue but it does provide residents with an alternative means of ingress and egress when the erosion reaches Riverview Drive in its current location (Figure 10). The new road in this configuration would be approximately 1,230 linear feet in length and would require clearing of 0.81 acres as well as partial acquisition of nine (9) parcels. This cost estimate was not fully developed and under-estimates the actual cost of the alternative. The alternative became cost-prohibitive before factors such as wetland mitigation and real estate acquisition were considered. The cost for relocation at a conceptual level is estimated to be \$1,178,000 (FY2021).

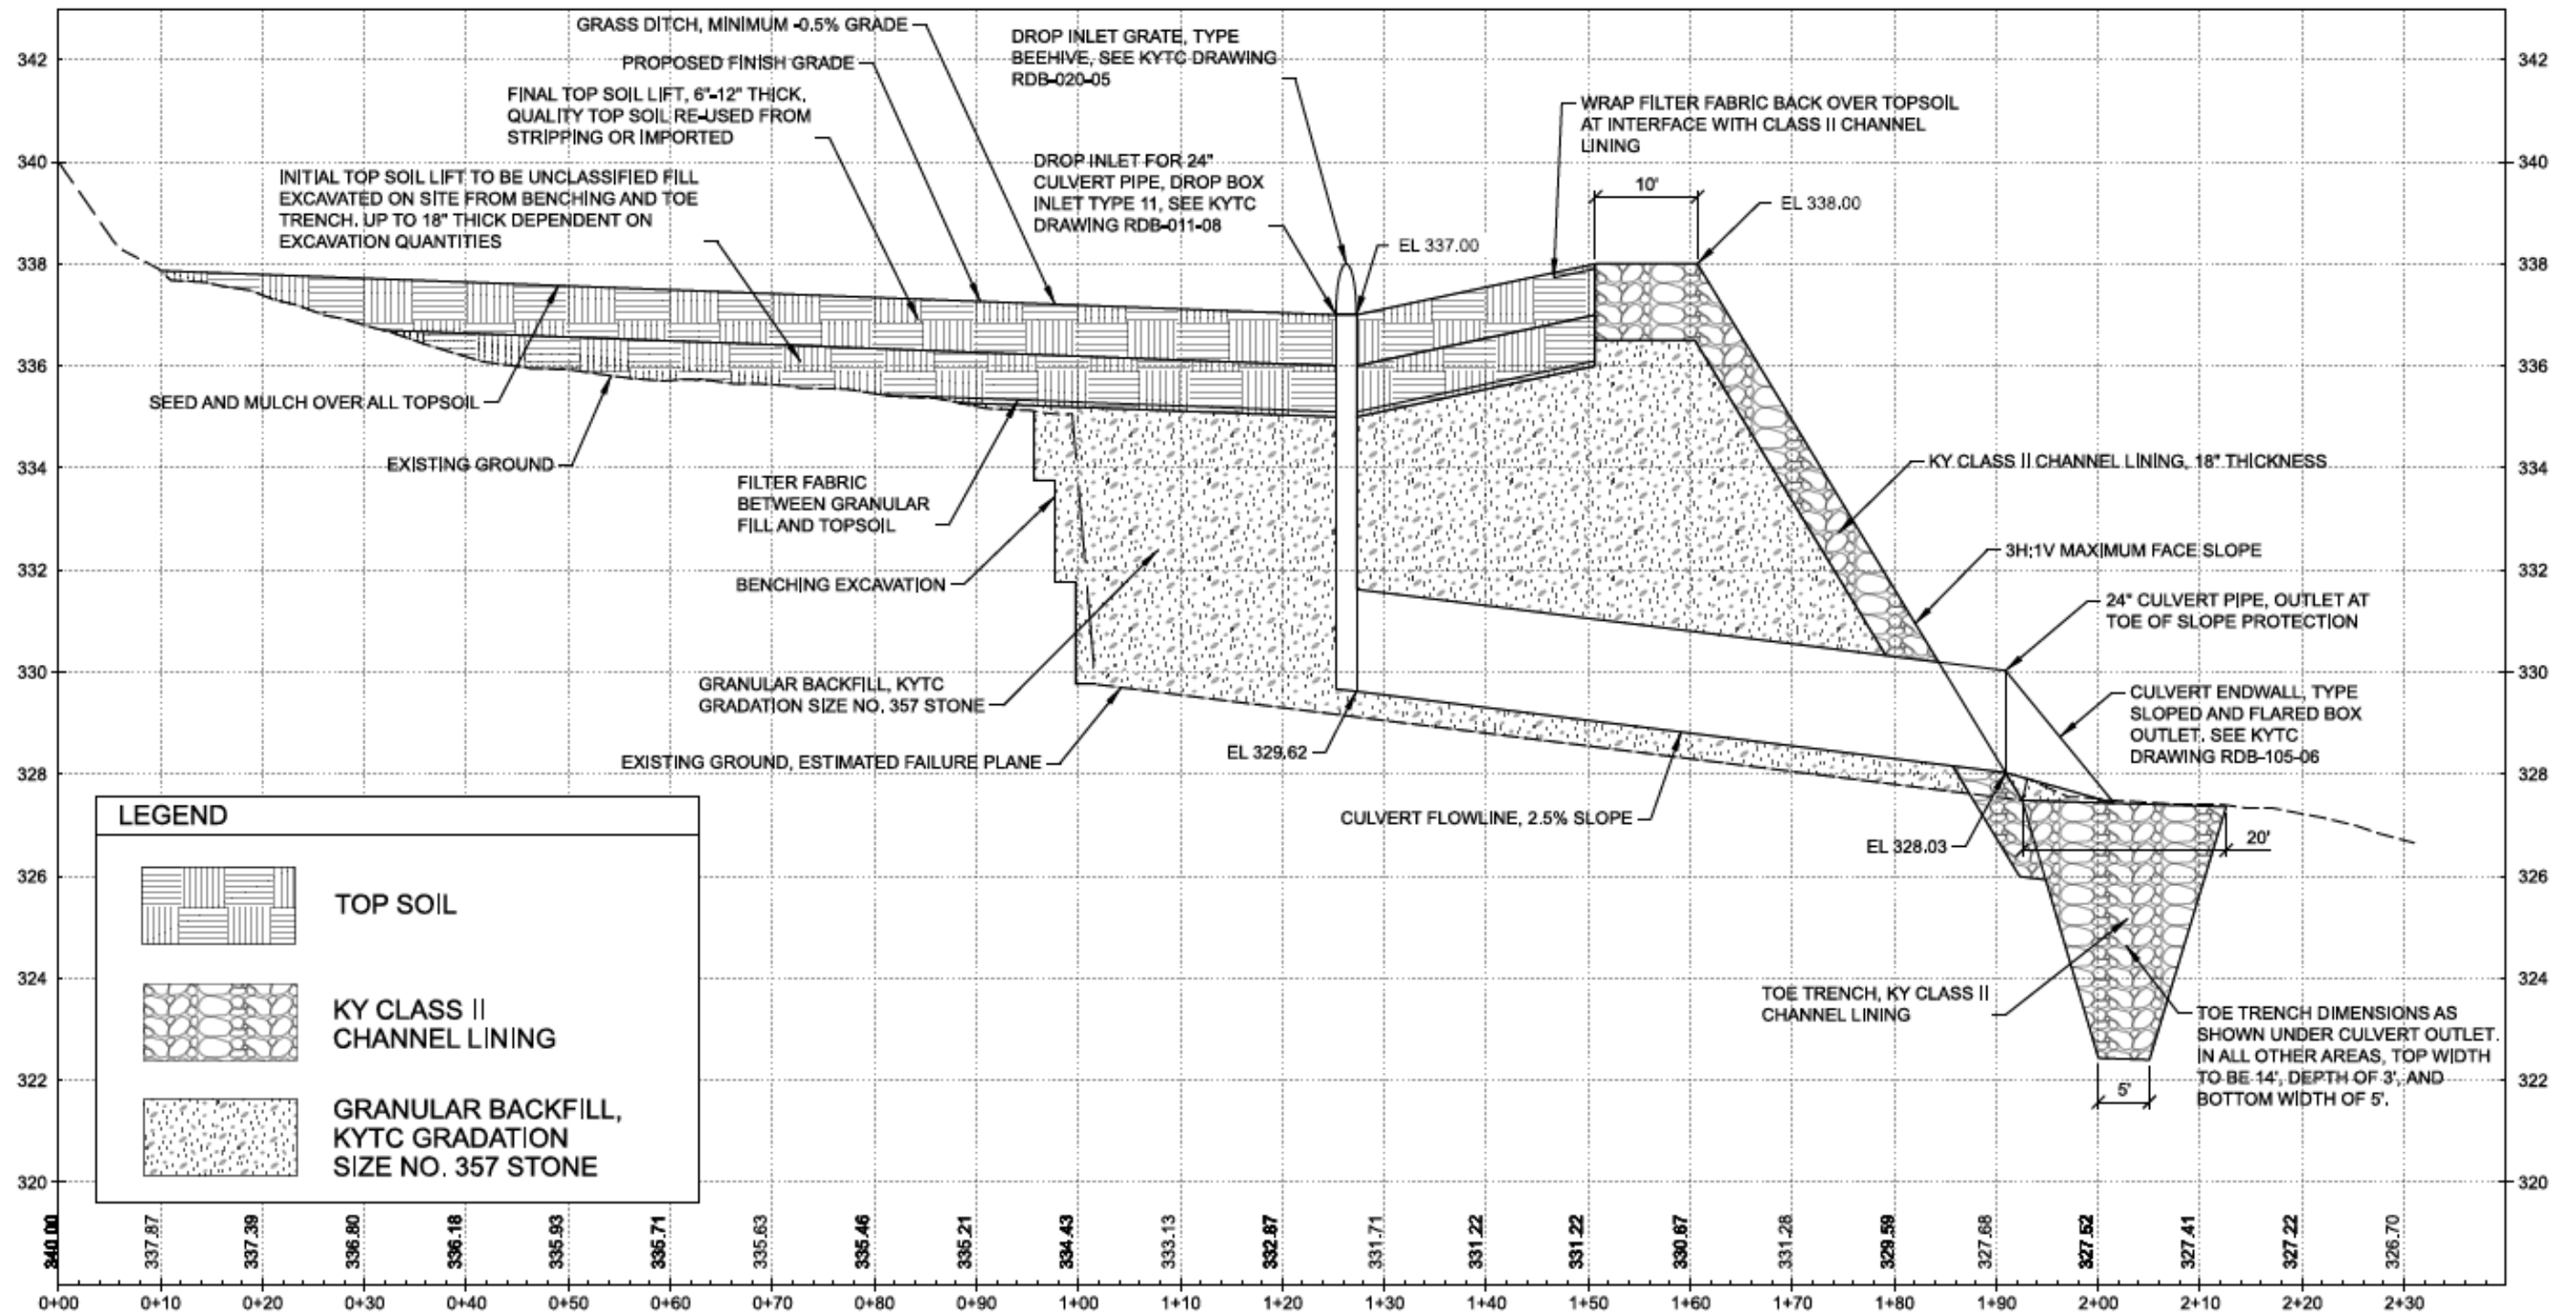
A1 PROFILE - CENTERLINE PROPOSED REPAIR
SCALE: 1"=10' HORIZONTAL, 1"=2' VERTICAL

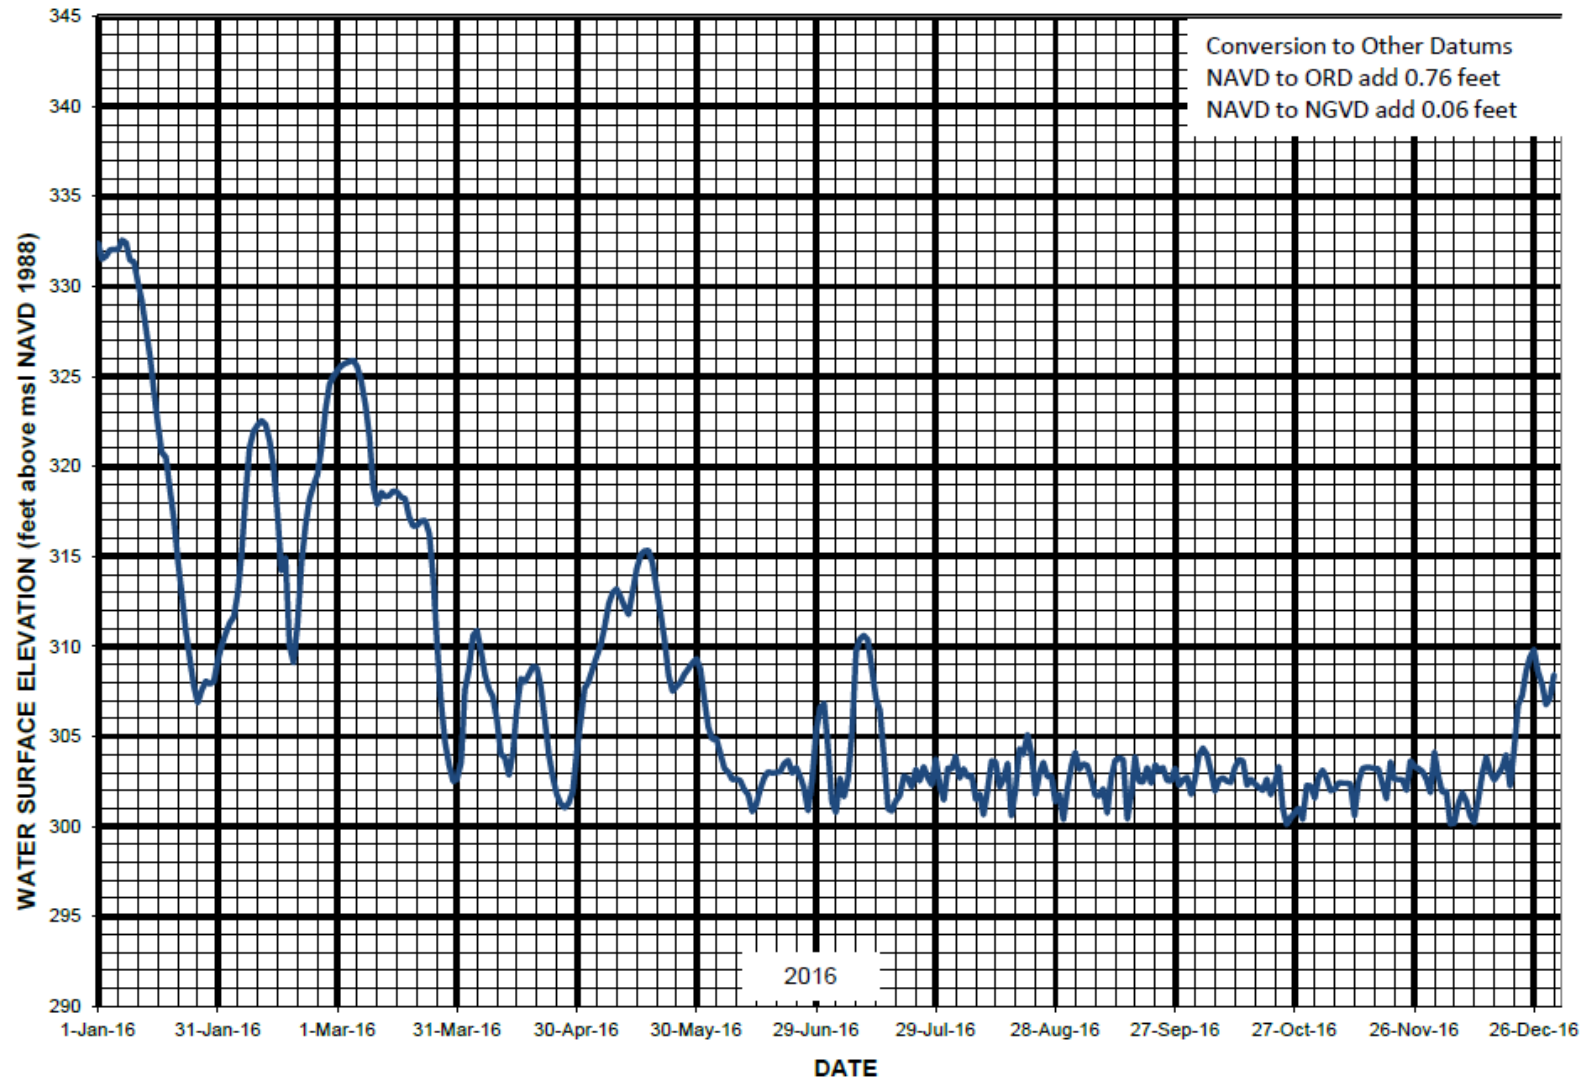
**ATTACHMENT #3
2016 OHIO RIVER HYDROGRAPH
@ LEDBETTER, KY
(TRANSPosed FROM PADUCAH GAGE DATA)**

**OHIO RIVER @ LEDBETTER, KENTUCKY
RIVER MILE 927.6**

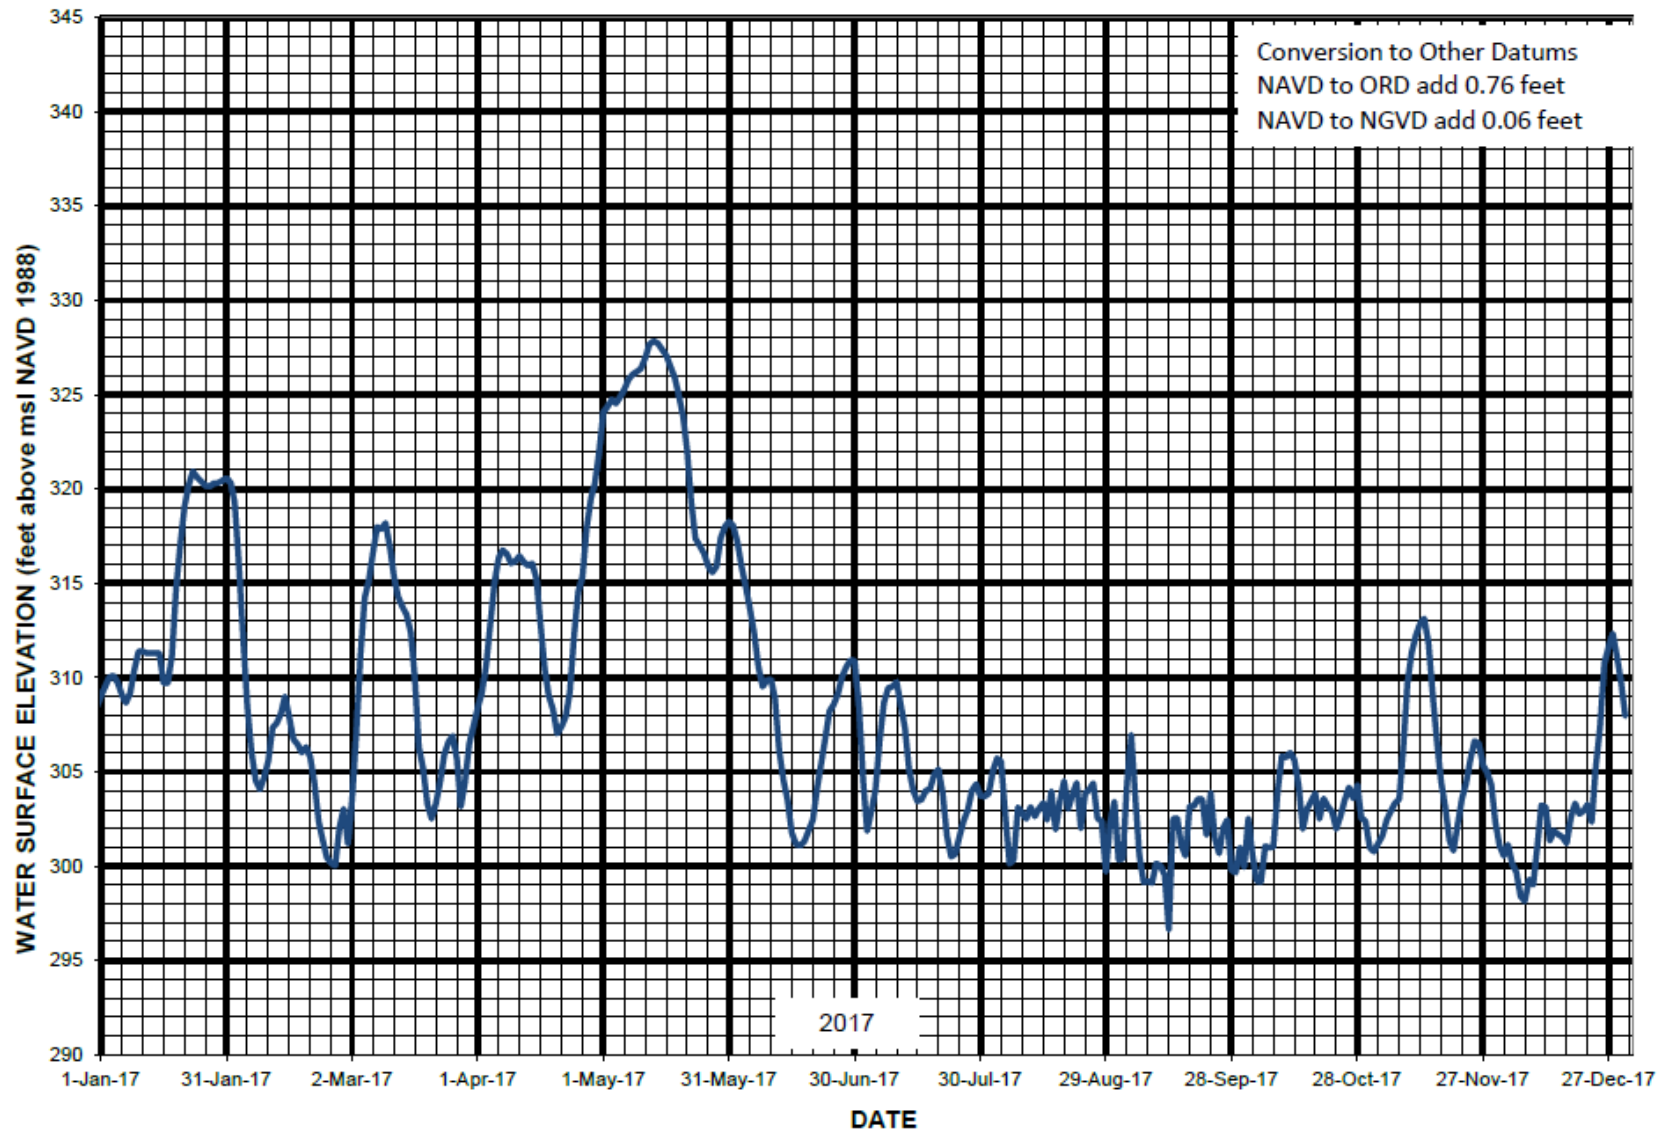
**ATTACHMENT #3
2017 OHIO RIVER HYDROGRAPH
@ LEDBETTER, KY
(TRANSPosed FROM PADUCAH GAGE DATA)**

**OHIO RIVER @ LEDBETTER, KENTUCKY
RIVER MILE 927.6**

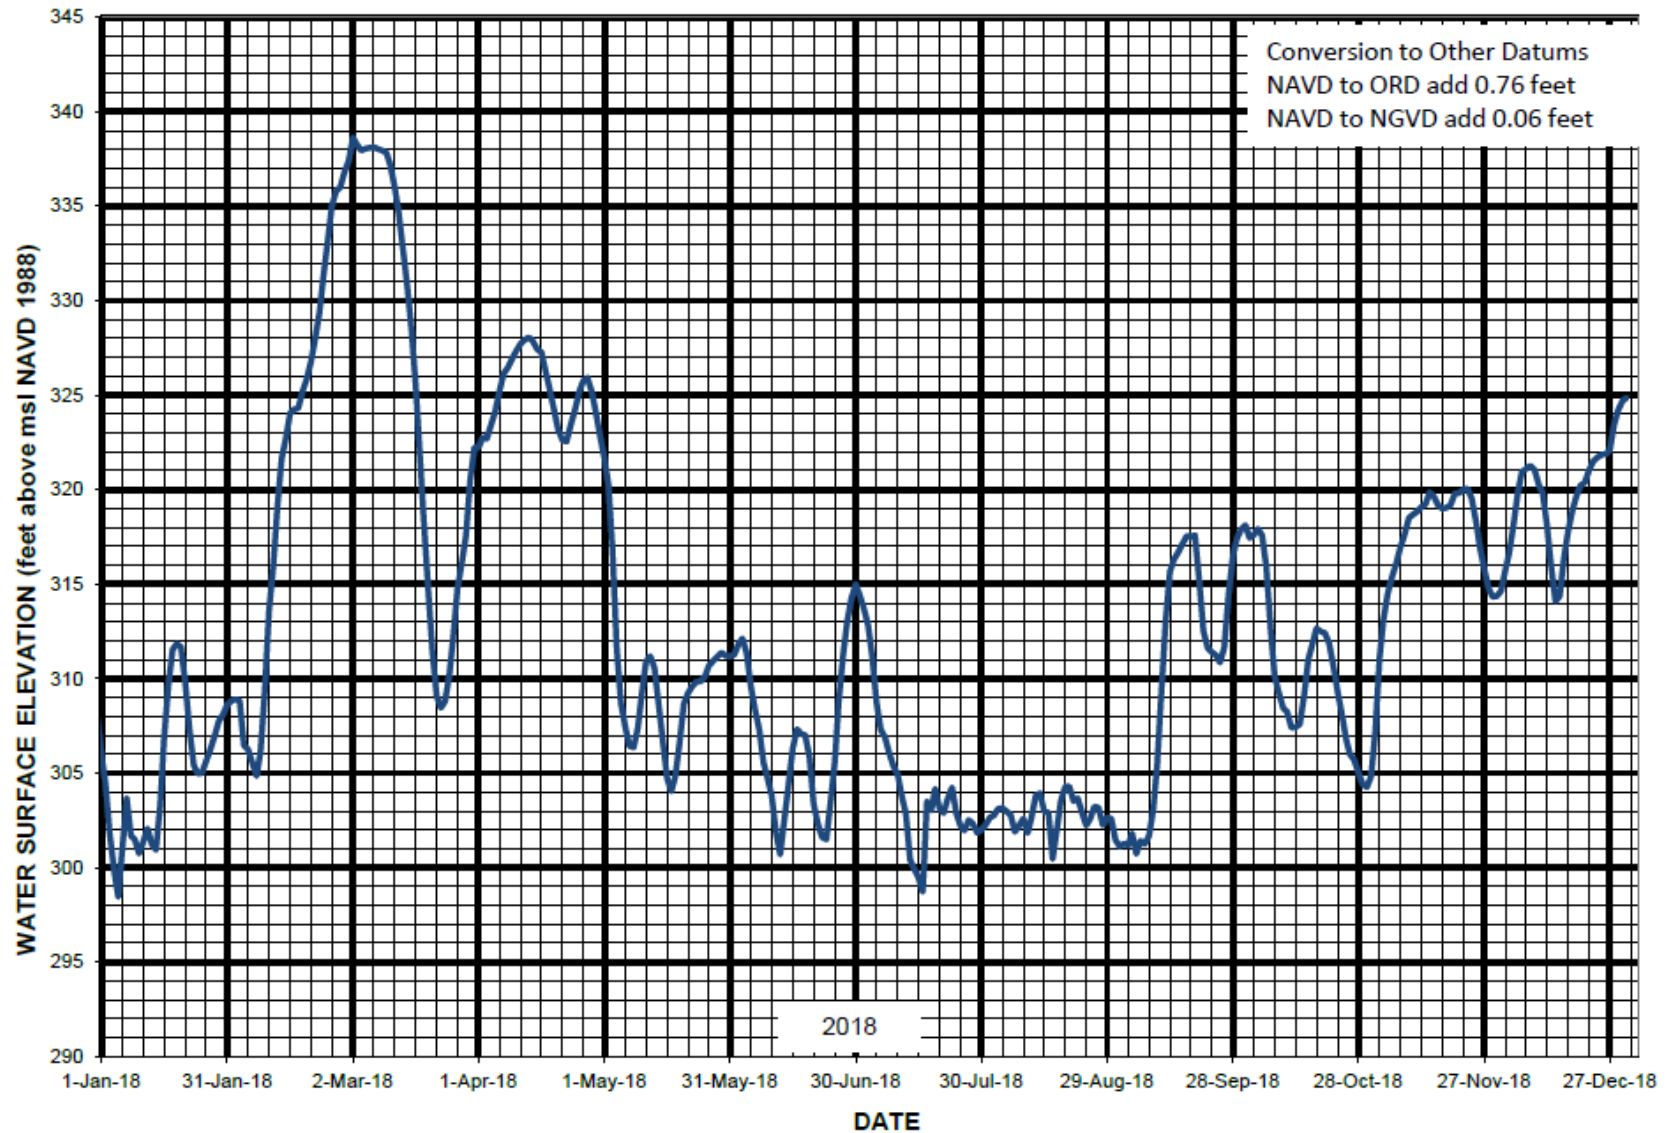
**ATTACHMENT #3
2018 OHIO RIVER HYDROGRAPH
@ LEDBETTER, KY
(TRANSPosed FROM PADUCAH GAGE DATA)**

**OHIO RIVER @ LEDBETTER, KENTUCKY
RIVER MILE 927.6**

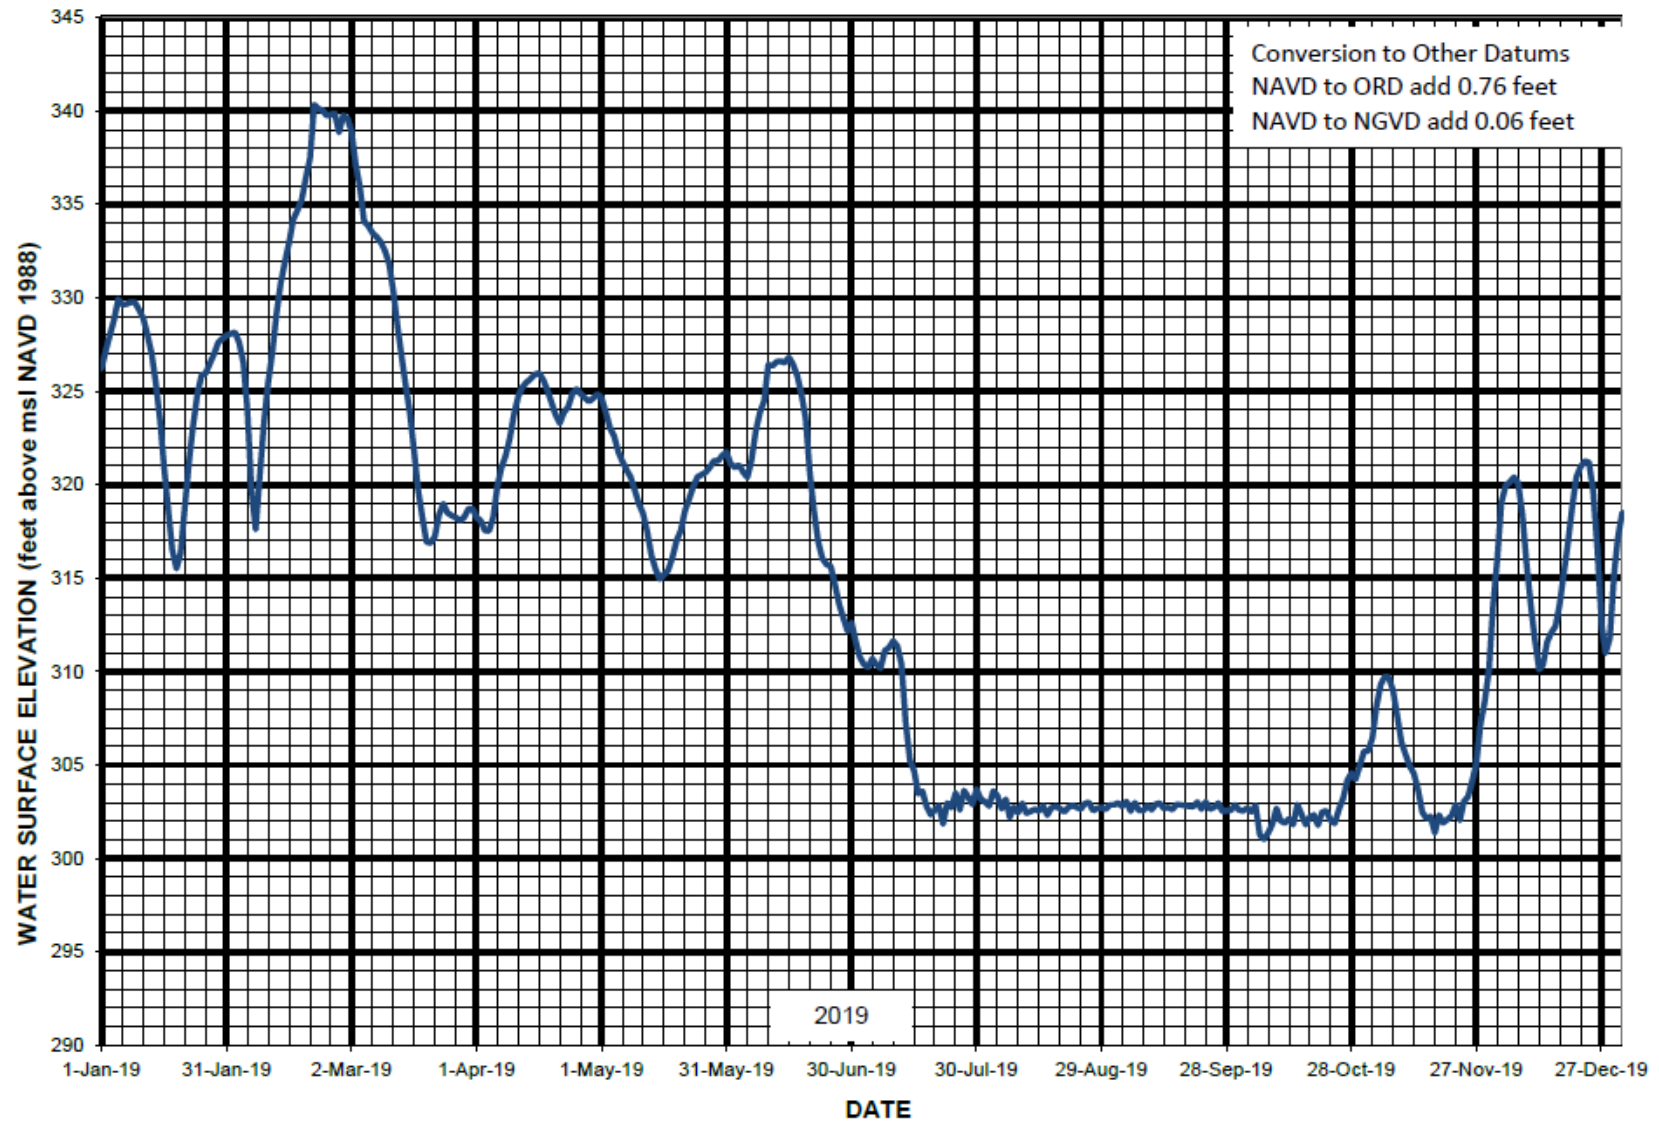
**ATTACHMENT #3
2019 OHIO RIVER HYDROGRAPH
@ LEDBETTER, KY
(TRANSPosed FROM PADUCAH GAGE DATA)**

**OHIO RIVER @ LEDBETTER, KENTUCKY
RIVER MILE 927.6**

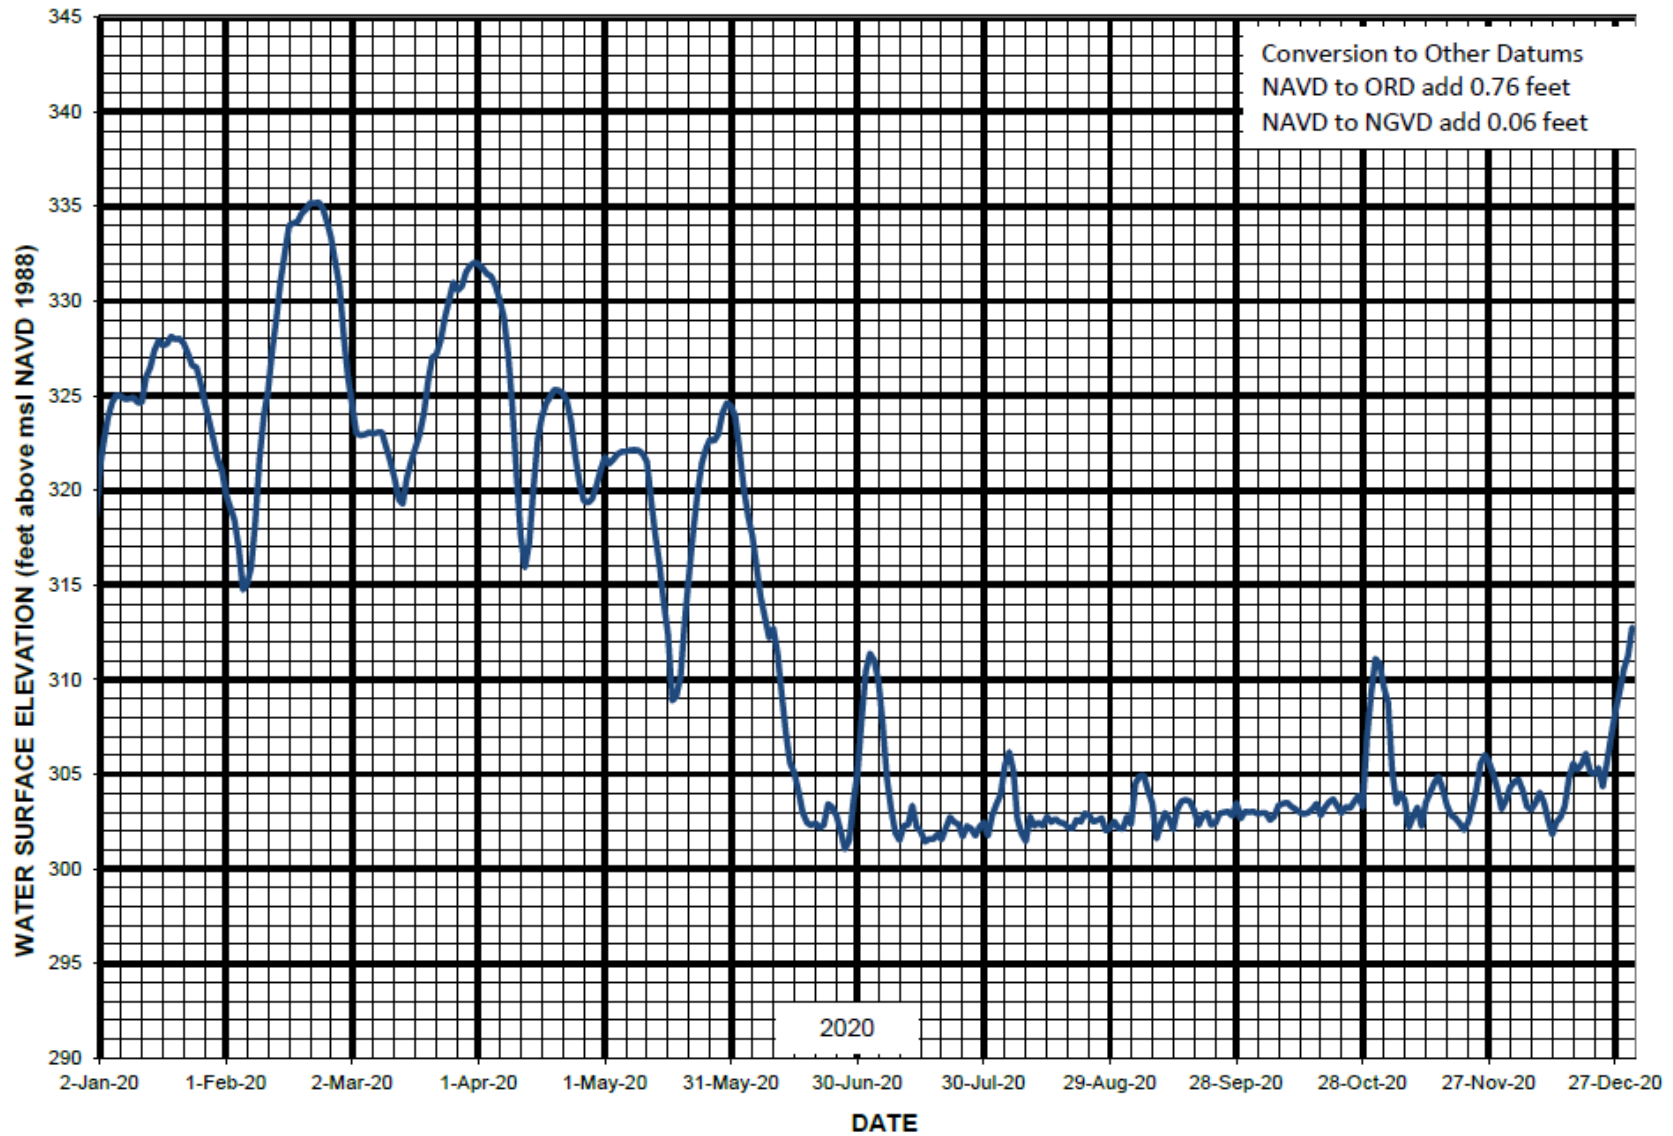
**ATTACHMENT #3
2020 OHIO RIVER HYDROGRAPH
@ LEDBETTER, KY
(TRANPOSED FROM PADUCAH GAGE DATA)**

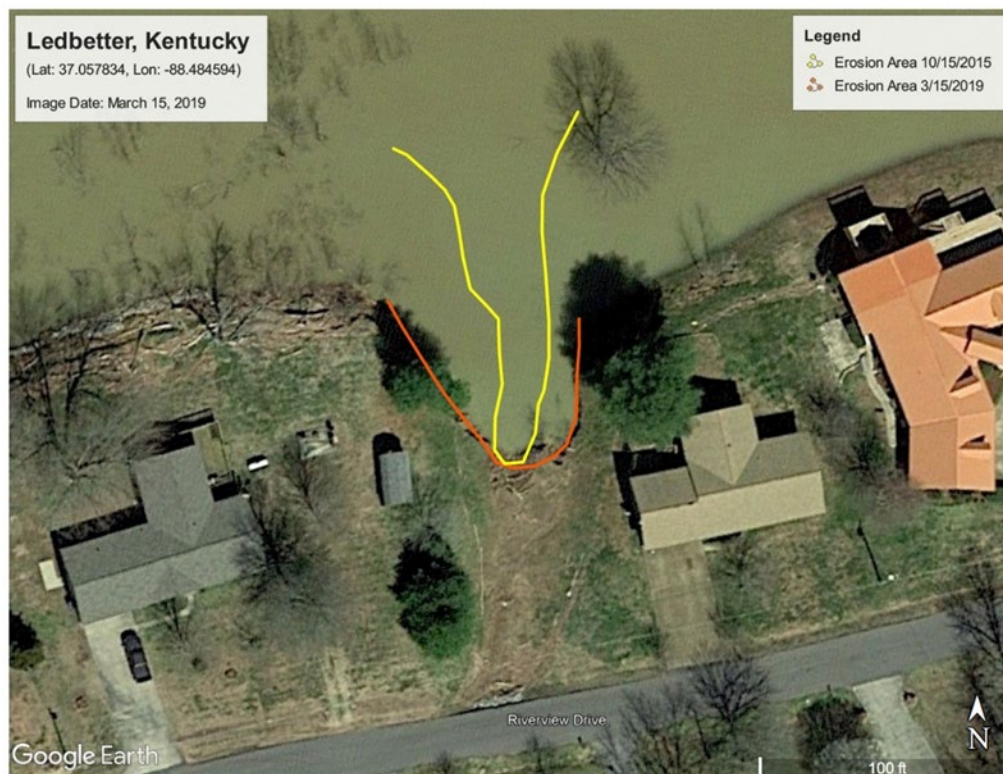
Figure 4. Approximate Erosion Area (10/15/2015 and 3/15/2019).

The estimated outline of the eroded area is shown on Figure 1. Over time, the eroded area appears to have widened significantly as seen in the difference in the approximate extents of the area from 15 October 2015 (yellow line) and 15 March 2019 (orange line).

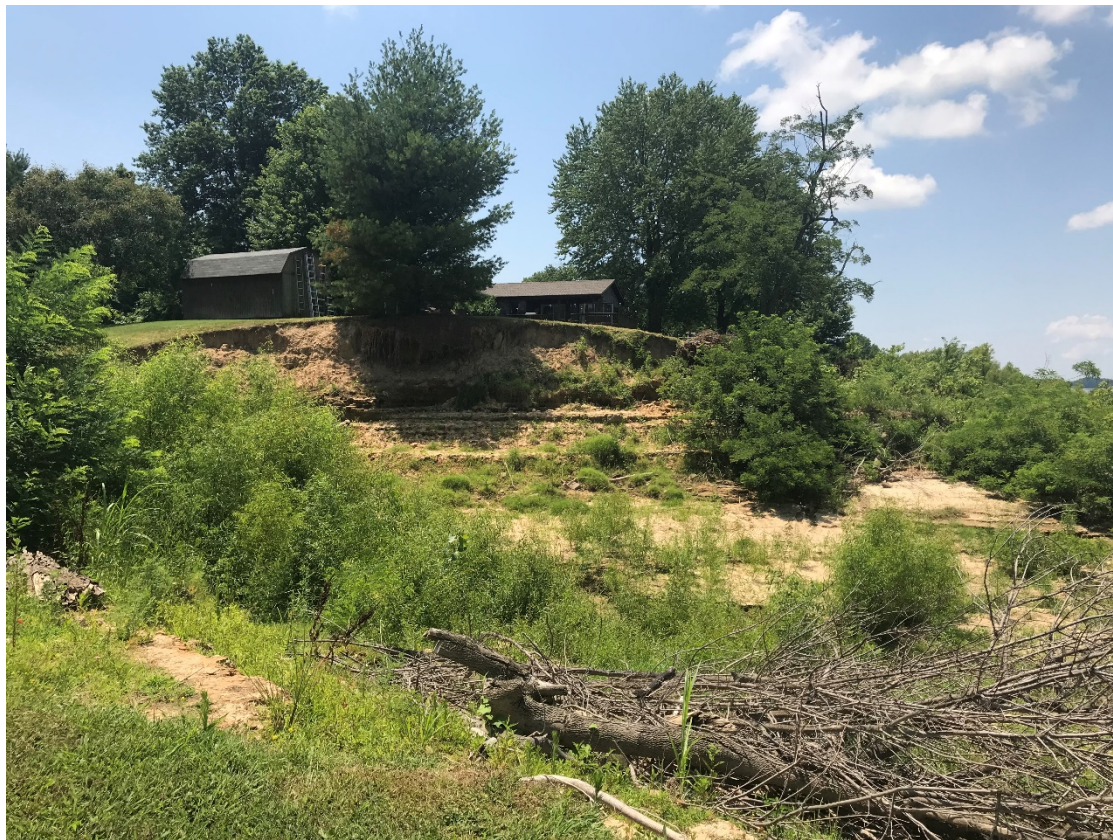
Figure 5. View of erosion within the drainage channel looking southwest (8 JULY 2020 site visit).

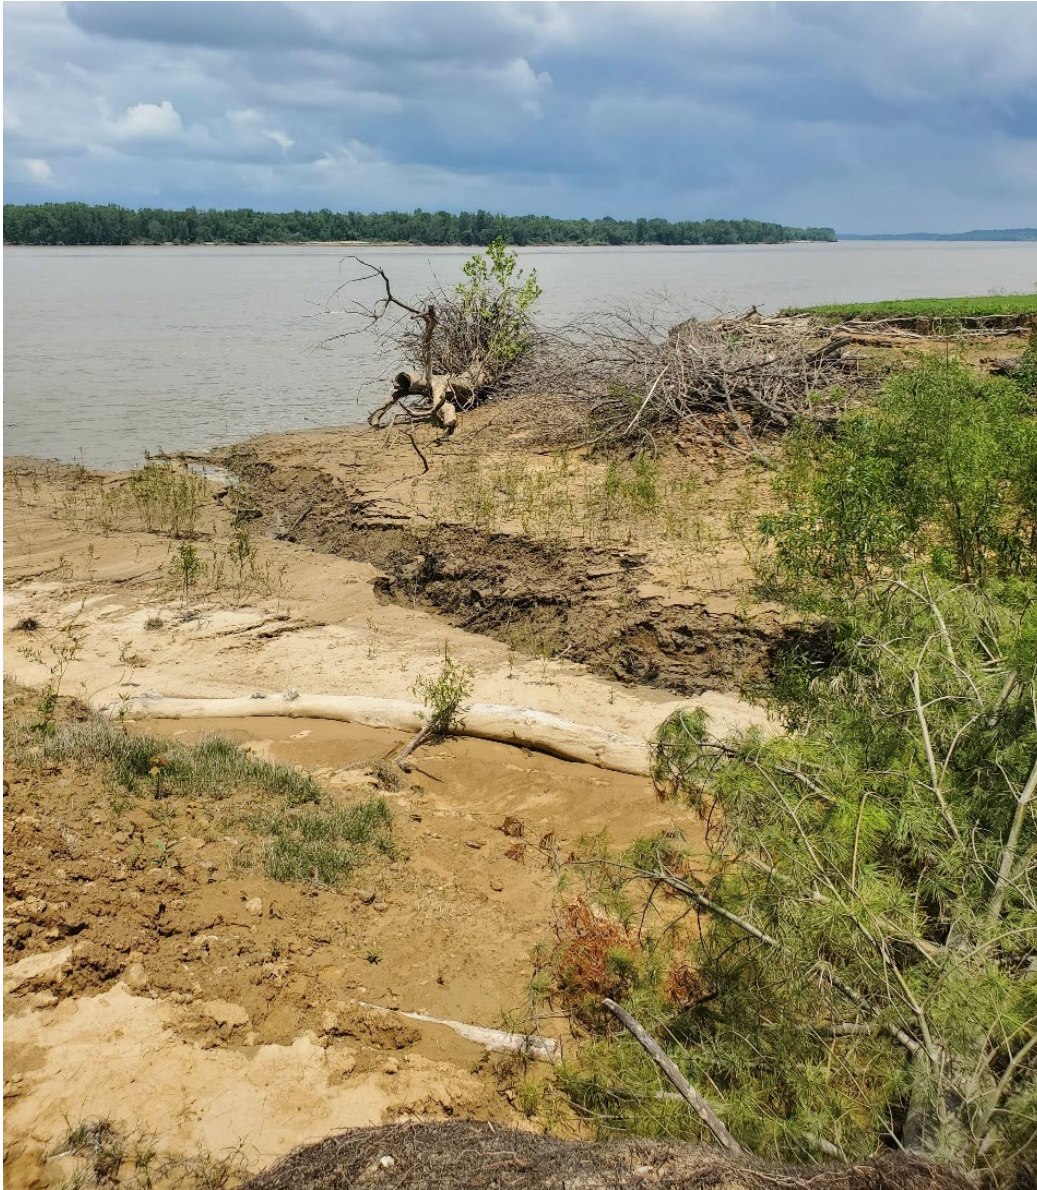
Figure 6: Eroded shoreline within the project area, view north-northeast (photo taken July 6, 2020)

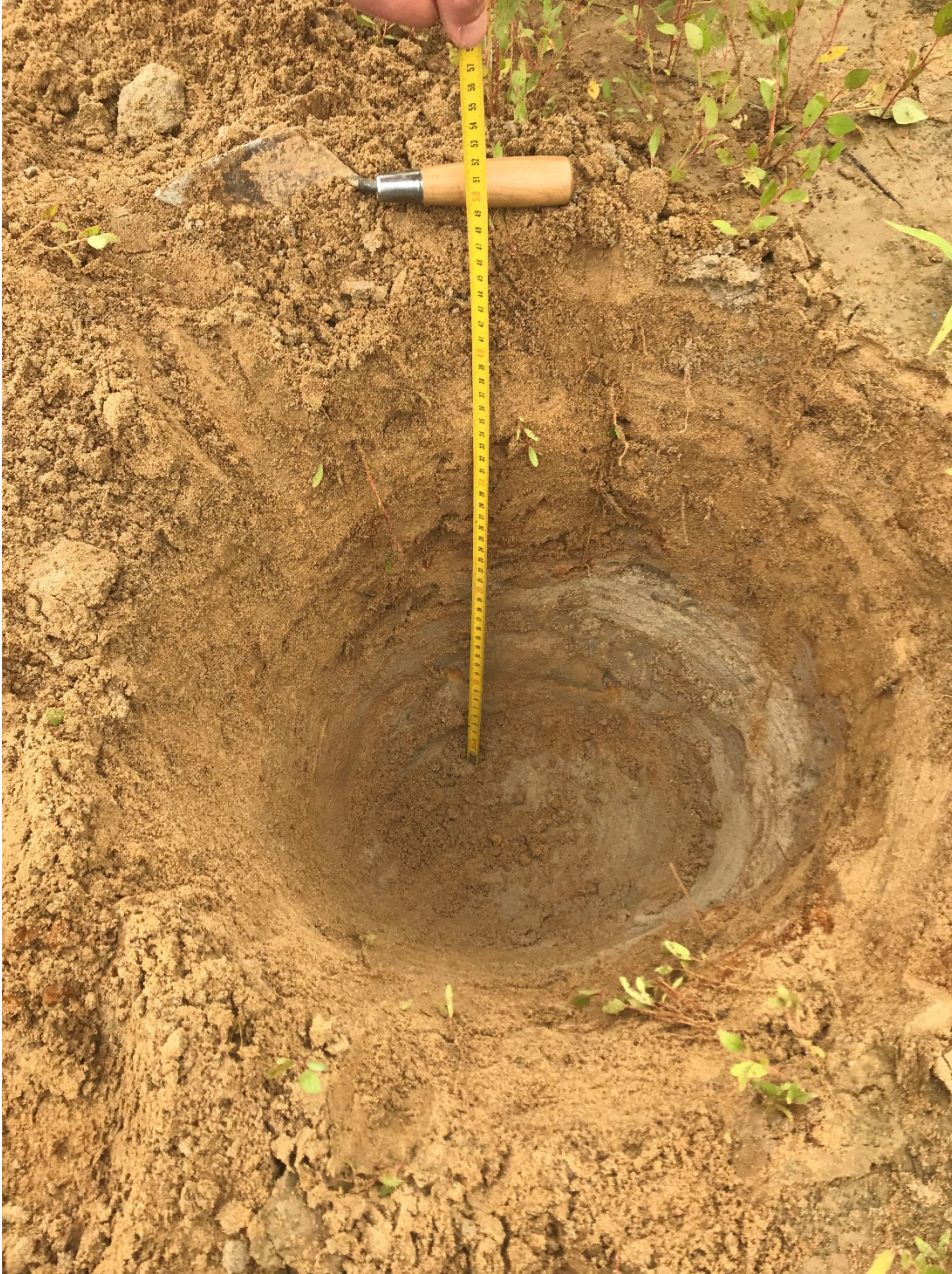
Figure 9: Negative shovel test with sand hydric soils (photo taken July 6, 2020).
