# GREEN RIVER LOCK AND DAM 5 REMOVAL

ROUNDHILL, KENTUCKY

### **BIOLOGICAL ASSESSMENT REPORT**

# APPENDIX C USACE MEMORANDUM

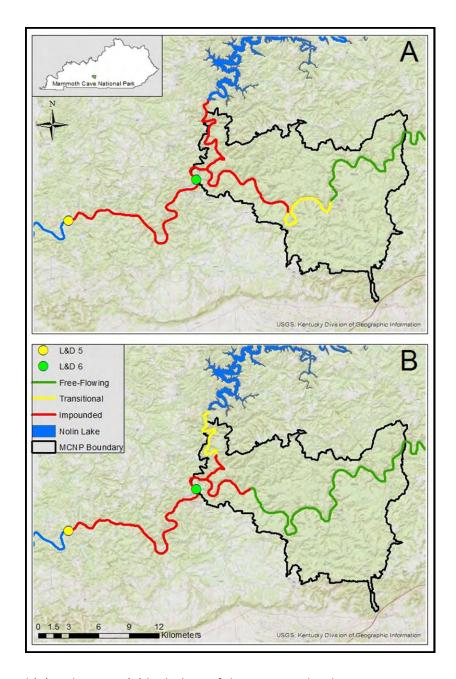
Figure 1. Historical (A) and current (B) hydrology of the Green and Nolin rivers near Mammoth Cave National Park (MCNP).

The extent of the historical hydrological conditions has shifted downstream following the breach of November 2016 and the subsequent dam removal in spring 2017. Currently, the Green River is no longer impacted from L&D 6, but the influence from lock and dam 5 (L&D 5, 37.16867/-86.40328) still remains. The impounded river from L&D 5 extends to the downstream pool of Crump Island on the Green River and upstream on the Nolin River past Second Creek. It is currently unknown if the extent of pool 5 extends upstream of Crump Island during high water. The Green River upstream of Crump Island exhibited free flowing conditions during summer and fall 2017. The current study categorized sites within the Nolin River and Green River, from L&D 6 upstream to Crump Island as impounded (L&D 5), and sites within the Green River, upstream of Crump Island, as free flowing.

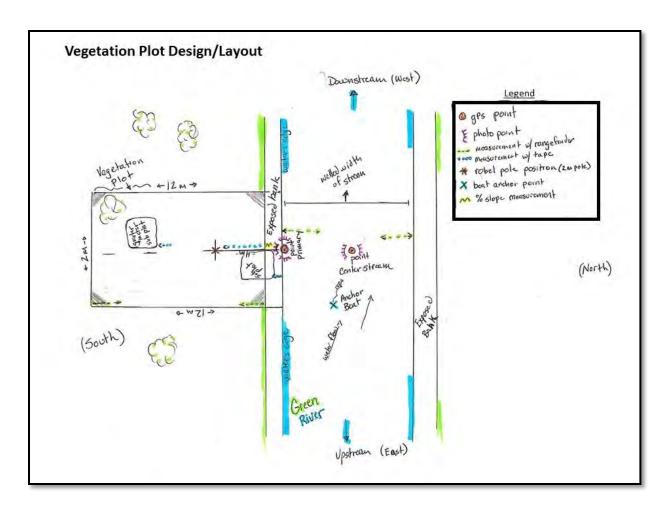
Figure 3. Vegetation site diagram.

Whether using canoe or motorboat, an anchor was essential to holding the boat in one relative location in the middle of the stream (Figure 3). Best accuracy was accomplished by dropping the anchor into the water several meters upstream of the point, with the flow pulling the boat downstream from the anchor (this holds the boat several meters downstream from where the anchor grabs into the stream bottom). A margin of error less the 20 meters was acceptable for recording center-stream location (the set of points created in office were locations used to navigate). If establishing the same plot is deemed important for long-term results, the points collected/installed can be used as the Bad Elf GPS PRO+ (refer to as GPS Pro) is capable of collecting points accurate to 8 feet (2.5 m). However, accuracy attained during sampling of center-stream points were mostly less than 20 feet but not less than 10 feet (multiple points were collected and averaged together). Accuracy information attained from GPS Pro was written on datasheets. Once points were collected in the center of stream, wetted stream width and two photo points of each bank were collected using a SIG Sauer rangefinder (model KILO2000) and a Panasonic Lumix camera (model DMC-TS30), respectively. The wetted width was obtained by aiming the SIG Sauer rangefinder at the water's edge of both banks and adding the two values together for the total wetted width of stream. Several aims at each bank were taken and then compared to strengthen confidence in the readings and eliminate the occasional error in the readings. Photos were taken by kneeling in the motorboat or simply sitting in the canoe, at a collection height of approximately 3 feet/1 m above the water (Figure 4A and 4B).

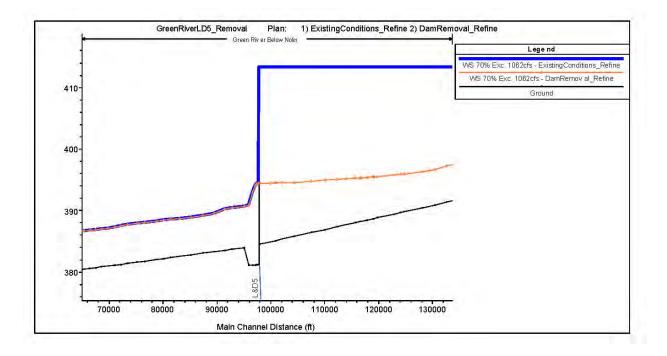
The exhibit shows the water surface profiles for the existing conditions (blue line) and conditions after dam removal (orange line). Both profiles are identical downstream of the dam, indicating that downstream flow is not affected by the dam. In addition, the depth and water surface slope downstream of the dam will remain the same after dam removal.

As documented in the USACE memorandum, GRLD5 does not attenuate flow, change downstream depths, or impact downstream water surface slopes to a measurable degree; therefore, shear stress and sediment transport capacity downstream of the dam are also not affected by the structure and are not expected to change after its removal. As a result, increased scouring and sediment deposition from changes in flow are unlikely to occur downstream after dam removal. Conversely, removal of the dam is expected to reduce scouring downstream of the dam by reducing the turbulent conditions caused by water flowing over the dam. Elimination of the plunging, vertical flow at the dam is anticipated to significantly reduce or stop scouring in the scour area currently located at the base of the dam. The restoration of more natural flow in this area will help retain the material placed in the scour area during dam demolition and allow fine sediments to accumulate in this area after dam removal.

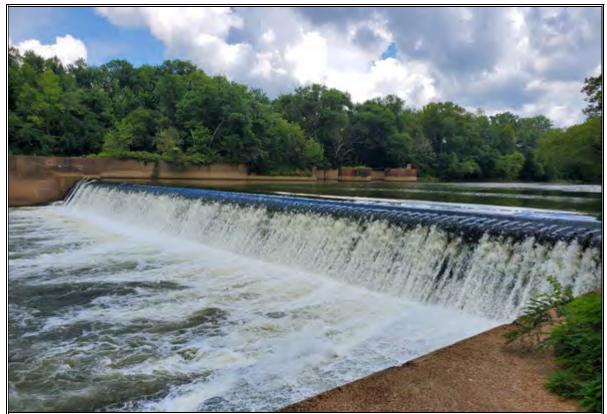
Photograph 1: View of the dam and upstream portion of the lock river wall, facing north from the left descending bank of the Green River. August 14, 2020.

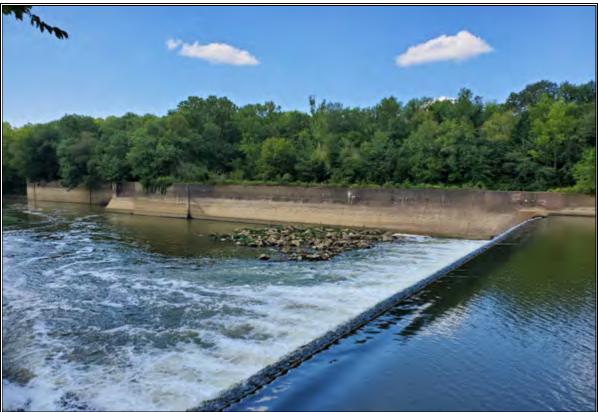
Photograph 2: View of the dam and downstream portion of the lock river wall, facing northwest from the left descending bank of the Green River. August 20, 2020.

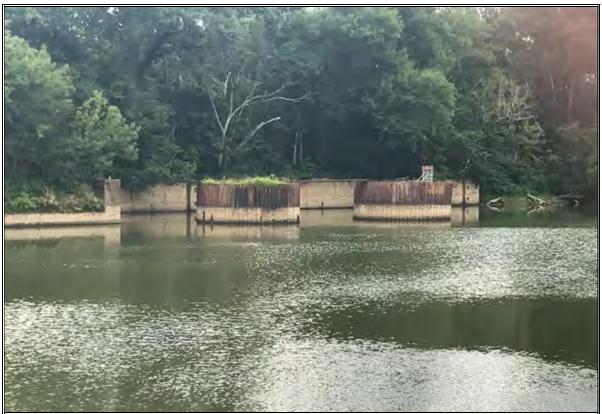
Photograph 3: View of the mooring cells and upstream guide wall (behind mooring cells), facing northeast from the left descending bank of the Green River. August 14, 2020.

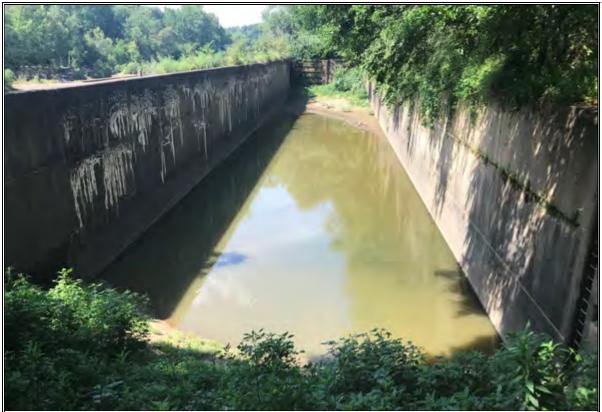
Photograph 4: View of the lock chamber showing the lock river wall (left side) and lock land wall (right side), facing west from the upstream end of the chamber. August 14, 2020.

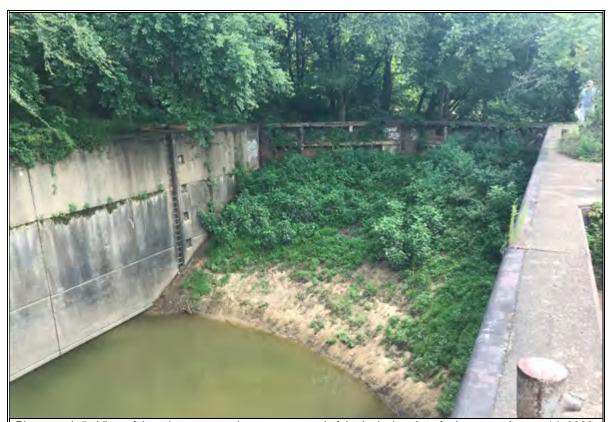
Photograph 5: View of the miter gates at the upstream end of the lock chamber, facing east. August 14, 2020.

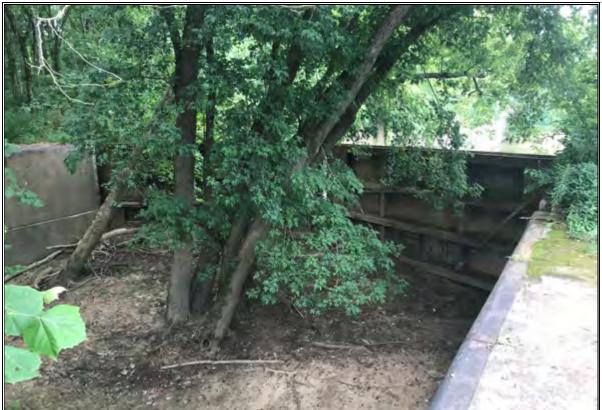
Photograph 6: View of the miter gates at the downstream end of the lock chamber, facing east from outside the chamber. August 14, 2020.

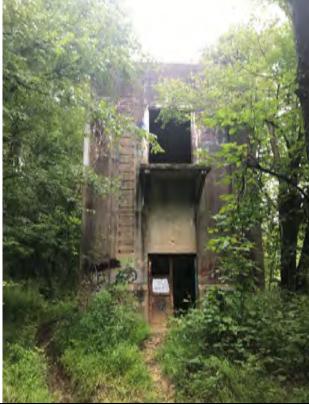
Photograph 7: View of the operations building adjacent to the lock land wall. August 14, 2020.

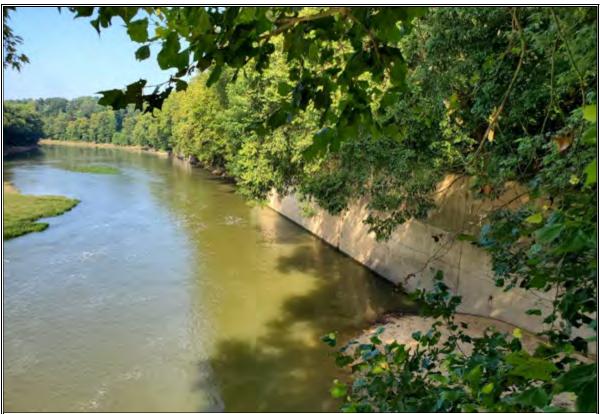
Photograph 8: View of the downstream guide wall, facing west from the end of the lock river wall. August 14, 2020.

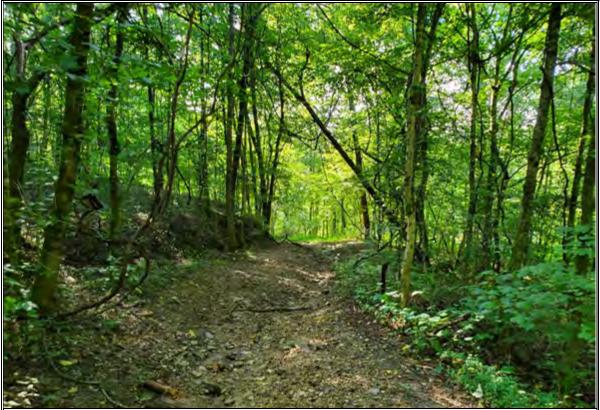
Photograph 9: View of the existing access road in the northern portion of the work area near Lock 5 Road. August 20, 2020.

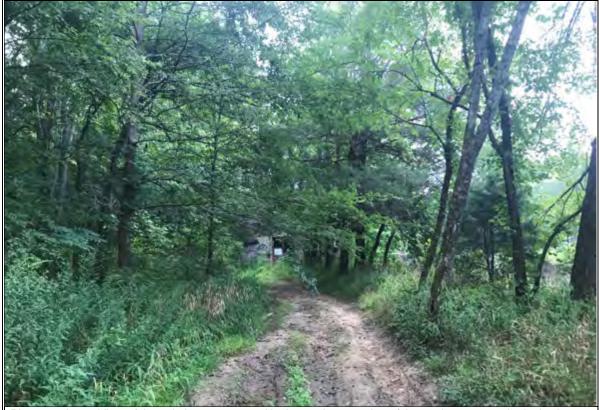
Photograph 10: View of the existing access road in the northern portion of the work area near the lock. August 14, 2020.

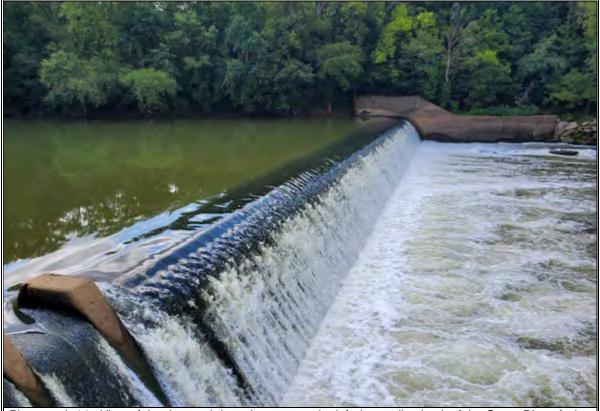
Photograph 14: View of the dam and dam abutment on the left descending bank of the Green River, facing south. August 14, 2020.

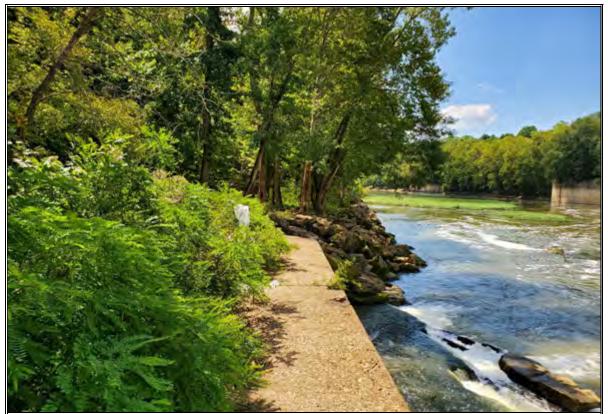
Photograph 15: View of the boulders along the left descending bank downstream of the dam abutment, facing west from the dam abutment. August 20, 2020.

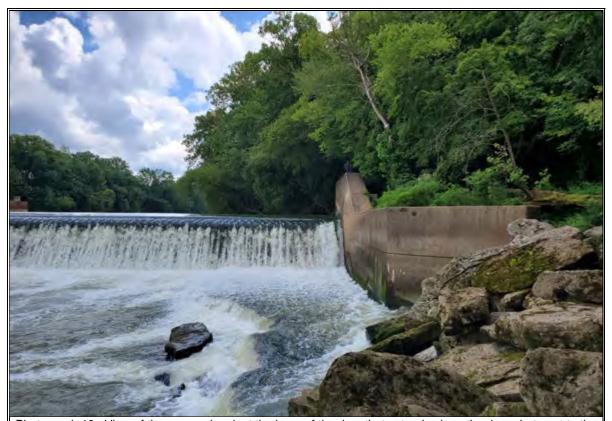
Photograph 16: View of the exposed rock at the base of the dam that extends along the dam abutment to the boulders, facing northeast from the left descending bank. August 14, 2020.

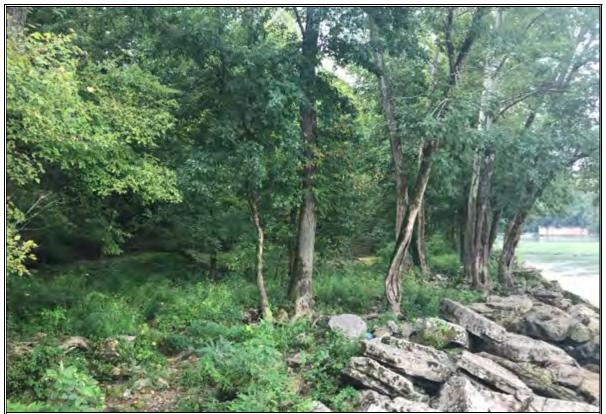
Photograph 17: View of suitable habitat for Price's potato-bean in the southern portion of the work area, facing southwest. No Price's potato-bean was found during the survey of this area. August 14, 2020.

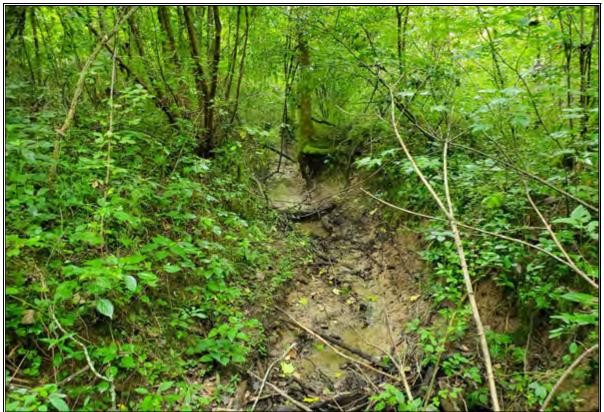
Photograph 18: View of the intermittent tributary to the Green River where a temporary crossing will be required during construction of the access road in the southern portion of the work area. August 14, 2020.

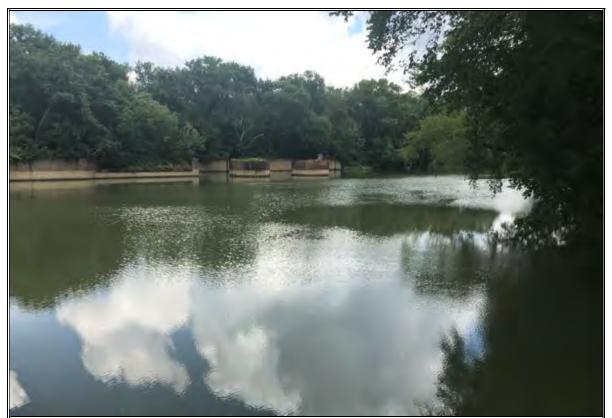
Photograph 19: View of Pool 5 upstream of the dam, facing northeast from the left descending bank of the Green River. August 14, 2020.

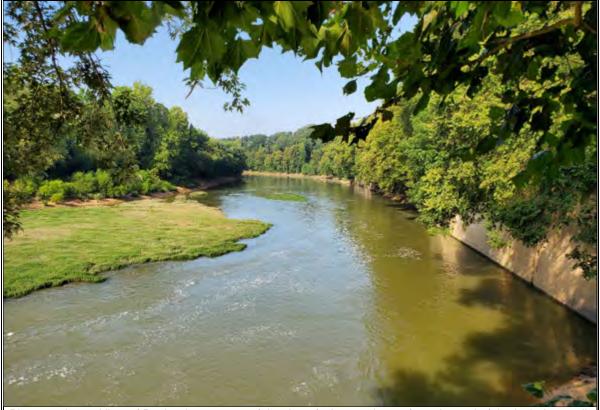
Photograph 20: View of Pool 4 downstream of the dam, facing southwest from the end of the lock river wall. August 14, 2020.

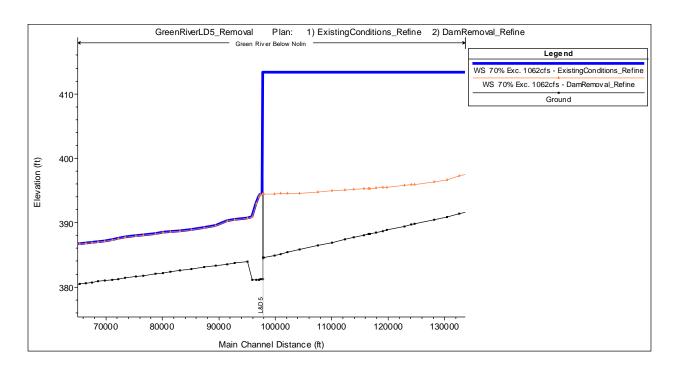
Note that downstream of L&D 5, water surface profiles are identical for both the with- and without-dam scenarios. This modeling, which is both 1-dimentional and steady-state, confirms that both the depth and water surface slope downstream of the dam are not influenced by the removal of the dam. Therefore, because L&D 5 does not attenuate flows, change downstream depths, or impact downstream water surface slopes to a measurable degree, shear stress and therefore sediment transport capacity below the dam are similarly unaffected.

Sediment transport capacity can be viewed as a function of shear stress, as this is the force of the water acting on the stream bed. Shear stress is a function of the weight of water (assumed constant), flow depth, and slope of the water surface. These variables and their response to a removal of the dam were evaluated with limited available hydraulic modeling. The figure below shows water surface profiles along the Green River for the existing condition with the dam in place (blue line), and dam removal condition (orange line). Green River L&D 5 is located near river station 98,000 in the figure. Both profiles are shown for the same flowrate of just over 1,000 cfs, however there is nothing significant about this particular flowrate and it was selected to illustrate trends which were gathered from modeling a full range of flows.
