Appendix B:

Geotechnical and Structural Analyses

APPENDIX B GEOTECHNICAL AND STRUCTURAL

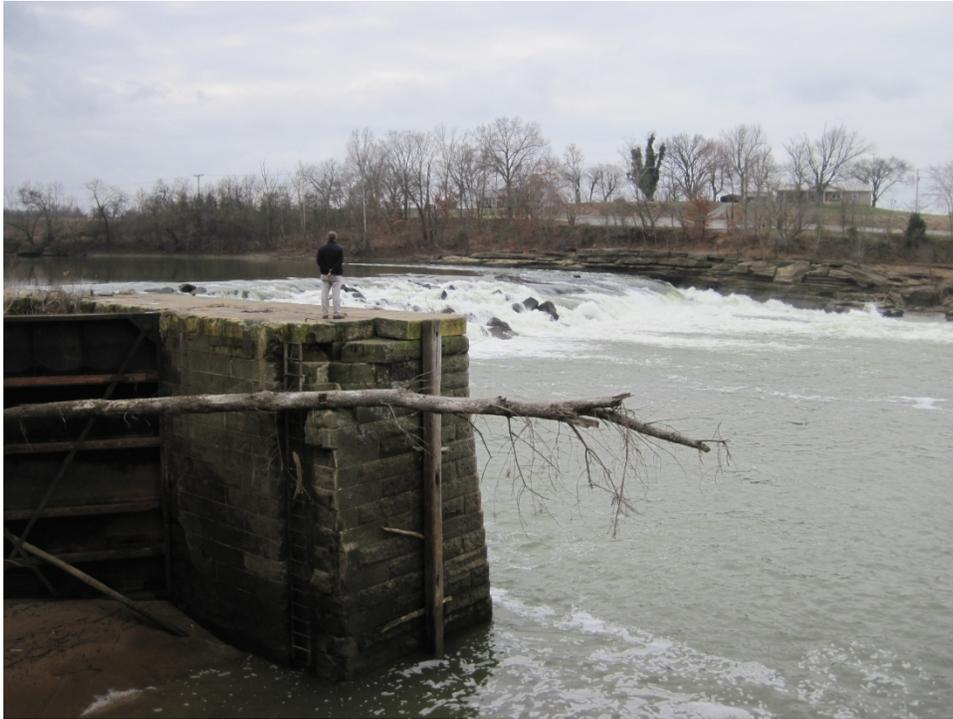
Figure GR3-1: Downstream River Wall and Dam of Green River Lock and Dam #3 (Dec. 2013)

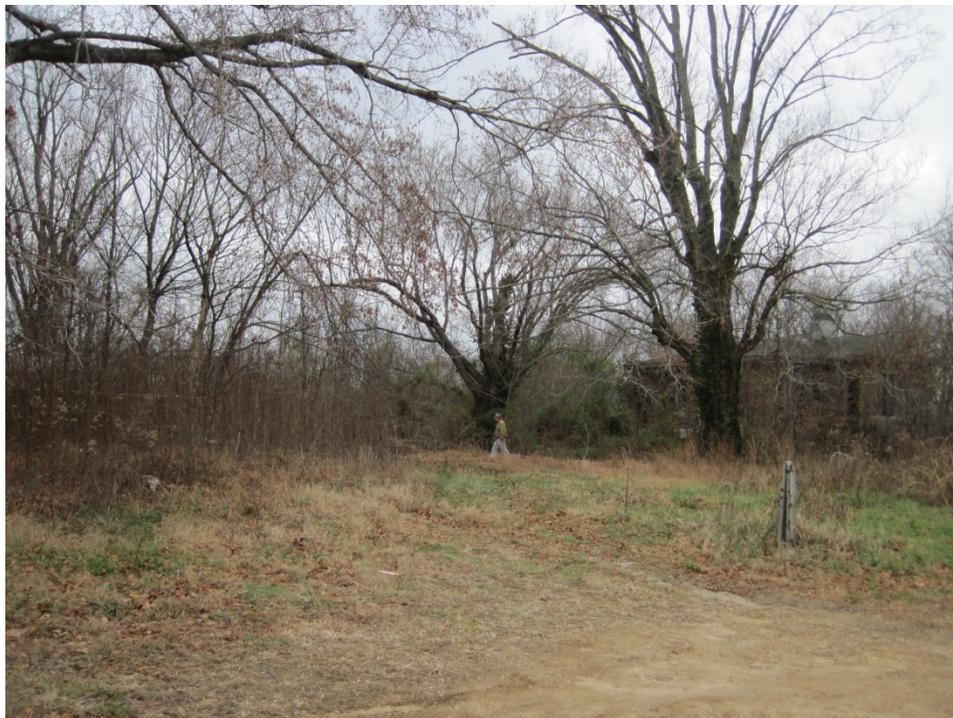
Figure GR3-2: Over grown area around Lock Master's house at Green River Lock and Dam #3 (Dec. 2013)

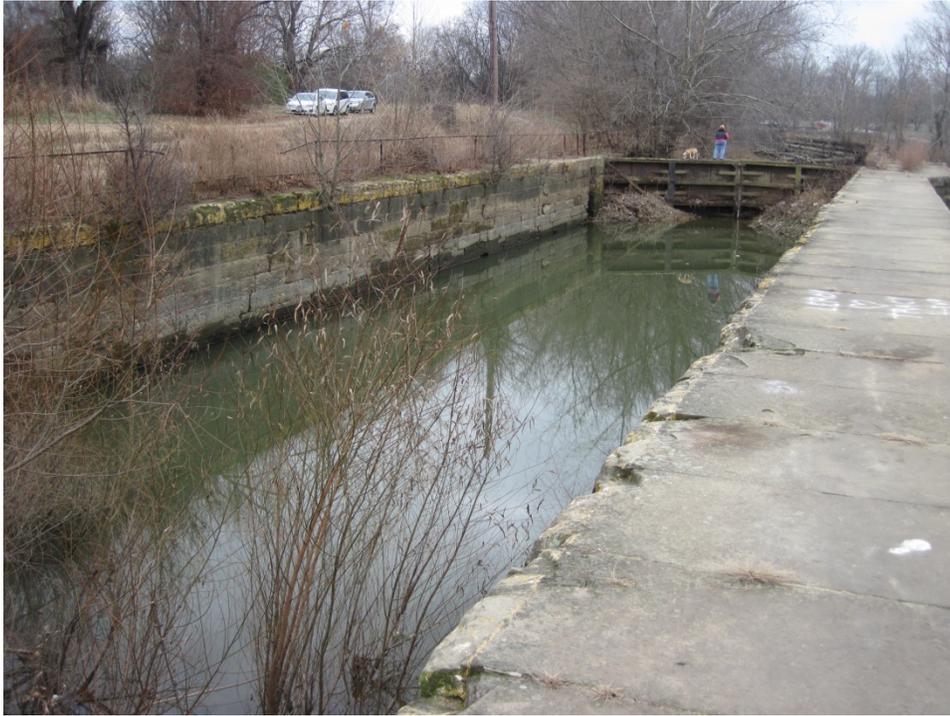
Figure GR3-3: Lock chamber looking upstream from river wall at Green River Lock and Dam #3 (Dec. 2013)

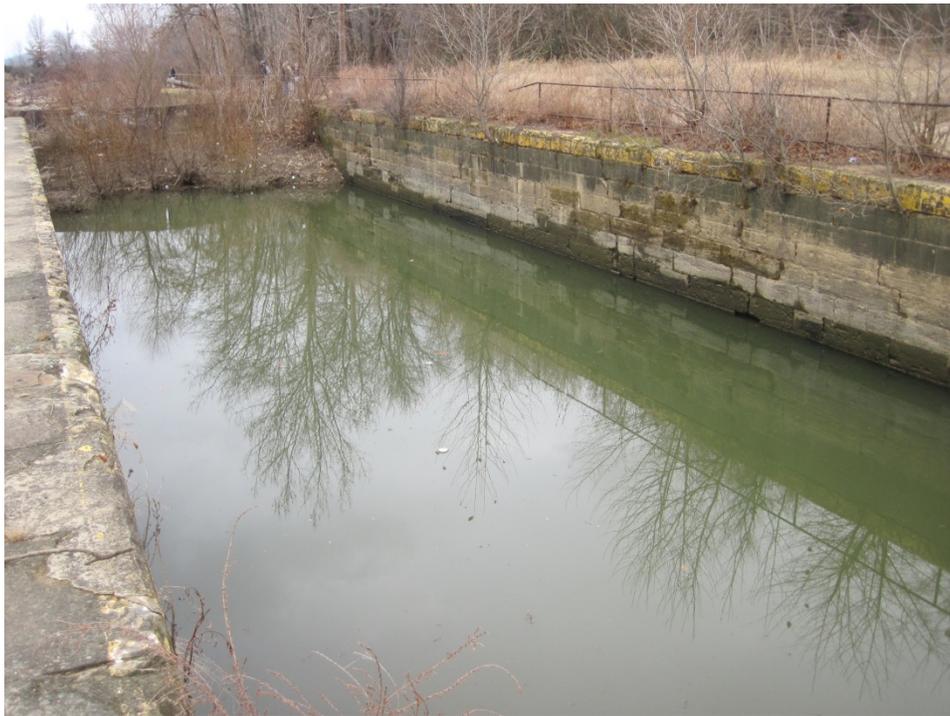
Figure GR3-4: Lock chamber looking downstream from river wall at Green River Lock and Dam #3 (Dec. 2013)

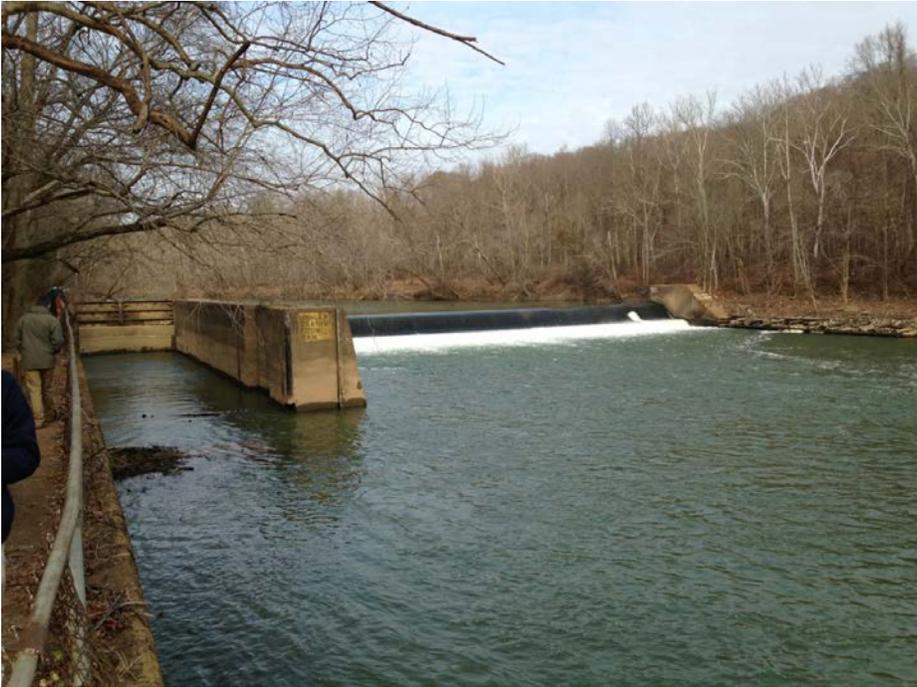
The concrete dam, though underwater at the time of the visit, appears to be in good condition. Since the dam is underwater, any potential undermining, underseepage, or other structural deterioration is unknown (Figure GR6-1). The only way to fully assess the condition of the dam would be when the flow was sufficiently low that water was not passing over the dam. This flow condition is very rare.

Figure GR6-1: Lock chamber and dam from downstream land wall at Green River Lock and Dam #6 (Dec. 2013)

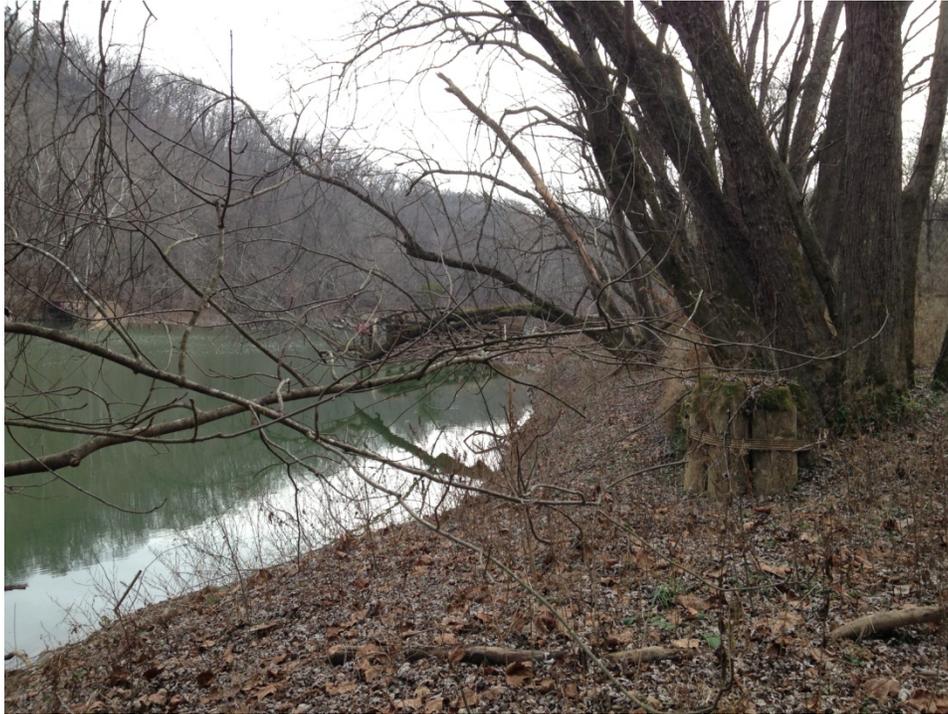
Most of the upper guide and guard walls are made of timber pilings and timber rails. These have been taken over by trees growing through the rails (Figures GR6-5, GR6-9). The complete failure of this wall section will not affect the river flow, or pool. The portion of the upper landside guide wall next to the upper gates is made up of concrete monoliths and is rotating with the growth of trees. A section of this wall was removed for the placement of the sheet pile cutoff wall. The approach channel has become blocked by silt, debris, and vegetation.

Figure GR6-5: Upstream approach channel from right river bank just upstream of Green River Lock and Dam #6 (Dec. 2013)

It appears that the guide and guard wall sections will not cause damage or concern should they continue to move. Therefore, no repair action is recommended. Lock walls appear stable with no repair action recommended. Also, egress for this structure is not an issue since the downstream gates have been removed.

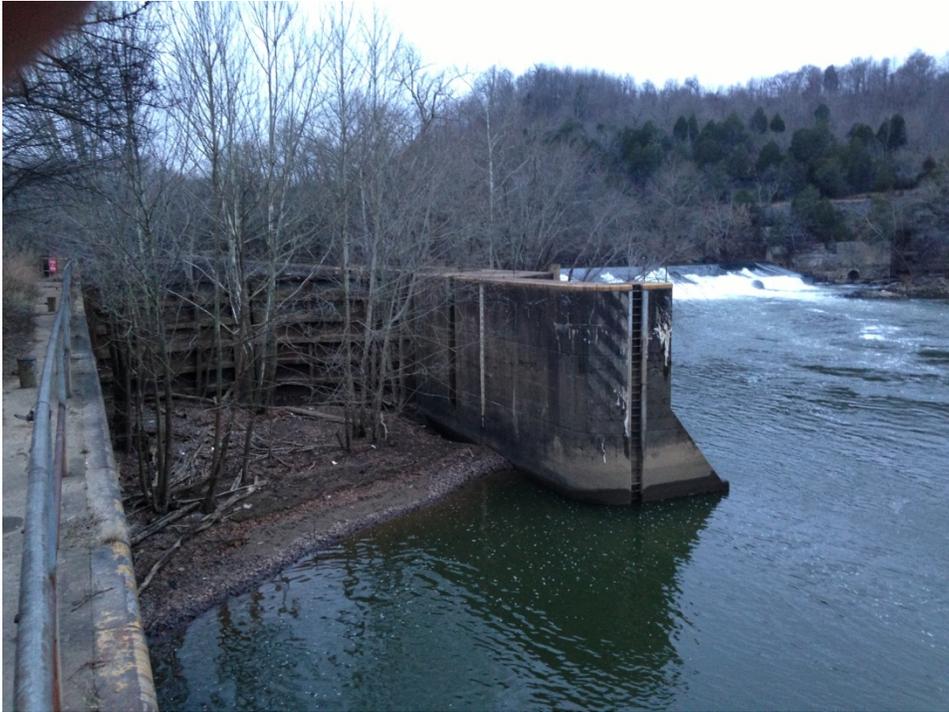
The lock, guide, and guard walls are in good condition (Figures BR1-1 & BR1-5). Their alignments are straight and the condition of the concrete is good. Some of the bulkhead slots, piping, and valve pits are missing their gratings. These have been removed in order to place rock in them, thereby reducing an entrapment hazard.

Figure BR1-1: Downstream River Wall and Dam of Barren River Lock and Dam #1 (Dec. 2013)

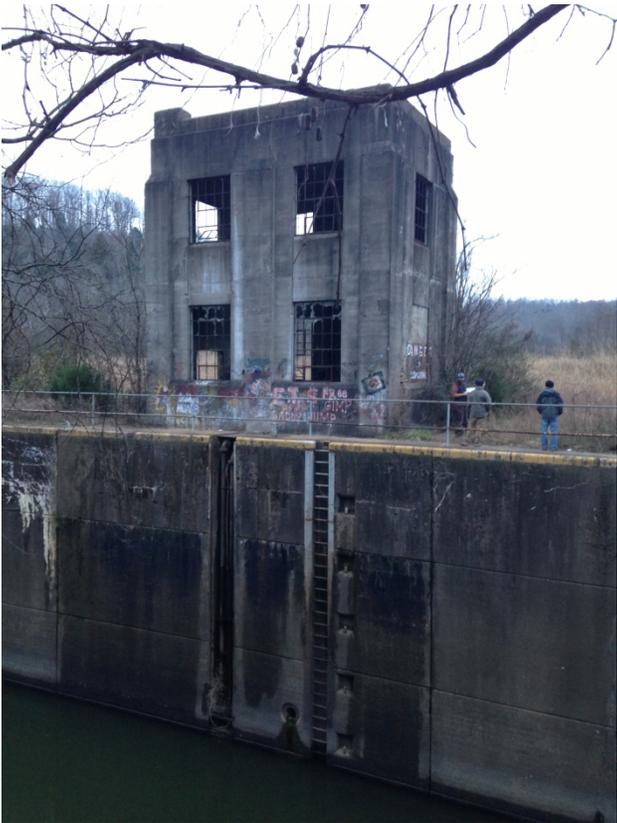
To keep people off the dam side lock wall, the upstream and downstream miter gates could be gated off with fan fencing barricades on the land side miter gates. Egress is provided at this structure through the following ways: ladders located on the lock walls (Figure BR1-2), vegetation and concrete berm just downstream of upstream miter gates (Figure BR1-3 & BR1-4), and the accumulated siltation located near the miter gates (though hard to see this in the photographs from this inspection due to high water during the time of inspection).

Figure BR1-2: Over grown area around Power House on river wall at Barren River Lock and Dam #1 (Dec. 2013)

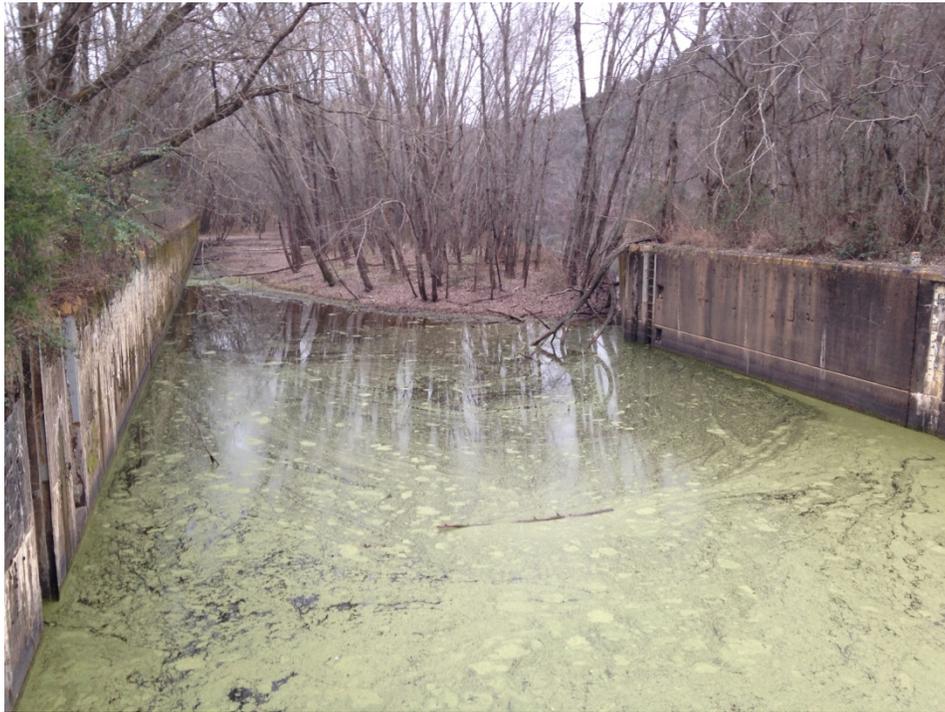
Figure BR1-5: Upstream approach channel from river wall at Barren River Lock and Dam #1 (Dec. 2013)

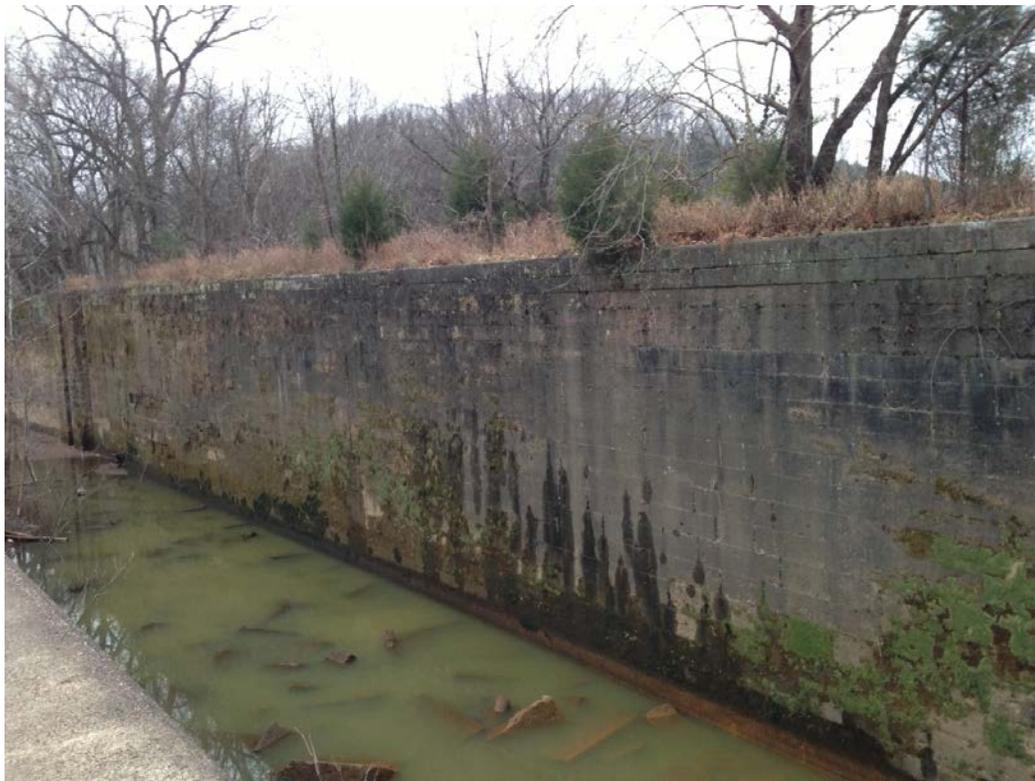
The old lock chamber was put out of service by placing a concrete cutoff wall across the upstream sill, and putting rock fill in the rest of the chamber. This concrete cutoff wall appears to be in good condition (Figure BR1-7). There was not much evidence of the rock fill in the chamber on this visit due to high water. Some of the rock or fill may have settled or washed away (Figure BR1-7).

Figure BR1-11: Old lock chamber with rock fill at Barren River Lock and Dam #1 (Dec. 2013)
