ROOF ASSESSMENT REPORT
FOR

**US Army Corps
of Engineers.**

72 North Street
Danvers, MA 01923

020CHS-087 - 99th RD-MA008

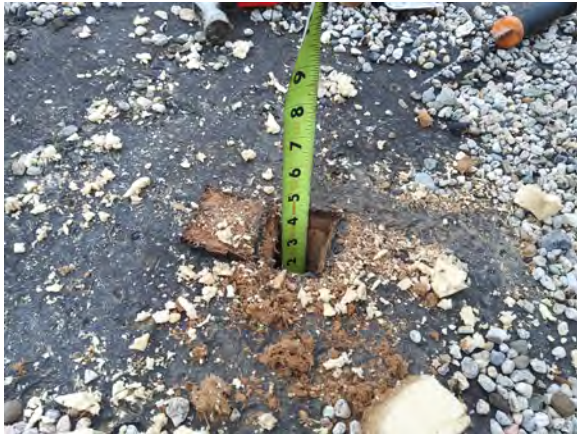
Core Cut:
Gravel
5-Ply Built-up Roof
1/2" Wood Fiber Insulation
3 1/2" Polyisocyanurate Insulation
Steel Deck

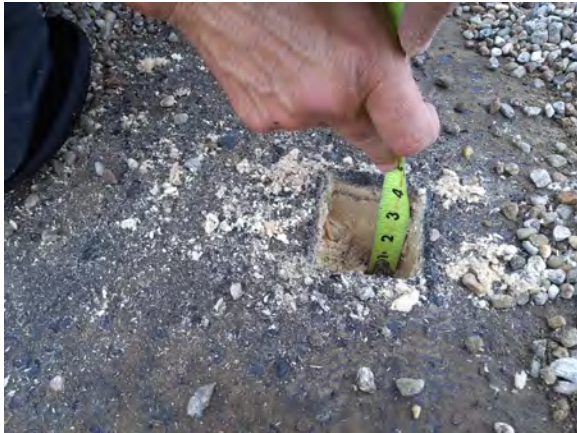
Core Cut:
Gravel
5-Ply Built-up Roof
1/2" Wood Fiber Insulation
3 1/2" Polyisocyanurate Insulation
Ice and Water Shield
Wood Deck
