# A PHASE I ARCHAEOLOGICAL SURVEY OF THE PROPOSED WASTE WATER TREATMENT SITE AT WILLIAM H HARSHA LAKE, CLERMONT COUNTY, OHIO

**April 4, 2019**

U.S.ARMY CORPS OF ENGINEERS LOUISVILLE DISTRICT ATTN: PMC-PL

Report Authored by Jared Barrett Archaeologist, MA, RPA

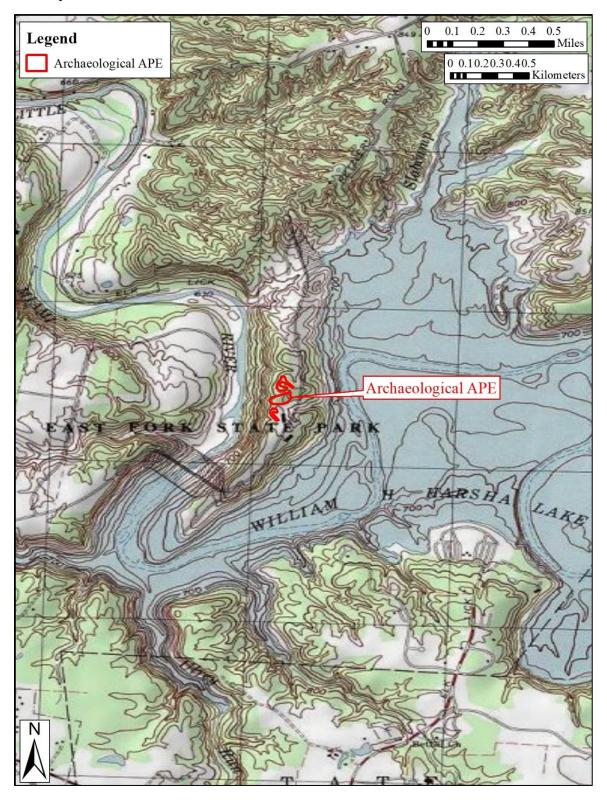
Figure 1: Excerpt of the Batavia, OH topographic map showing location of proposed waste water treatment system at William H. Harsha Lake.

The following report describes the results of the Phase I archaeological survey of the proposed waste water treatment site at William H. Harsha Lake in Clermont County, Ohio (Figures 1–2). The proposed project area is located northwest of the William H. Harsha Lake visitor center on the west side of Slade Road. The project includes three proposed areas for the waste water treatment site as well as the existing waste water treatment plant and a contractor laydown area. The proposed archaeological Area of Potential Effects (APE) measures approximately four acres and consists of the three areas, the existing waste water treatment site and the contractor laydown area.

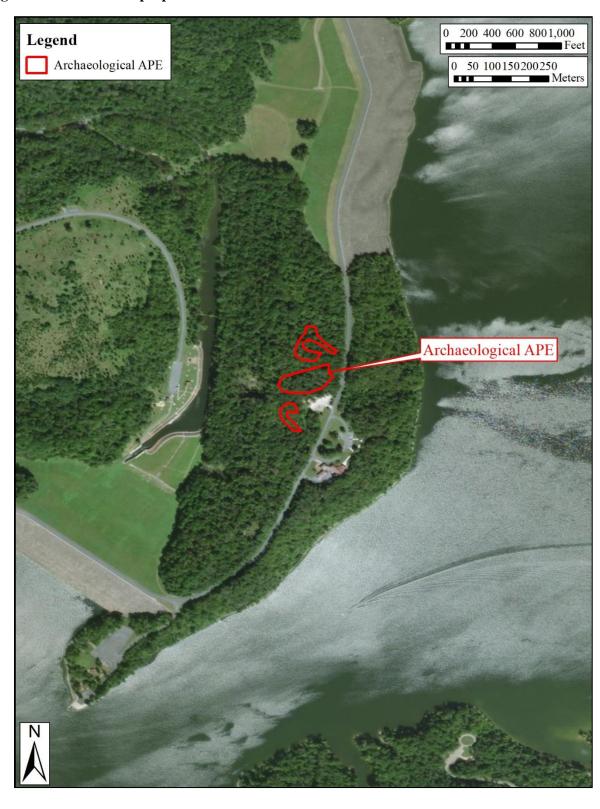
Figure 2: Aerial view of proposed waste water treatment site at William H Harsha Lake.

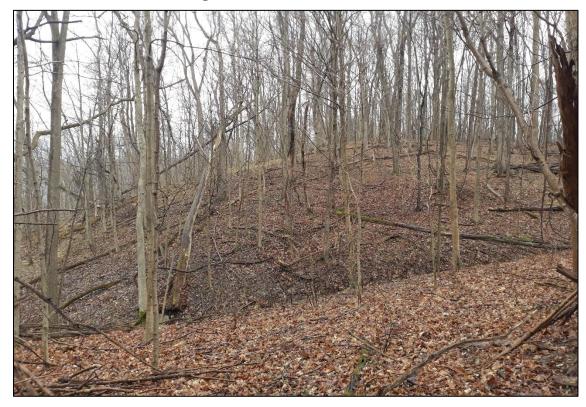
Figure 3: Overview of Area 1, facing north

Land use within the APE consists of forests, an existing waste water treatment plant, and a gravel parking area. General views of the APE are presented in Figures 3 through 6. Vegetation within the project area consists of secondary growth trees and shrubs. The APE is drained by the Little Miami River located west of the project area. Elevations range from between 790 to 840 feet AMSL.

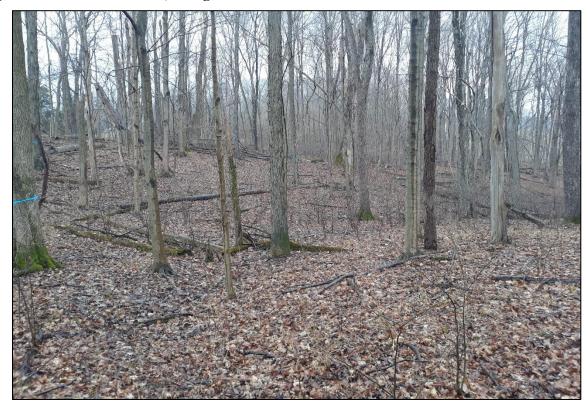
Figure 4: Overview of Area 2, facing south

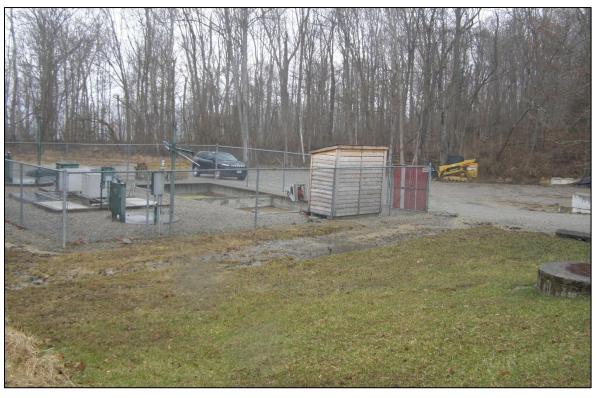
Figure 6: Overview of existing wastewater treatment plant and proposed contractor laydown yard, facing northwest.

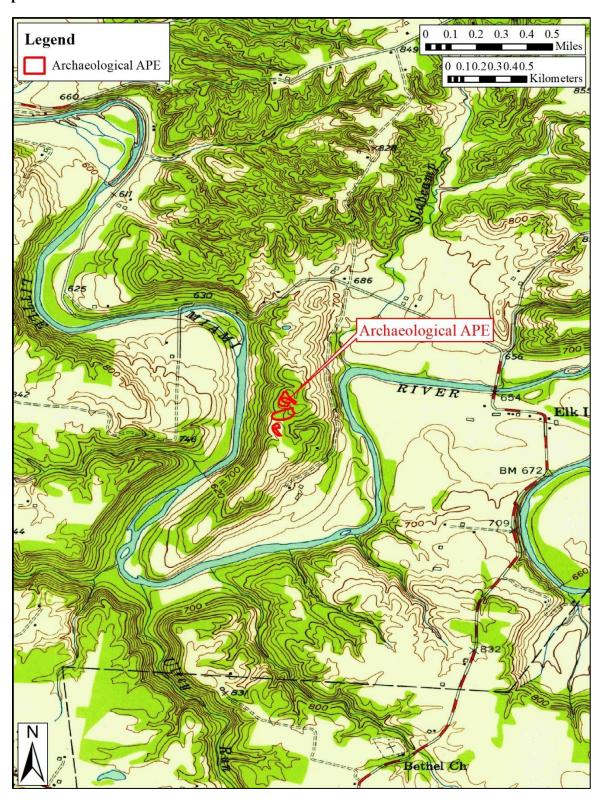
Figure 7: Excerpt of the 1953 Batavia, Ohio topographic map showing location of APE. Note area prior to creation of William H. Harsha Lake.

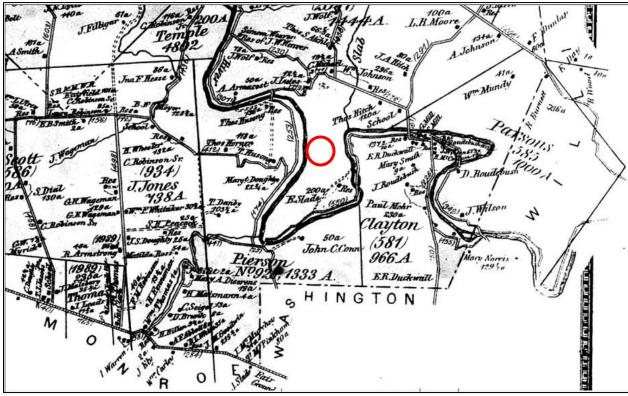
Figure 8: Excerpt of the Batavia Township, Centreville, Olive Branch, and Amelia map Ohio from 1870 showing general location of proposed waste water treatment site (circled in red) (Lake 1870).

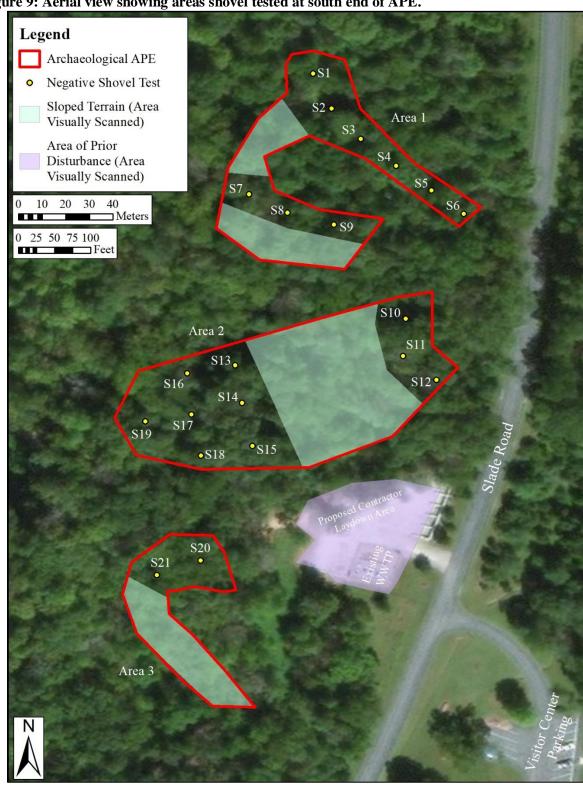
Figure 9: Aerial view showing areas shovel tested at south end of APE.

21 shovel tests were excavated across the three areas that make up the APE (Figure 9). The rest of the APE was subjected to pedestrian survey and visual examination of the sloped terrain that was greater than 15 degrees and previously disturbed terrain (see Figures 3 through 6). Visual examination of the APE did not identify any historic properties or archaeological sites within the project area. All shovel tests excavated during the survey were negative for cultural material. A single soil profile was identified during the course of the survey. The soil profile of shovel tests excavated within Areas 1, 2, and 3 consisted of a dark yellowish brown 10YR 4/4 silty loam clay top soil extending up to 9.8 inches (25 cm) below ground surface. This top soil was underlain by a brownish yellow 10YR 6/6 loamy clay subsoil (Figure 10). For specific soil profiles see Table 2 for further descriptions.

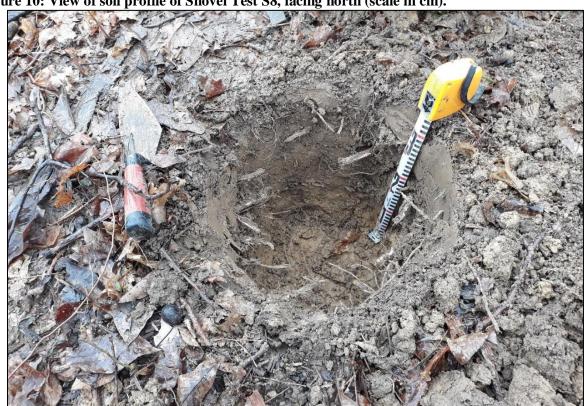
Figure 10: View of soil profile of Shovel Test S8, facing north (scale in cm).

yellowish brown silty loam clay	brownish yellow loamy clay	
S8	0-25 cm: 10YR 4/4 dark	25-35 cm: 10YR 6/6	Negative for cultural material
	yellowish brown silty loam clay	brownish yellow loamy clay	
S9	0-25 cm: 10YR 4/4 dark	25-35 cm: 10YR 6/6	Negative for cultural material
	yellowish brown silty loam clay	brownish yellow loamy clay	
S10	0-25 cm: 10YR 4/4 dark	25-35 cm: 10YR 6/6	Negative for cultural material
	yellowish brown silty loam clay	brownish yellow loamy clay	
S11	0-20 cm: 10YR 4/4 dark	20-30 cm: 10YR 6/6	Negative for cultural material
	yellowish brown silty loam clay	brownish yellow loamy clay	
S12	0-25 cm: 10YR 4/4 dark	25-35 cm: 10YR 6/6	Negative for cultural material
	yellowish brown silty loam clay	brownish yellow loamy clay	
S13	0-25 cm: 10YR 4/4 dark	25-35 cm: 10YR 6/6	Negative for cultural material
	yellowish brown silty loam clay	brownish yellow loamy clay	
S14	0-21 cm: 10YR 4/4 dark	21-31 cm: 10YR 6/6	Negative for cultural material
